## Final Report Work Period: September 1, 2021 – November 30, 2023

For Texas On-Site Sewage Facility (OSSF) Research Contract #582-22-31192

# Understanding Problems and Identifying Solutions for Texas OSSFs using Drip Irrigation

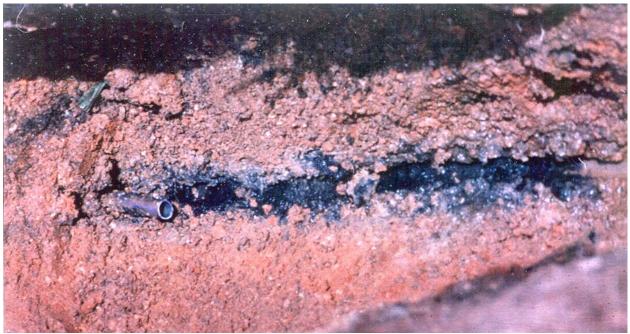
Figure 5. Drip dispersal of primary effluent not working because of organic overloading (about 4.5 years in use).

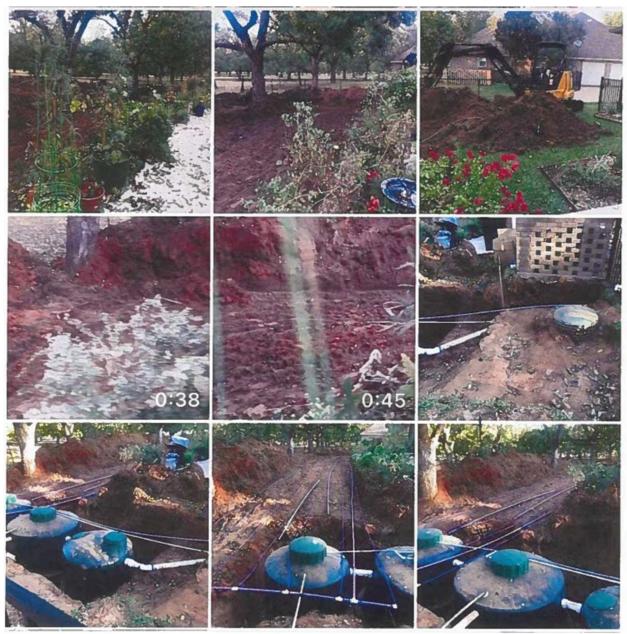
One of the cases regarded a property located in the Pecan Plantation neighborhood, where the drip system was installed on October 10, 2022 (Fig. 8). At the time of the visit, it was noticed that effluent was surfacing in several areas (Fig. 9). Design Information included a drip field 1,500 square feet large, 4-bedroom home, soil texture group IV. If calculated according to the Texas Rules, the required area would be at least 3,600 square feet (360 gpd with water saving devices ÷ loading rate 0.1 gpd/sq.ft. for a Class IV Soil). The owner purchased the house in the year 2013, knowing that the previously failing system was fixed, but the repaired system started failing in 2021 (which means in less than 10 years).

Figure 8. Pecan Plantation site, Hood County, Texas (Site # 1-1). Images taken at installation, October 10, 2022 (Photos taken by homeowner).

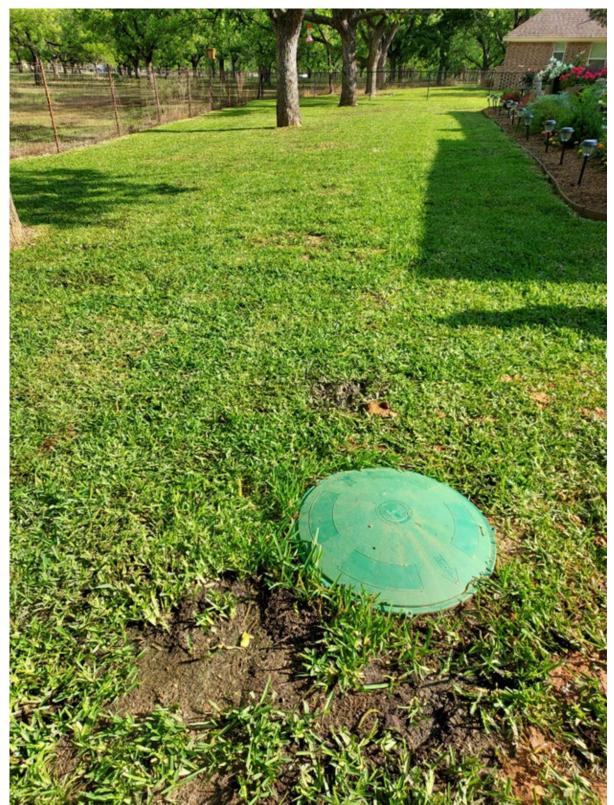
Figure 9. Pecan Plantation site (Site # 1-1), Hood County, visited on May 3, 2023 (Photo Anish Jantrania).

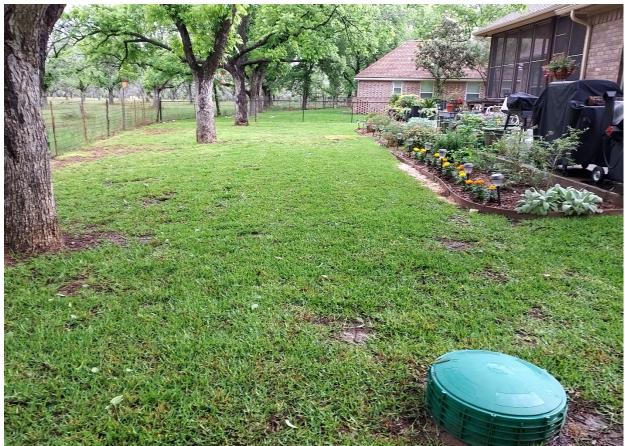
Based on a follow up interview with the Health Department, conducted at the end of the summer 2023, a new contractor was then hired (after the visit by AgriLife here reported) and started repairing the system in July 2023. During the repair, the contractor found old leaching chambers under the drip full of water. The contractor dug up the chambers and filled the entire area with the gravel material that he uses for his drip installation and installed a new drip system (Fig. 10). Upon revisiting the site in May 2024, the repaired drip field appeared to have fixed the effluent surfacing problems and the homeowner indicated that the system was finally working fine for them (Fig. 11).

Figure 11. Pecan Plantation site (Site # 1-1), visited on May 2, 2024 (Photo Anish Jantrania).

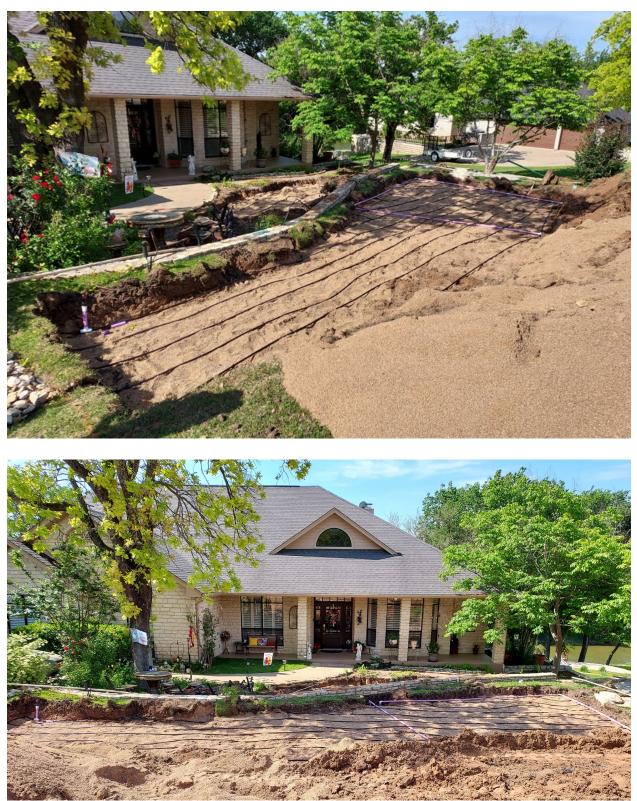
Figure 12 shows another property where the same contractor was installing a repair system using his approach for drip systems. Based on a follow up interview with the Health Department, the repaired system started operating on July 14, 2023, and no problems had been noticed, although very little rain had fallen since the repair. Figure 13 shows the photos taken during the follow-up visit in May 2024, where the system was observed to be operating in good condition. These observations suggest that it may be beneficial in certain site conditions to use gravel bedding for installation of drip systems.

Figure 12. New way of doing it – Using gravel as bedding materials. (Site # 1-2). (Photo Anish Jantrania).

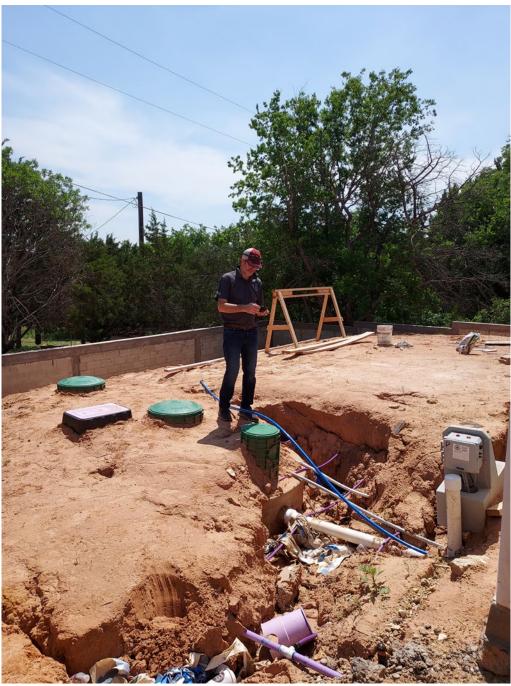
Figure 14 shows another case visited, where a new installation was not in use yet. The issues observed at the site included improper fill and the retaining wall installed without a liner or drains. A year later, the same site was visited in May 2024, and the house was still not occupied; however, the drip field was repaired, and the retaining wall repair was ongoing (Fig. 15).

Figure 14. New Installation not in use yet (Site # 1-6).

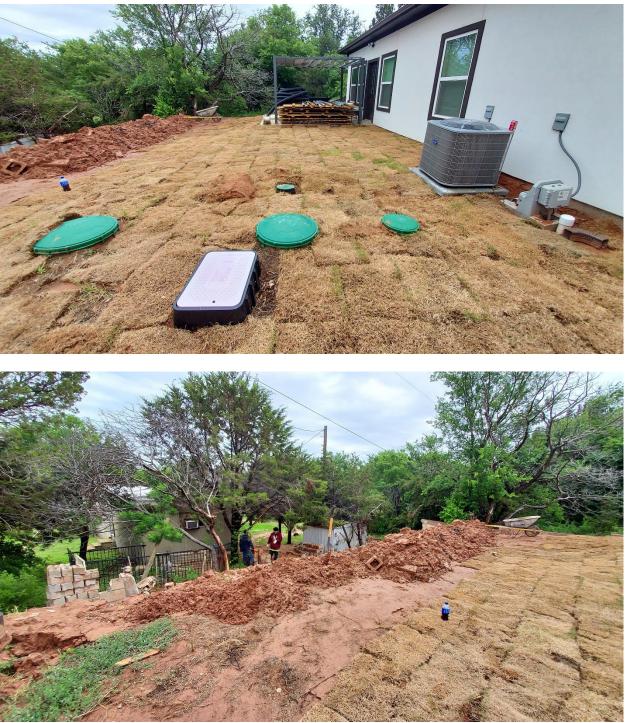
Figure 15. Site # 1-6, visited on May 2, 2024 (Photo Anish Jantrania)

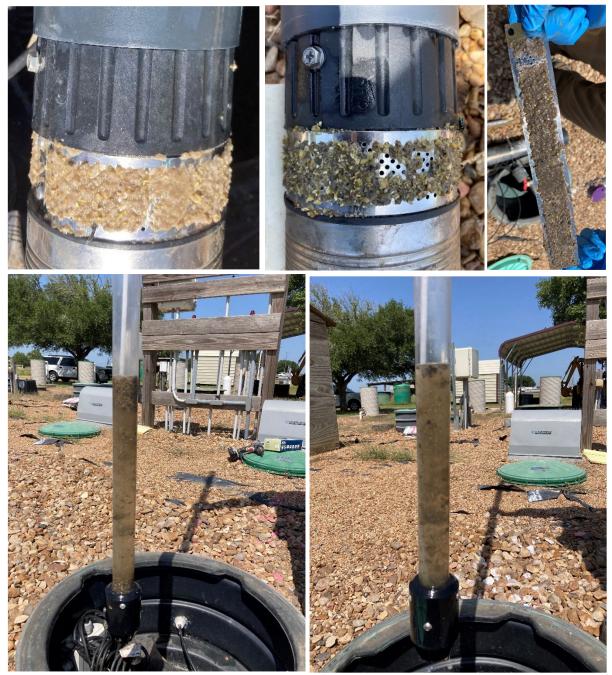
Figure 27. Pump filters clogged probably due to the combination of chicken feed and toilet paper. Chicken feed was not used anymore after the first applications: Pump filter clogged on July 14 and 17, 2023 (TOP); sludge judge test from Sc pump tank (BOTTOM LEFT) and from Sc.A/D pump tank (BOTTOM RIGHT), on July 19, 2023.

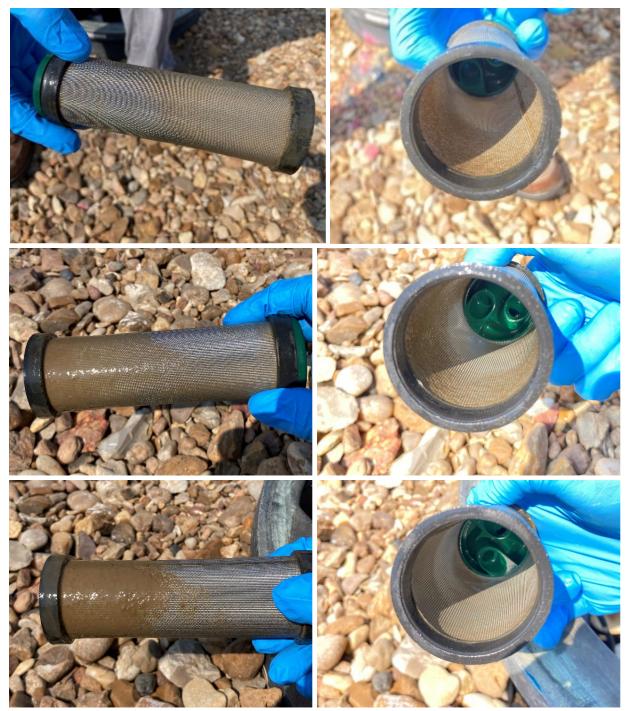
Figure 29. Filters status on August 25, 2023, after several days of sludge application: Simple screen (TOP), Aztec Dual Spin Filter #1 (MIDDLE), Aztec Dual Spin Filter #1 (BOTTOM).

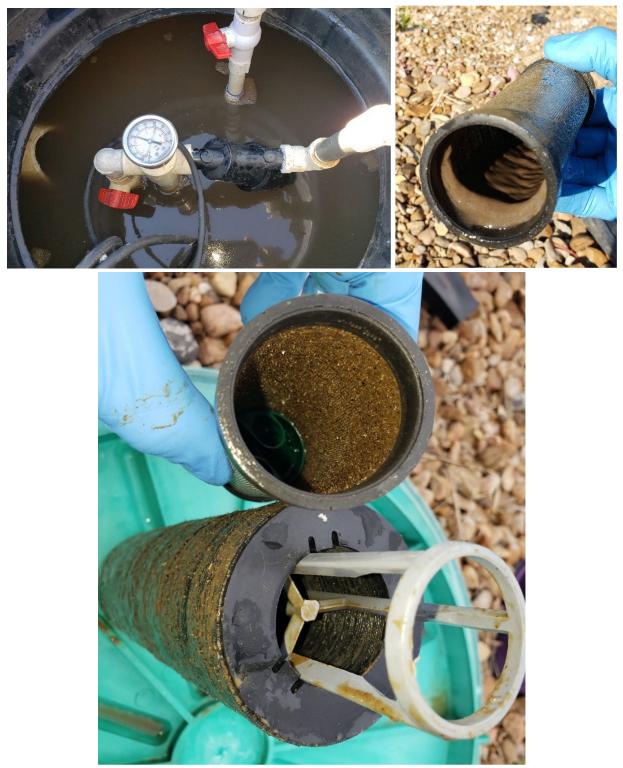
- <u>Artificial clogging was successful</u>, with high water alarm occurring on five occasions: August 28, September 18, October 10, November 8, and November 30, 2023. The typical scenario included (example from August 28, after capping back flow for the simple screen): pump found running at 42 psi; water not going out to the drip field; filter 100% plugged; pump running in override mode with water temperature at 46 degrees C (normally was 35 C); filter removed and cleaned; back flush line re installed; everything back to normal (Figs. 29-31).

Figure 30. Pump tank high water and clogged filters a few days after capping the back filter flow: pump tank and simple screen on August 28, 2023 (TOP); simple screen and disc on October 10, 2023 (BOTTOM).

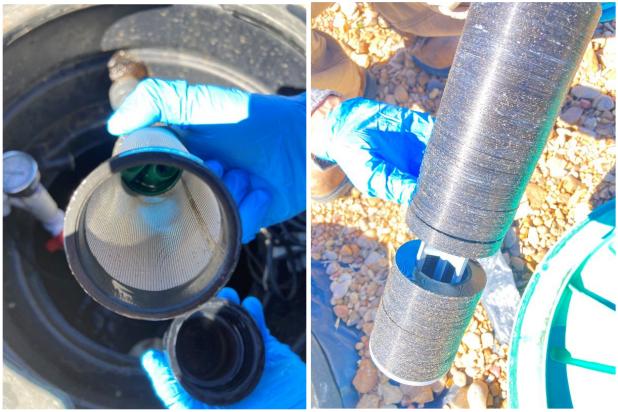
Figure 31. Once the back flush lines were reinstalled, filters looked clean again (October 17, 2023).

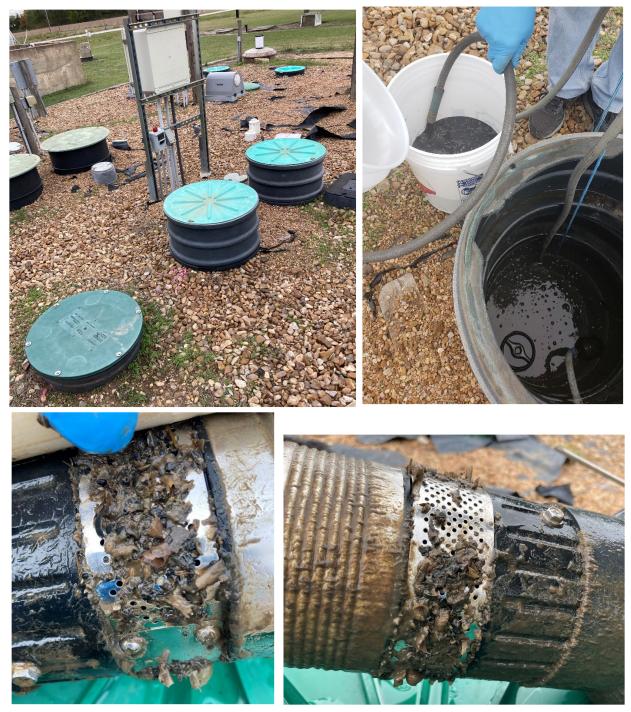
- On November 2-8, 2023, sludge was collected from the <u>trash tank</u>, and added only to the pump tank with the simple screen filter. <u>Right after applications</u>, both flow and the pressure declined during the dosing, likely due to a clogging that was observed in the pump filter (Fig. 32).

Figure 32. On November 2, 2023, sludge started to be collected from the trash tank (TOP). The flow and pressure declined during the dosing, likely due to the pump filter clogging (November 8, 2023, BOTTOM).

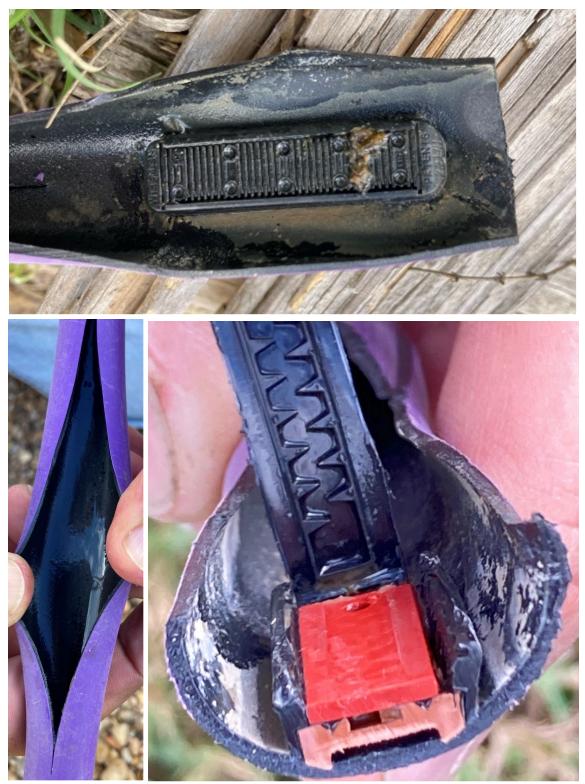
Figure 33. Drip line was cut open and observed toward the end of the experiment, right before the final clogging phases (November 8, 2023). Very little deposit was found in the end portions of the line, including in the emitters.

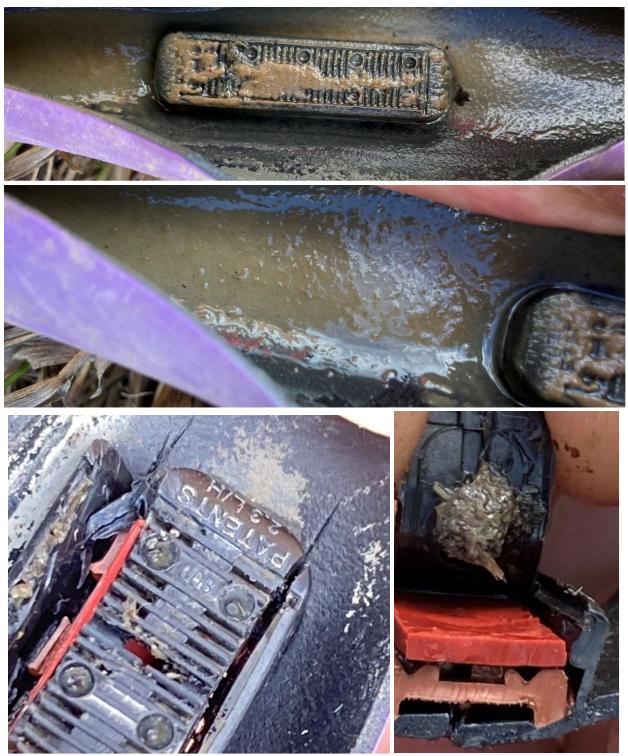
- On November 8 and 11, 2023, the drip line was sectioned and observed. It is evident the presence of <u>deposit outside the tubing near the emitters</u>, inside the tubing, and inside the <u>emitters</u> (Figs. 33-35). On December 11, 2023, the drip line was sectioned again. The inside of the line looked clean, likely because no sludge had been added for weeks in the last phases and the line was flushed on November 7 and 8. On the other hand, <u>emitters showed signs of clogging</u>, which was likely the reason for the flow's constant decline (Fig. 36).

Figure 34. More deposit compared to the front or end of the line was found in middle sections (November 8, 2023). It is evident the deposit of some material inside the tubing, including inside the emitter.

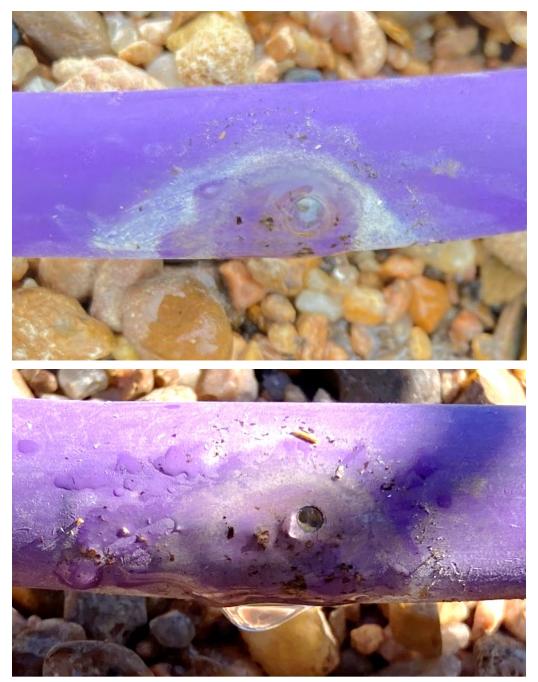
Figure 35. Some deposit was found outside the line, including larger material likely due to the type of sludge added in the last days (from the trash tank). Pictures were taken on the same portion of the line on November 11 (top) and on November 15 (bottom).

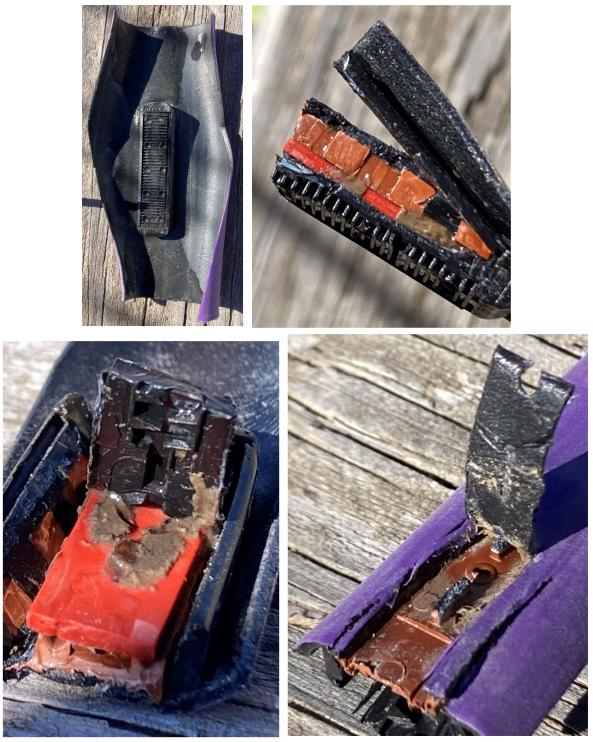
Figure 36. Simple screen filter line section on December 11, 2023. Line looked clean, likely because no sludge had been added for weeks in the last phases, and the line was flushed on November 7 and 8; emitters, on the other hand, showed signs of clogging, which was likely the reason for the flow constant decline.
