Final Report DRAFT
Work Period: September 1, 2019 – August 31, 2021

For Texas On-Site Sewage Facility (OSSF) Research Contract #582-19-96830

Implementation of Low Pressure Dose Systems with Various Configurations

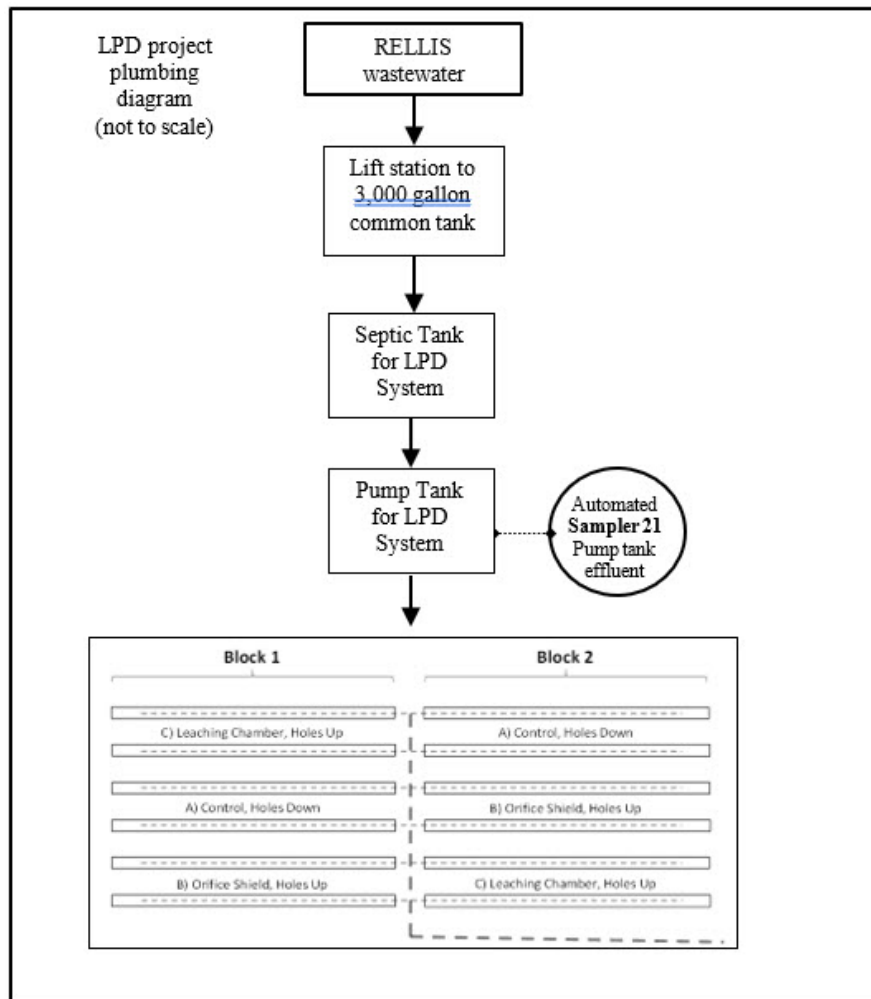
Figure 4. LPD experiment plumbing design

LPD field experiment plumbing design included the following: a continuous wastewater flow supplied by the RELIS Campus wastewater treatment facility to the existing lift station operating near the research facility; raw wastewater added to the existing 3,000-gallon common tank (feed tank) that supplies wastewater to all three research projects funded by the TCEQ Solicitation; a dedicated pump in the feed tank to supply raw wastewater to a septic tank for the LPD System, which is connected to a pump tank by gravity; one automatic sampler installed (Sampler #21) to collect weekly samples from the pump tank effluent; and a pump tank used to dose the LPD drain field (Figure 4). An aerial view of the AgriLife Waste Water Research Facility Center, at Texas A&M RELIS Campus, Bryan Texas is shown in Figure 5. Indicated are all areas used for the TOGP Grant Application Number 582-19-93772, and details shown for the LPD field experiment, including plumbing design and planned drain field.

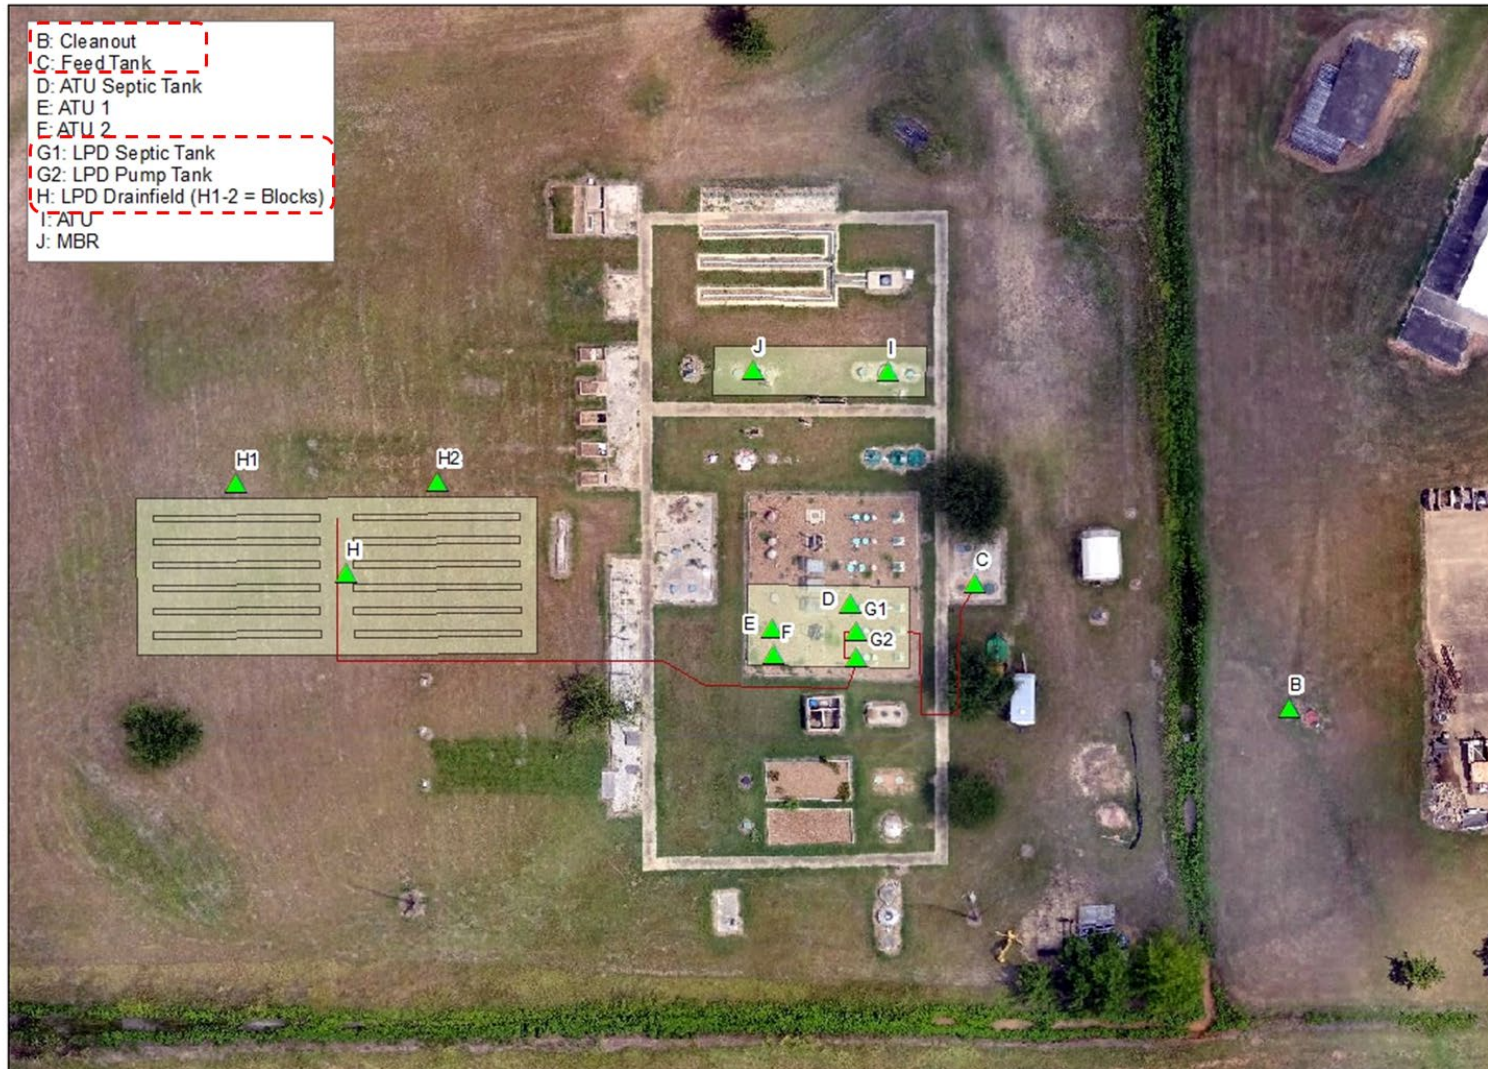
Figure 5. Aerial view of the AgriLife Waste Water Research Facility Center, at Texas A&M RELLIS Campus, Bryan Texas. Indicated are all areas used for the TOGP Grant Application Number 582-19-93772. Details are shown for the LPD field experiment, including plumbing design and planned drain field

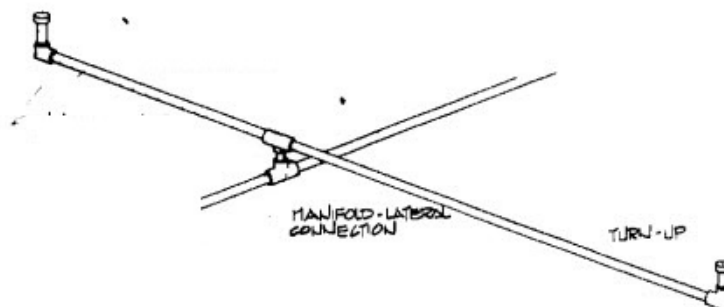
Figure 6. Schematic of the distribution system connection between manifold and lateral (extracted from North Carolina State University Sea Grant College Publication UNC-S82-03).

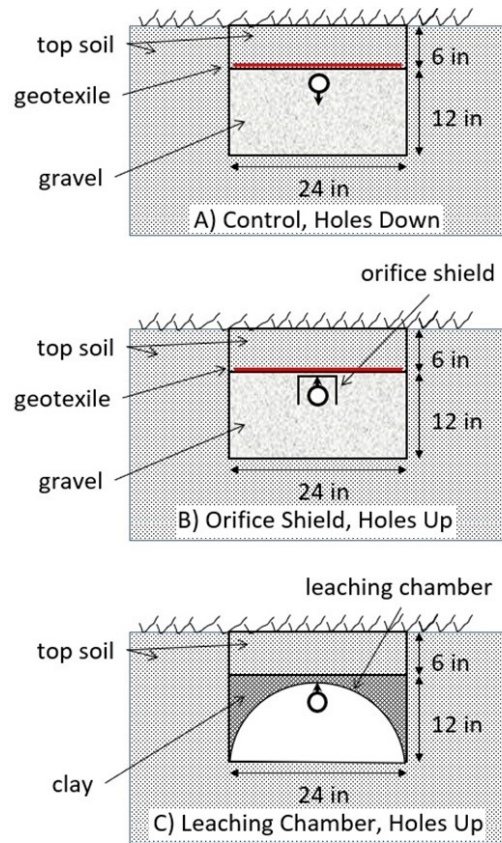
Figure 7. Cross-section view for three LPD Configurations

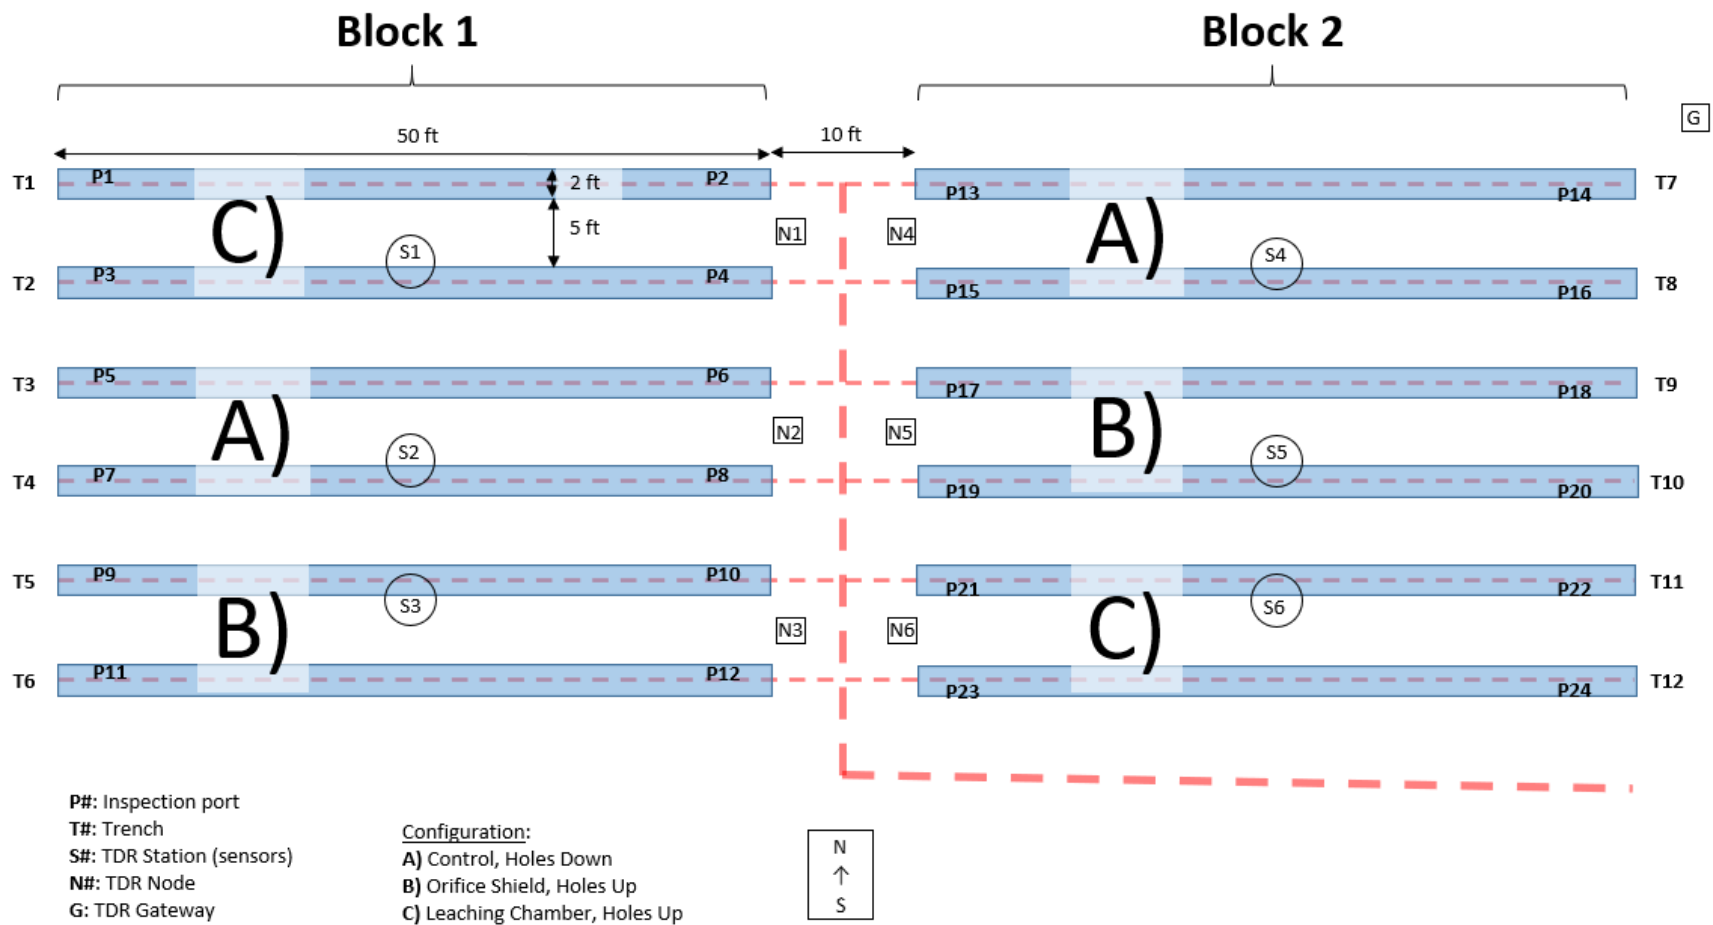
Figure 8. Experimental design, and location of monitoring activity (inspection ports and TDR stations)

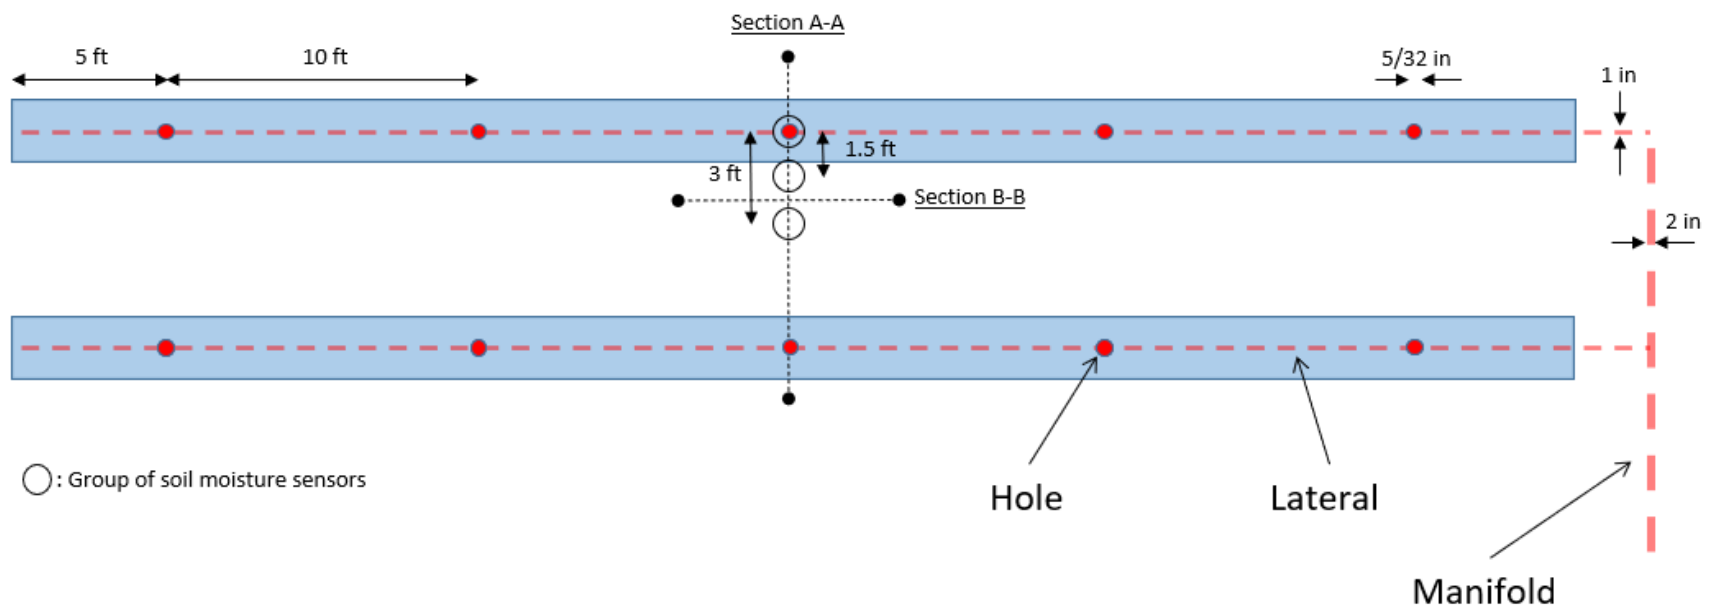
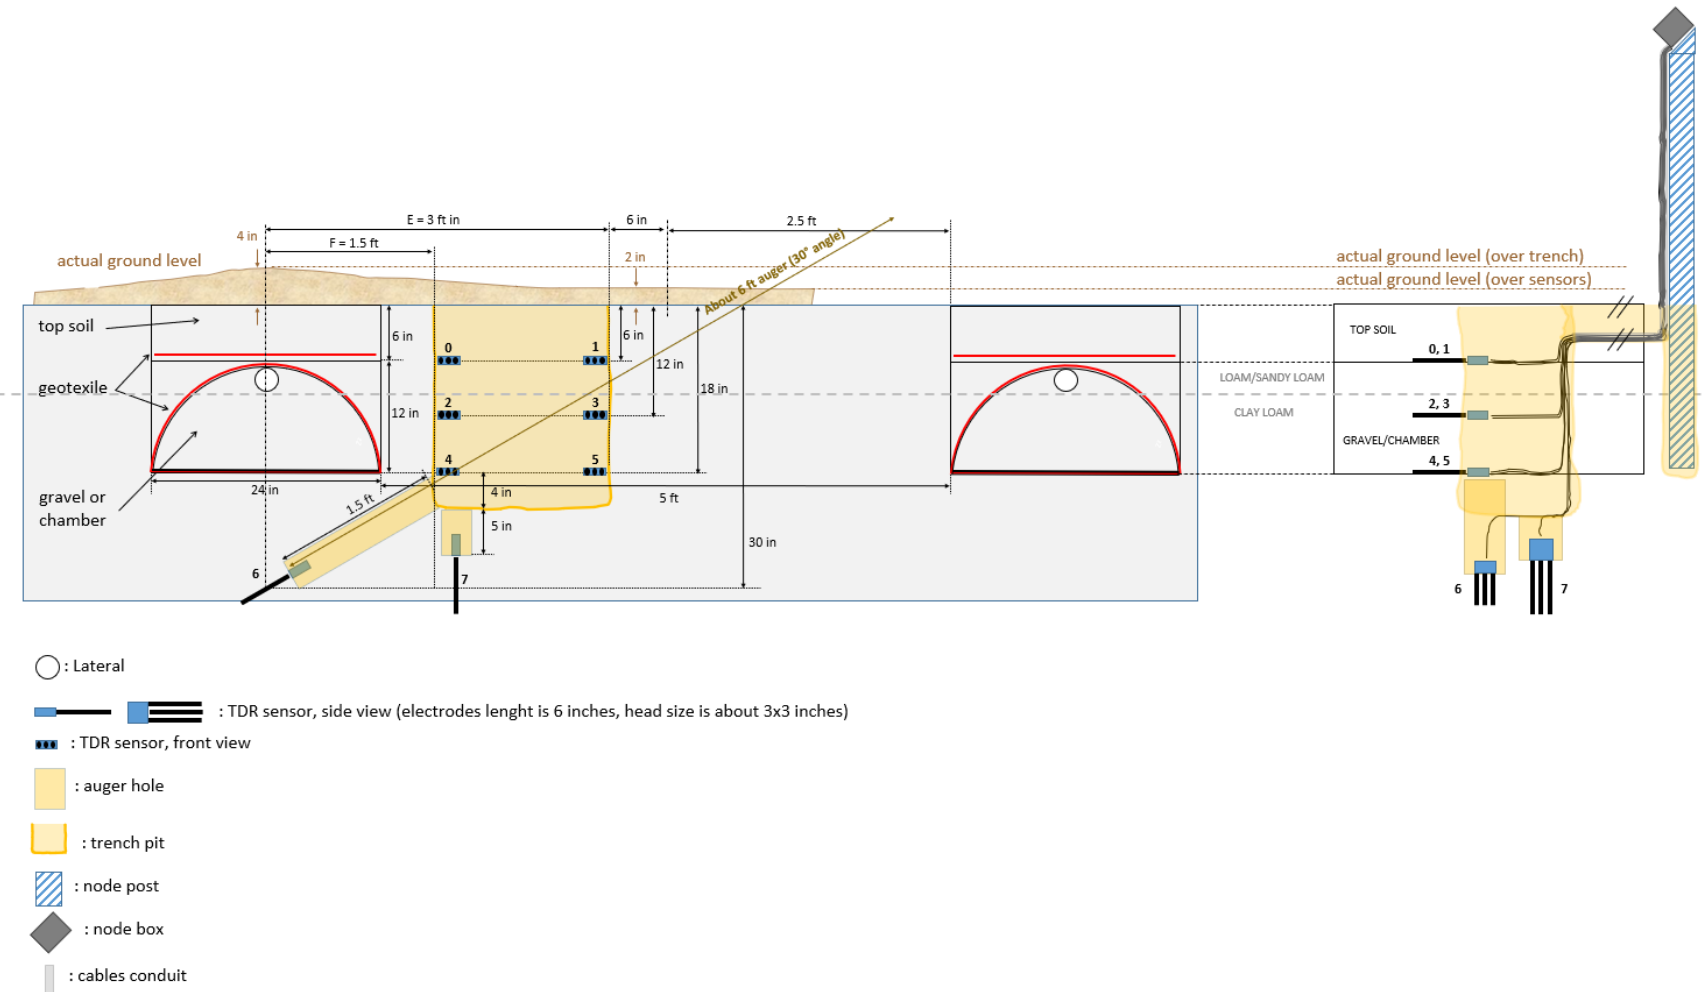
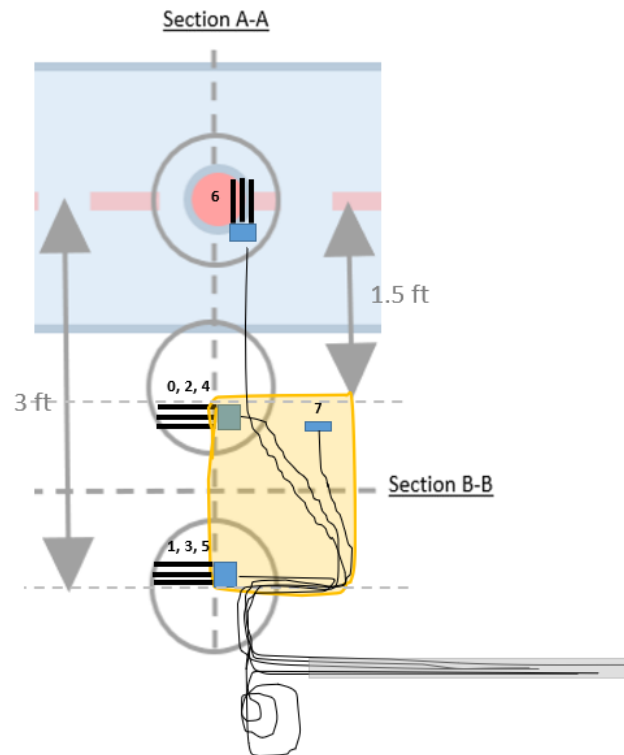
Figure 10. Distribution line and soil moisture monitoring sensors installation details.

Figure 10 (cont.) Distribution line and soil moisture monitoring sensors installation details. Orange area indicate soil movement.

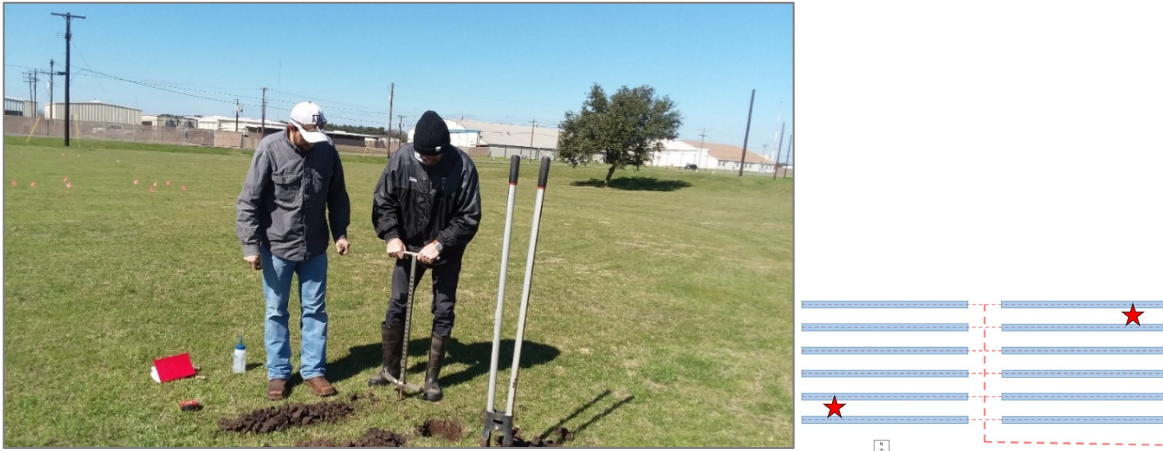
Figure 12. Phases of the soil profile evaluation performed on February 14, 2020, by Ryan Gerlich, TCEQ Certified Site Evaluator

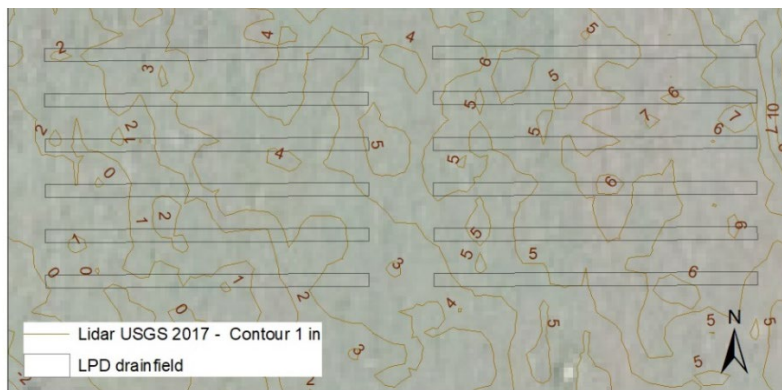
Figure 13. Lidar USGS contour elevation isolines (at 1 inch interval) in the drain field area. Elevation is referred to the lowest point (South West corner)

Construction originally planned for the spring 2020 was postponed. This delay was anticipated due to COVID19 epidemic field activities restrictions, and was communicated to TCEQ by email on March 24, 2020. Construction and experiment start where later further postponed, as communicated to TCEQ by email on August 14, 2020. Construction started on November 3, 2020, and field distribution and plumbing were finalized on November 20. On December 10th a fence was installed all around the distribution field to prevent wildlife from entering the area and vandalism, and construction was completed on December 12, 2020, including pump installation. On December 17 head pressure was tested, and head resulted uniform for all 12 laterals. Pump outflow was then regulated to ensure at least 5 feet pressure. A drop of about 10 inches total (0.8% slope) was found from the North East corner to the South West corner of the drain field area. The drop was assessed with a laser before construction, and it was confirmed by a more detailed contour elevation map generated using Esri ArcGIS Software from USGS Lidar (Light Detection And Ranging) image (Figure 13).

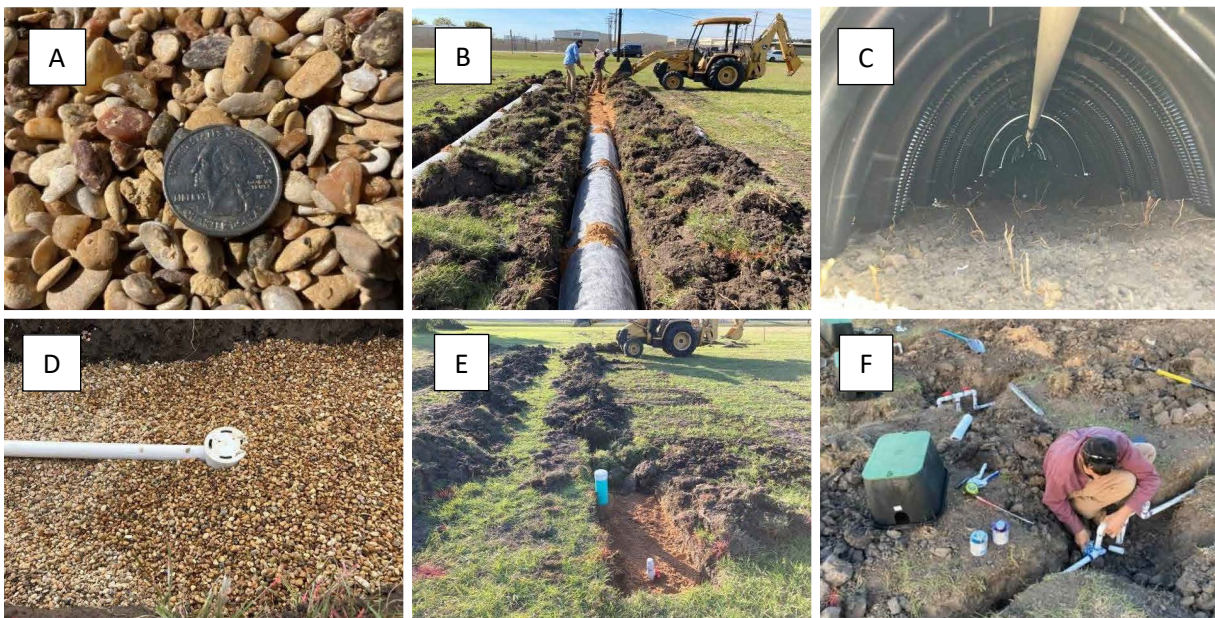
Figure 14. Images of the installation process: A) pea gravel, B) Leaching chamber installation, C) Location of lateral under leaching chamber, D) Orifice shields in gravel trench, E) Closing of a gravel trench, showing inspection port and valve, F) Connection of laterals to manifold

Figure 14 shows some key features of the installation (pea gravel size, leaching chamber installation and location of lateral, orifice shields in gravel trench, inspection port location, and connection of laterals to manifold). An image of the LPD drain field completed, as it looks at the end of the experiment on November 2021, is reported in Figure 15.

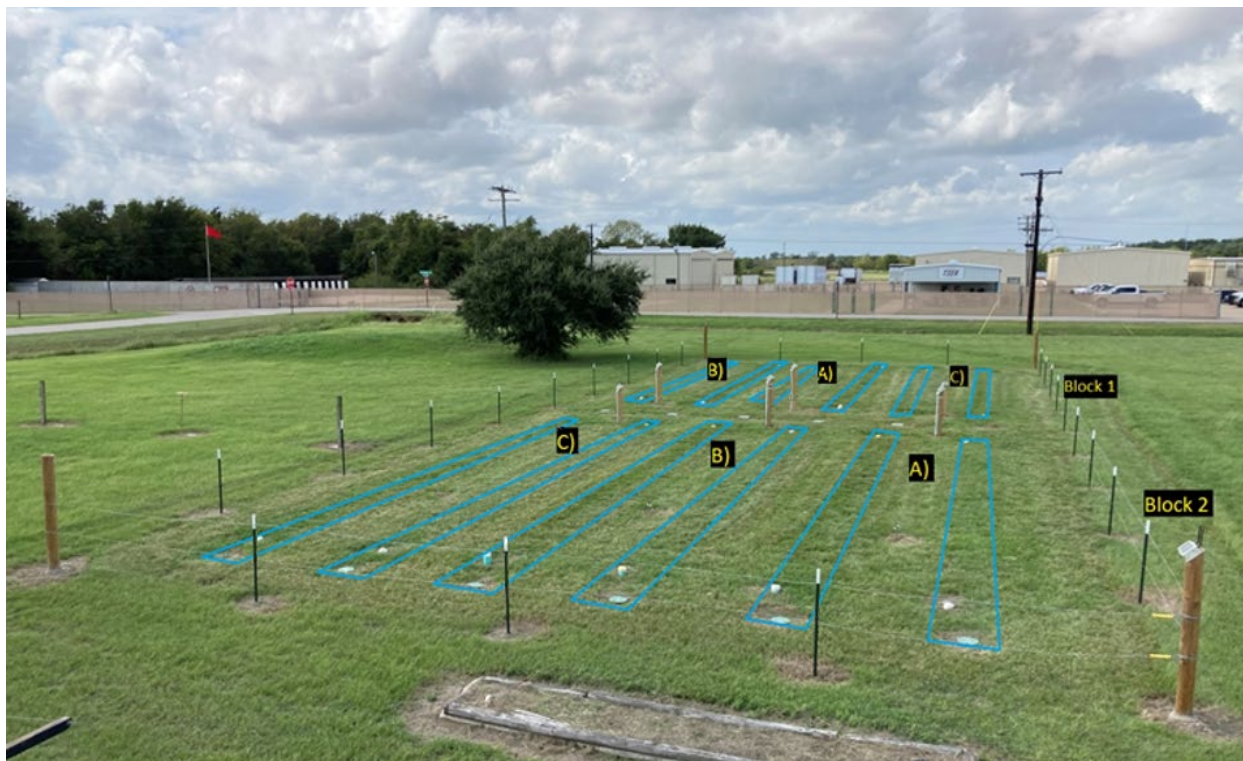
Figure 15. Image of the LPD drain field as it looks at the end of the experiment, on November 2021. Highlighted are the location of trenches and configurations in the experimental design

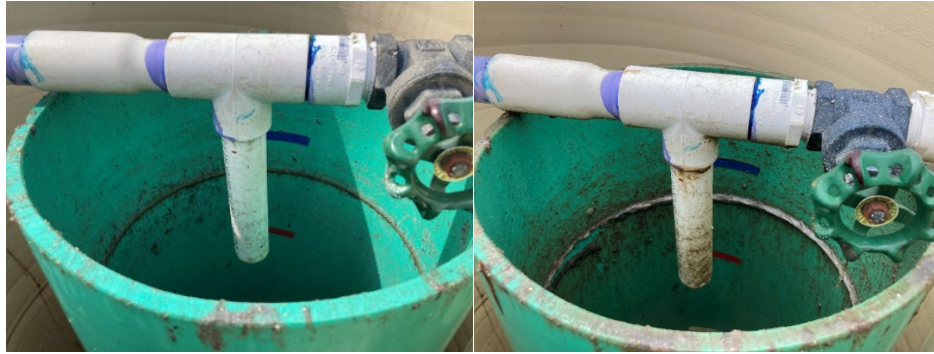
Figure 16. Detail of the calibration tank design. Left: at experiment start (with calibration tags); Right: at experiment end (noticeable the deposit where level has been controlled)

the stored volume is discharged by gravity towards the septic tanks. After the changes were made, daily flow was estimated again and determined to be 9.2 gal/run (221 gal/d), and effluent pumped to the drain field at an average of 65.1 gal/dose (a little more than 3 times/d). Figures 16 and 17 shows a detail of the calibration tank.

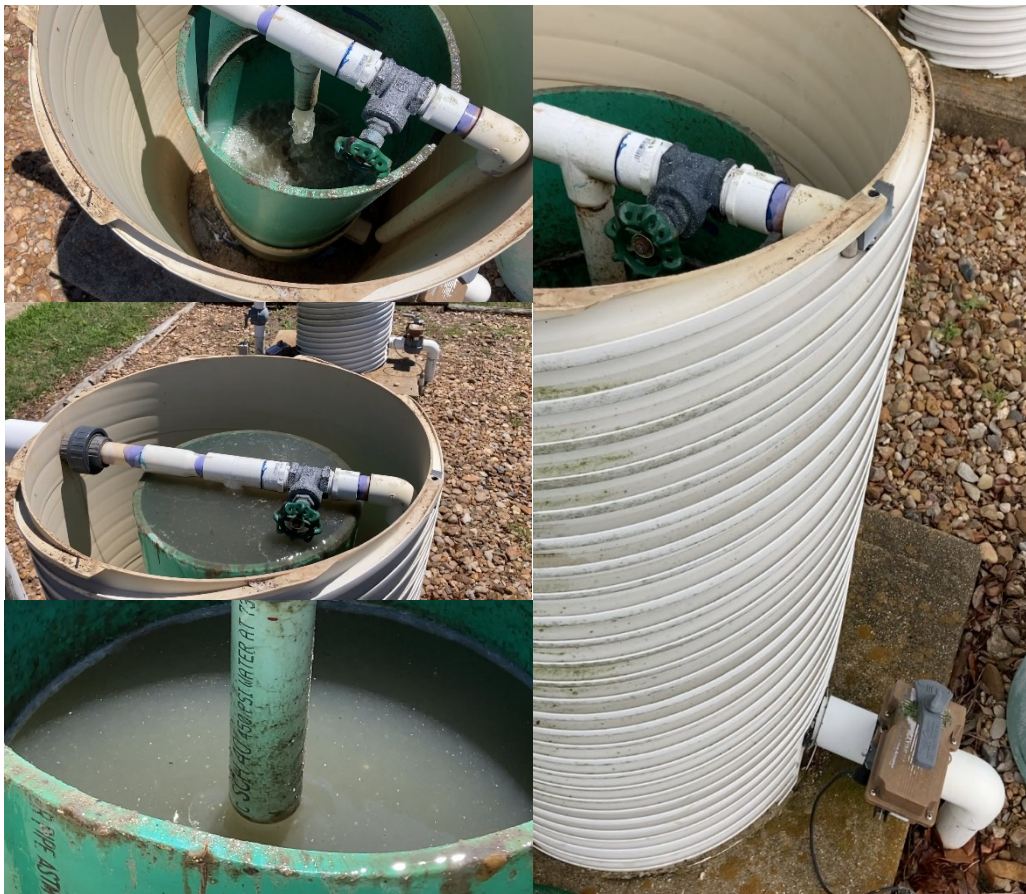
Figure 17. Calibration tank phases. Left top: loading; Left center: draining surplus; Left bottom: calibrating (loading ended); Right: Jandy valve open to send calibrated volume to the septic tank

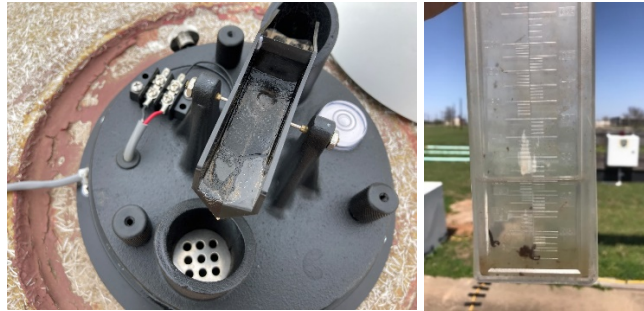
Figure 18. Rain gauges installed at the Center. Left: Tipping bucket (with ice blocking the mechanism, in February 2021); Right: existing manual gauge

Precipitation events were quite frequent, with strong storms end of December 2020 beginning of January 2021, and in the summer. Temperature was characterized by an exceptional cold front recorded in February 2021, with minimum temperatures constantly below freezing from February 12 to 20, and maximum temperatures constantly below freezing from February 14 to 16 (Figures 19 and 20). The tipping bucket did not work properly between February 14 and 22, as water froze, and the mechanism resulted blocked.

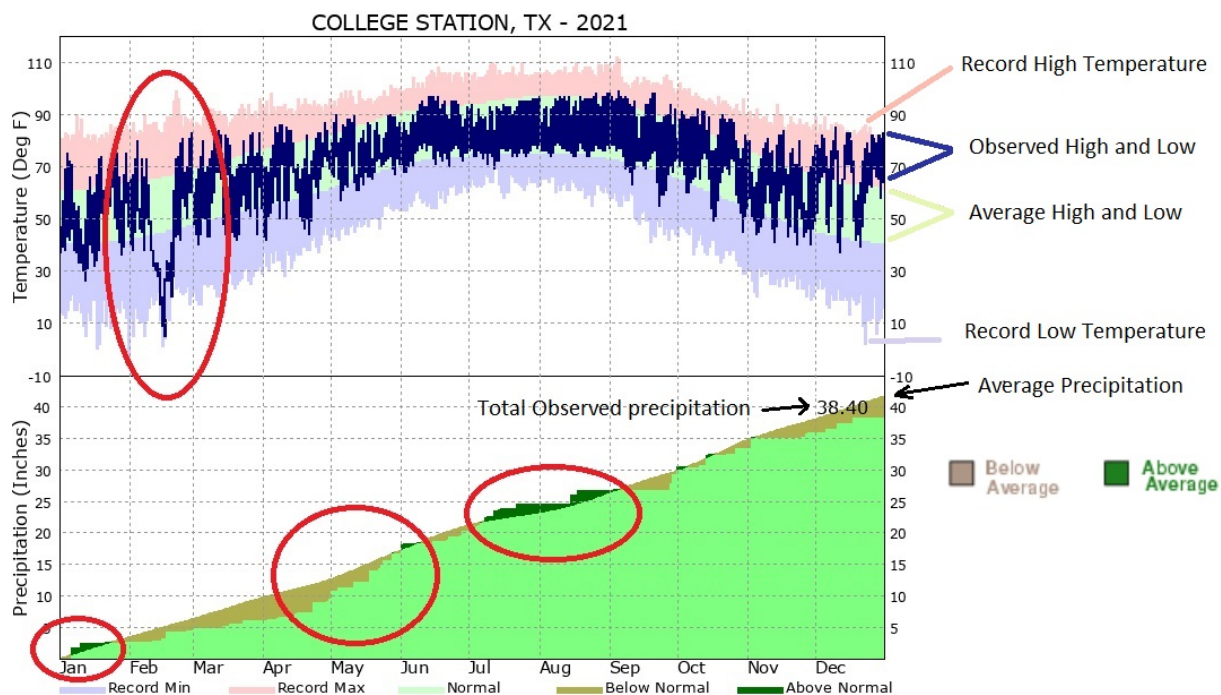
Figure 19. Temperature and precipitation data and long term records, recorded at the nearby NOAA Station (KCLL) in 2021. Red circles show freezing or high precipitation conditions observed during the project period.

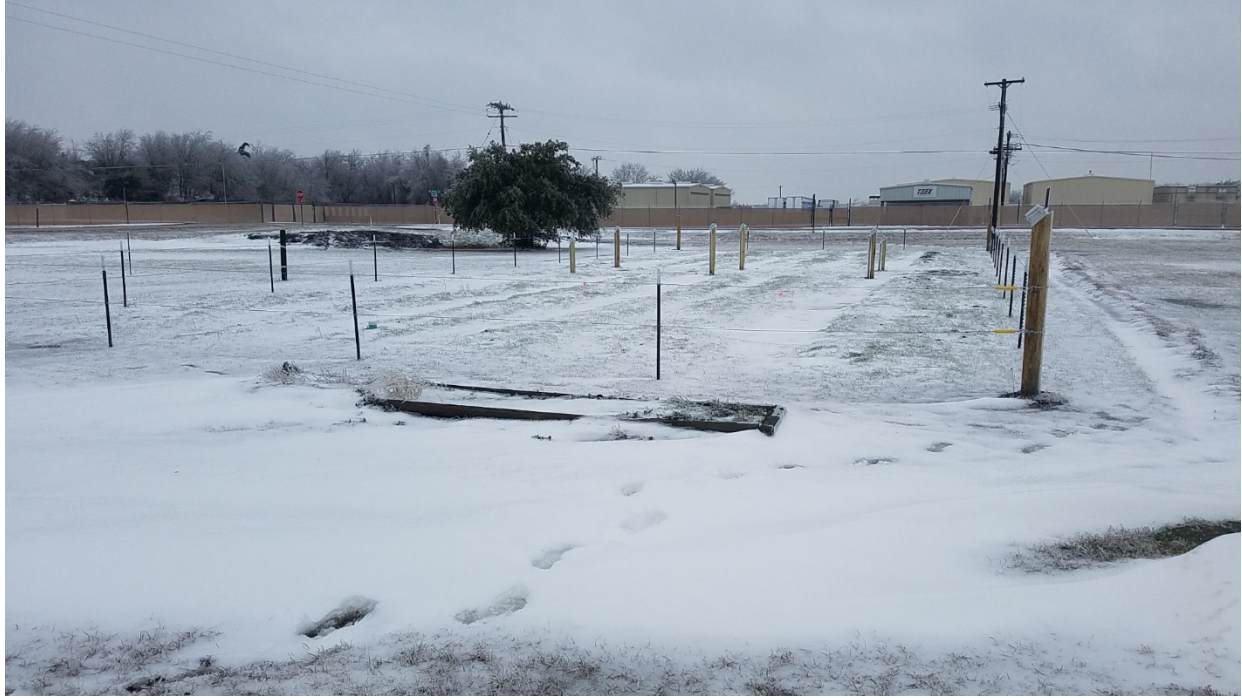
Figure 20. Snow deposit after the exceptional cold front recorded in February 2021

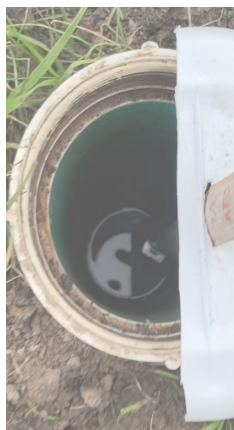
Figure 21. Inspection port monitoring consisted in the measurement of the distance between the port top and the water level, converted to water level based on elevation of the port top and the trench bottom

Measure of water level from inspection ports begun on January 7, 2021. Monitoring was performed more frequently than planned in the first two months (every 1-2 days) to collect as much information as possible in the early project stages. Monitoring consisted in the measurement of the distance between the port top and the water level. As elevation of the port top and the trench bottom had been determined previously, this value could be converted to water level (Figure 21).

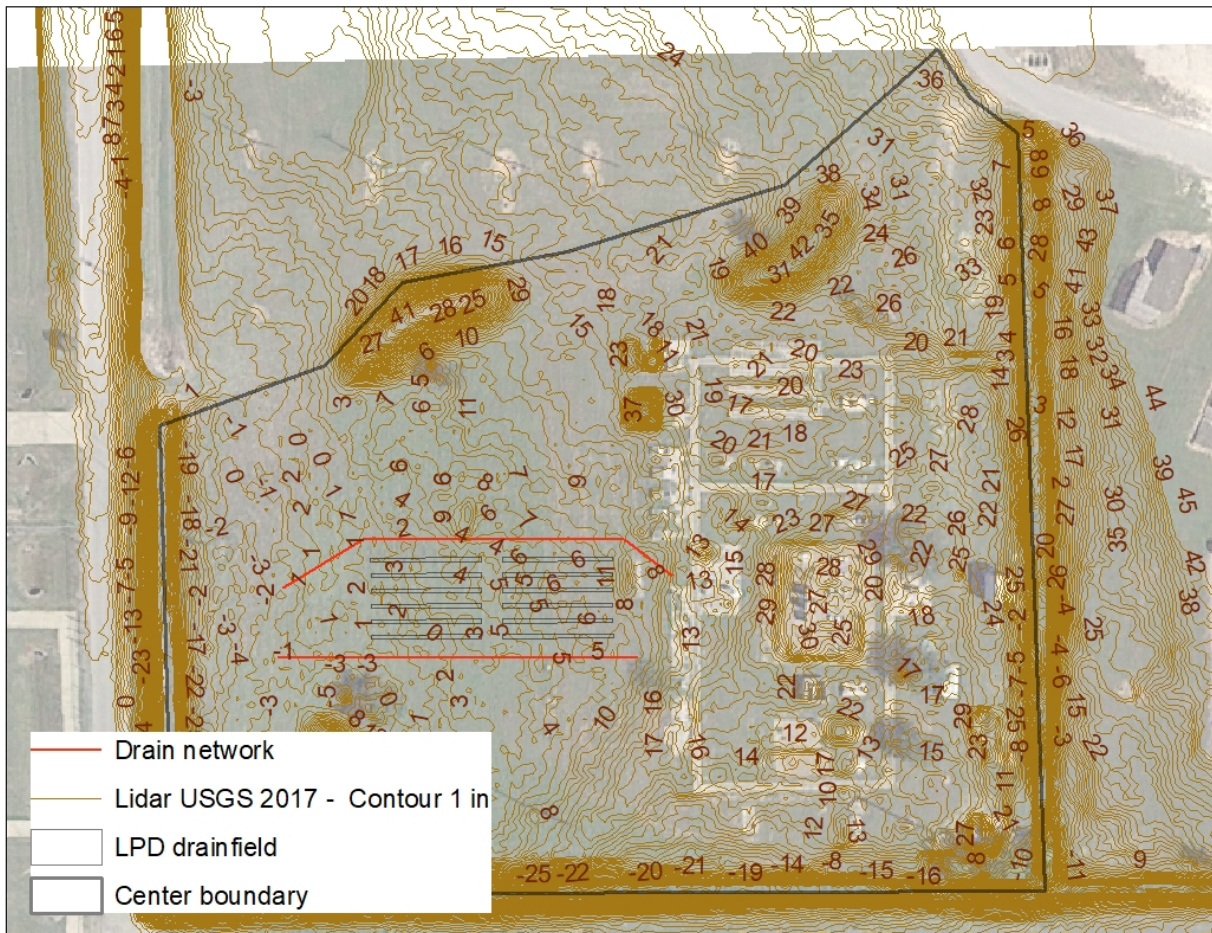
Figure 22. Location of the drainage relief network and Lidar USGS contour elevation lines (at 1 inch interval). Elevation is referred to the lowest point of the drain field (South West corner)

An anomaly was observed in these first monitoring period, after the strong rainfall events in December and January. Trenches located in the northern side filled much more than the others. As large deposits were observed on top of these trenches, it was interpreted that this could have be related to runoff coming from upstream the Center; likely worsened by the fact that trenches were new and porosity in the topsoil was still quite high. As a response, a drainage relief network (approximate section of 2 ft x 6 inches) was built around the distribution field to divert most runoff away from the field. After the intervention the issue did not present anymore. Figure 22 shows the location of the drainage relief network, together with the Lidar USGS contour elevation isolines for the surrounding area.

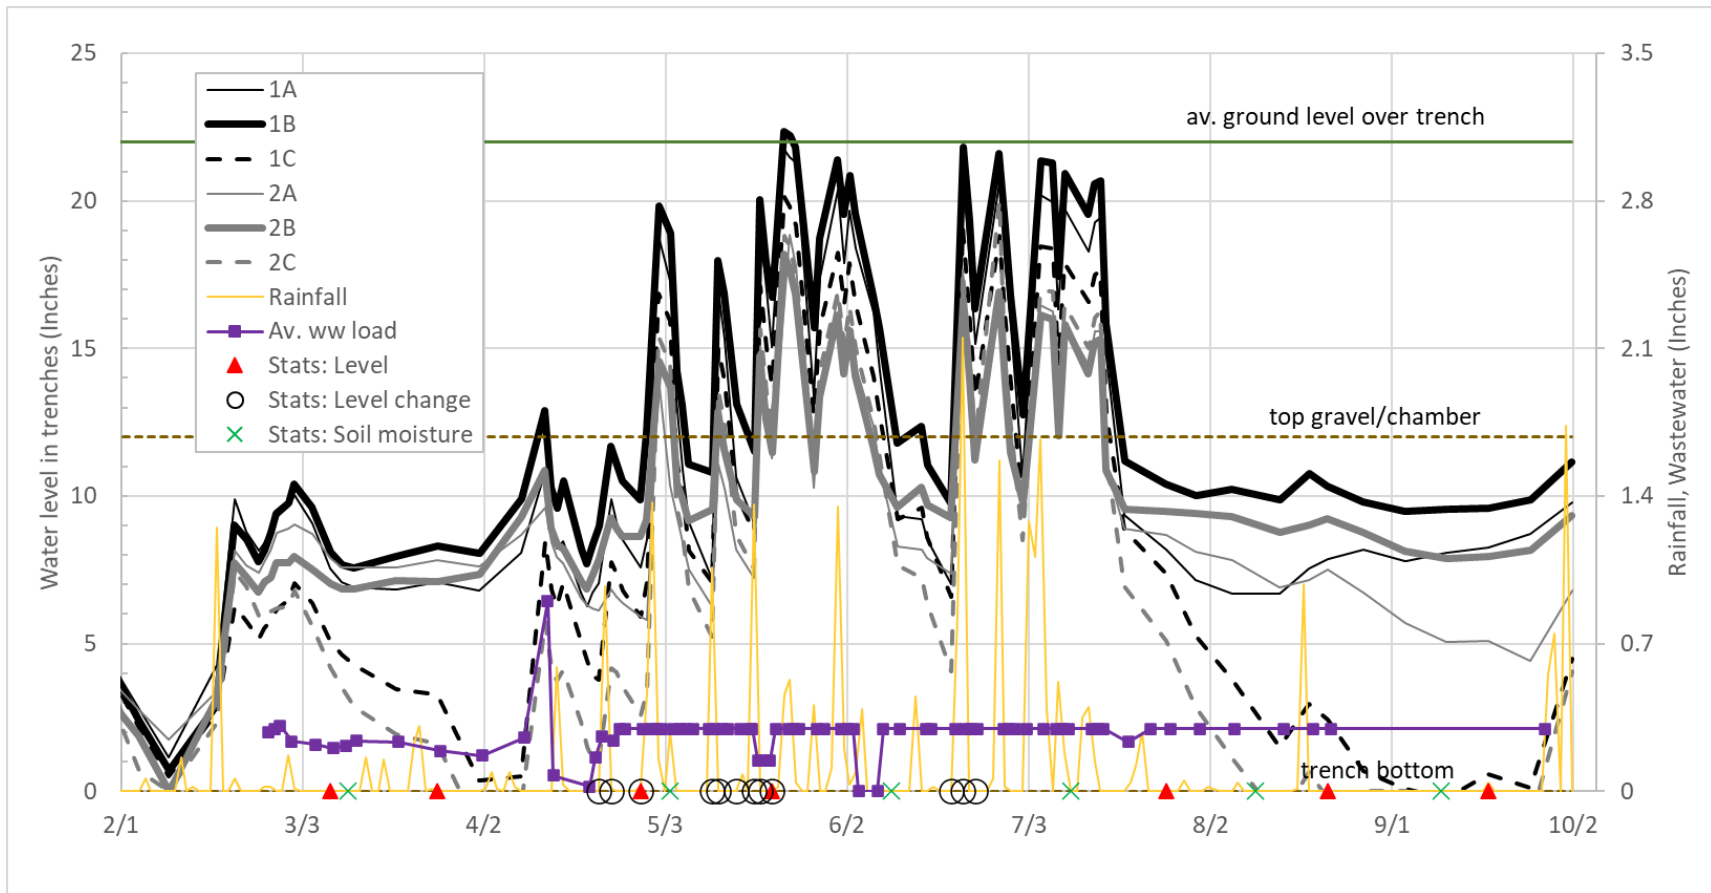
Figure 23. Estimated wastewater daily load, average water level (average of the two trenches in each block, measured from the bottom of the trench), and daily precipitation. Also indicated are levels for trench bottom and top (either gravel or chamber), ground level over the trench (including the soil added to ensure drainage off the trench), dates used for statistical analysis (water level, water level increase/decrease, and soil moisture)

The figure shows that the water level quickly responded to rain and wastewater loading events. And overflowed occasionally after heavy storms (mostly in Block 1). Trenches had water most of the time, even after several dry weeks, and level was above the gravel (or top chamber) only for few days after rain events. Trenches under configuration with holes up and leaching chamber showed the lowest levels and were empty on few occasions, while other two configurations behaved similarly. Each configuration had a tendency for higher levels in Block 1 with respect to Block 2. The choice to split the experiment in two blocks was therefore successful in addressing this different behavior within the area. Driving factors could be both the difference in slope and in texture. Accidental overloading clearly affected water level in all trenches (April 9-13), with a rise of several inches. Figure 24 shows details of effects on water levels of the overload and the intentional interruptions in May and June. The overload was estimated as 0.9 inch per day.

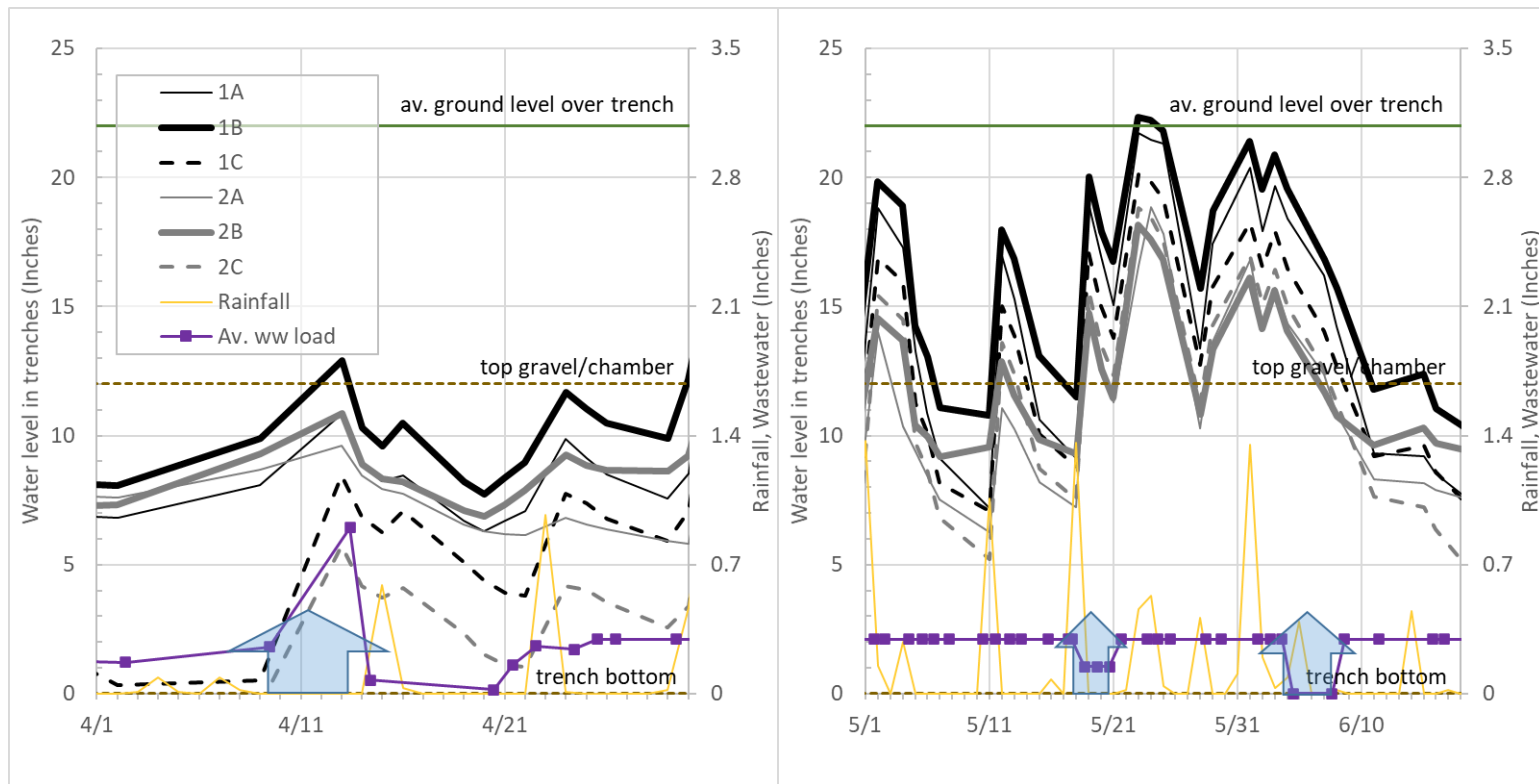
Figure 24. Estimated wastewater daily load, average water level, and daily precipitation. Effect on water levels of overloads (April 9-13) and intentional interruptions (May 17-20, June 3-7). Width of the arrows identifies the length of the event

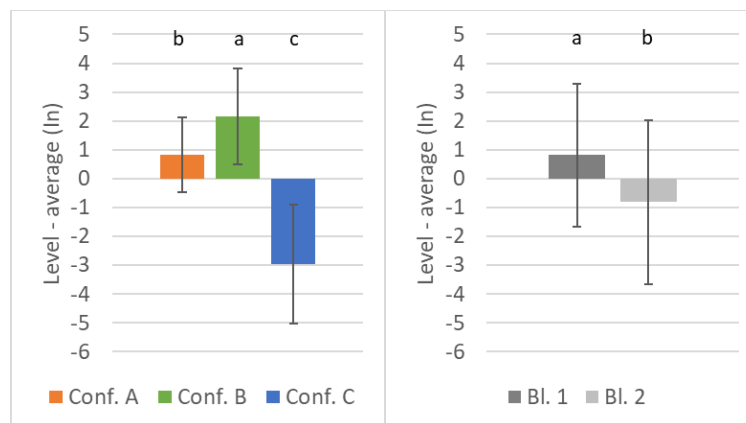
Figure 25. Average water level in the trench from events chosen about every month a few days after a rain event, and expressed as inches above or below the overall daily average. Bars indicate standard deviation, and letters show if configurations (left) or blocks (right) are significantly different among each other with the T-Test.

Statistical analysis conducted on selected data (one level measure about every month a few days after a rain event), found that there was a statistically significant difference of water level among the three configurations: with respect to the average, water level was at +0.8, +2.1, and -3 inches, respectively in design A, design B, and design C. Results showed that there was a statistically significant difference between the two blocks, with water level higher than the average (+0.8 inches) and below the average (-0.8 inches), respectively in block 1 and block 2.

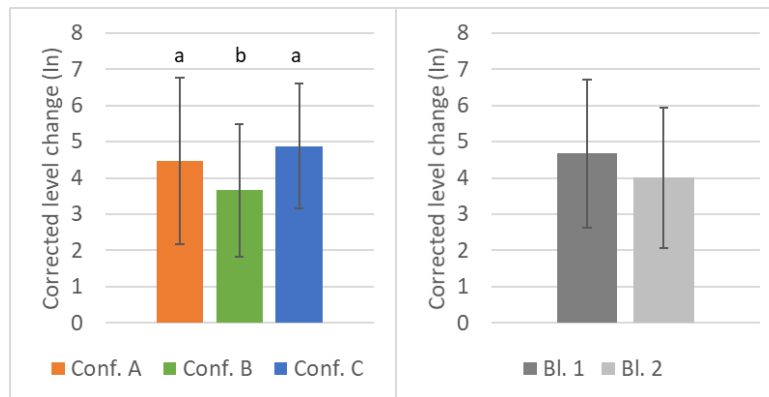
Figure 26. Water level change (increase/decrease) in the trench during four rain events (April 22-29, May 12-15, May 18-21, June 20-24), expressed as corrected absolute level change. Correction of the level change considers the inches of rain, the days after the rain event, and the level reached in the trench. Bars indicate standard deviation, and letters show if configurations (left) or blocks (right) are significantly different among each other with the T-Test.

Configurations and blocks were also compared for water level change (absolute value of increase/decrease) in the trench, by analyzing four rain events (April 22-29, May 12-15, May 18-21, June 20-24). To have more comparable values, measured level change was corrected considering the inches of rain, the days after the rain event, and the level reached in the trench. The analysis determined that there was a statistically significant difference among design B (lower level change) and the other two configurations (greater level change). No statistically significant difference was found between the two blocks, but when only level increase was analyzed (excluding level decrease data), Block 1 had significant greater level increase compared to Block 2.

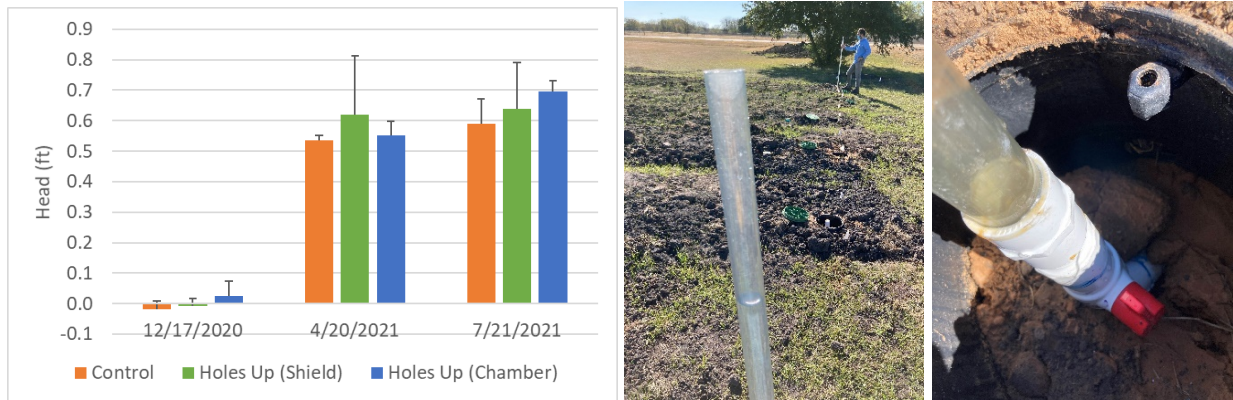
Figure 27. Pressure on laterals as measured at the beginning of the experiment (December 17, 2020), and on April 20 and July 21, 2021. Head reported in the chart is the increase with respect to the average of December 2020 observations, and is referred to a common reference level in the drainfield. Left: Columns show the average value for each configuration, while error bars indicate the standard deviation value. Right: images of the reading through transparent PVC SCH40 pipes inserted in the turn-up at the end of the laterals

Pressure in the laterals was measured quarterly. Compared to December 17, 2020, values were significantly higher in April 20 (+ 0.57 in) and July 21 (+ 0.64 in), 2021. There were not statistically significant differences among configurations. As water rose in the transparent pipes added to the laterals turn ups, some sediment was observed in April and July, which could explain part of the increased pressure. Sediment was denser in trenches located toward the North side of the drain field, the farthest from the effluent source.

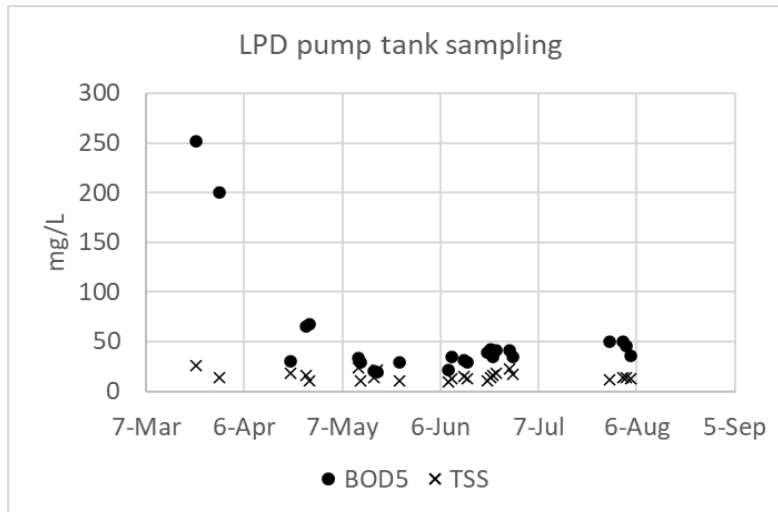
Figure 29. Wastewater quality (BOD5 and TSS) during the experiment months, as measured from grab samples collected from the LPD pump tank
