Final Report DRAFT
Work Period: September 1, 2019 – August 31, 2021

For Texas On-Site Sewage Facility (OSSF) Research Contract #582-19-96830

Implementation of Low Pressure Dose Systems with Various Configurations

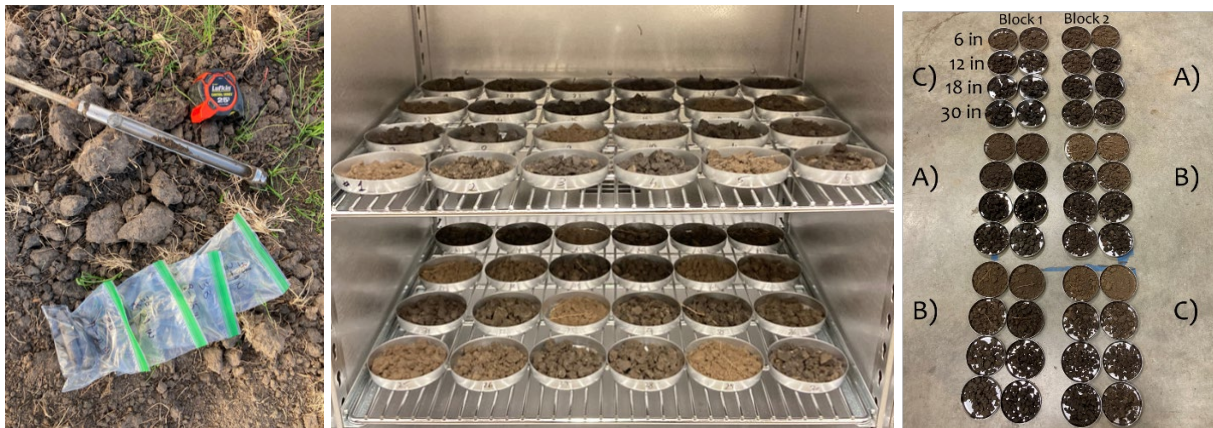
Figure 30 Soil moisture measured with the gravimetric method from core samples collected before the experiment start, on November 24, 2020. Left: field sampling; Middle: oven detail; Right: dried samples

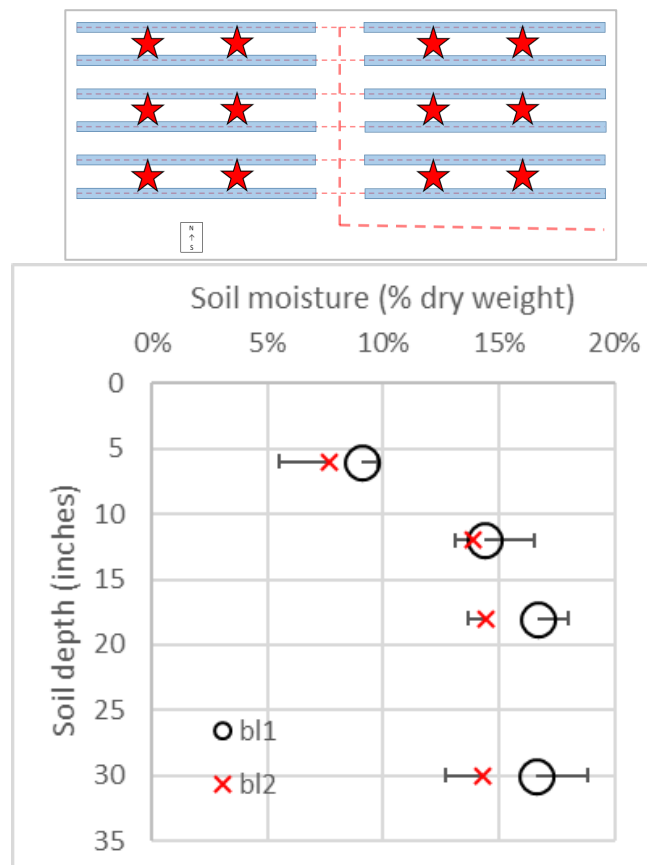
Figure 31. Soil moisture measured with the gravimetric method from samples collected with probe soil sampler before the experiment start on November 24, 2020. Top: Location of sampling (stars); Bottom: Average moisture on dry weight for all samples in each block at each depth, and bars indicating standard deviation (shown only on one side to facilitate representation)

Although not included in the monitoring plan, soil samples were collected to assess moisture content using the gravimetric method on November 24, 2020 to obtain preliminary information on the project area before altering it with construction. Samples were collected along the soil profile at 12 locations, and moisture calculated on dry weight. Results showed that the West portion of the field (Block 1, 14.2%) was slightly wetter than the East portion (Block 2, 12.6%), and resulted statistically different at 15-21 inches of depth.

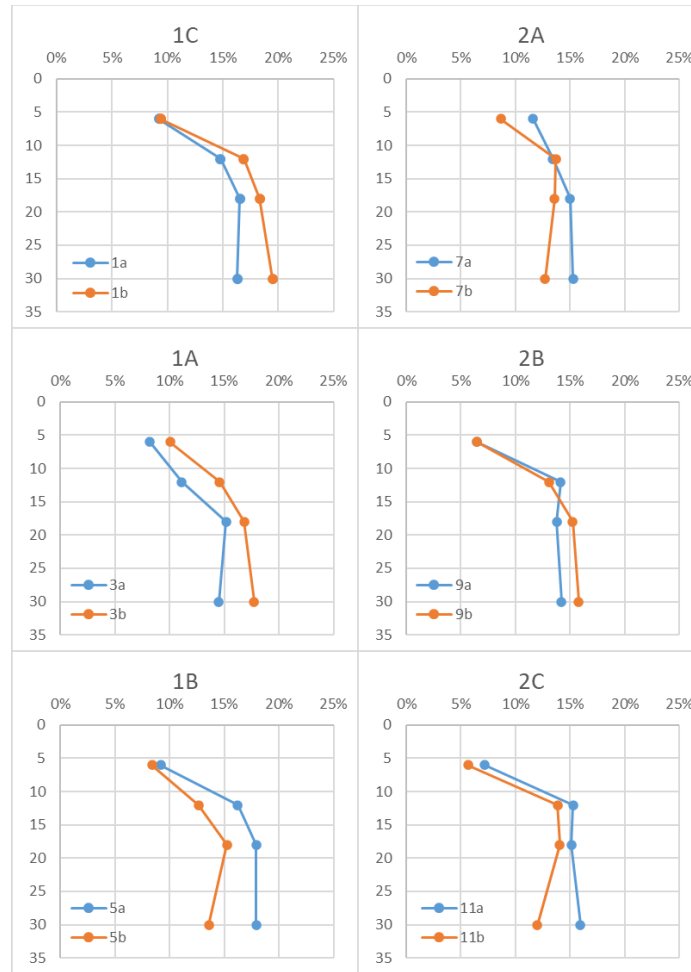
Figure 32. Soil moisture measured with the gravimetric method from samples collected with probe soil sampler before the experiment start on November 24, 2020: Moisture on dry weight for all collected samples, and organized as in the actual drain field (Block 1 on the left and Block 2 on the right, configurations in the same location). Legend indicates the number of the trench located North of the profile (1, 3, 5, 7, 9, 11), and the location along the trench (a = 1/3 from West, b = 2/3 from West)

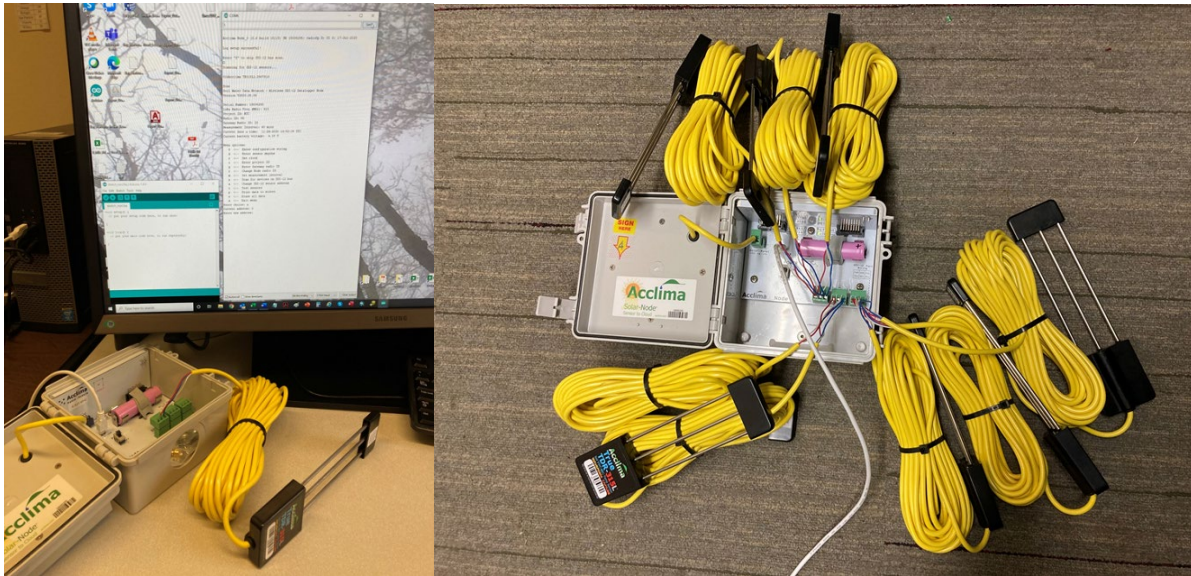
Figure 33. Time Domain Reflectometer (TDR) sensors configuration before installation

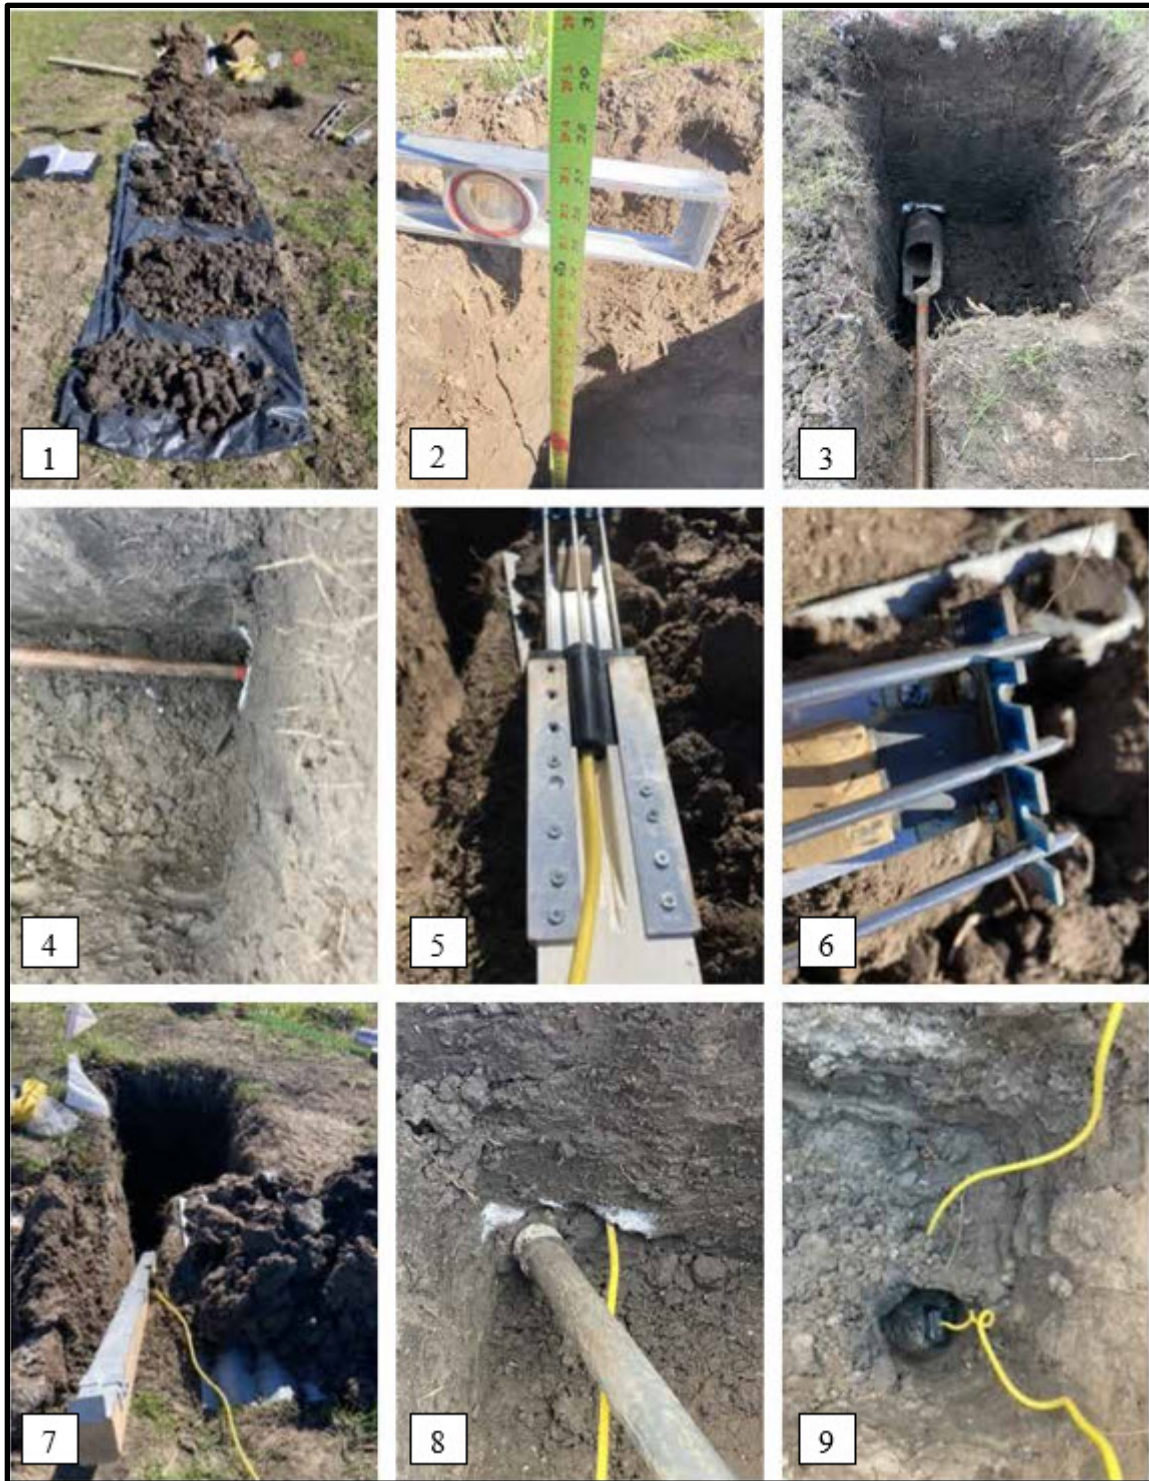
Figure 34. Phases of Time Domain Reflectometer (TDR) installation. Picture 1: 4-inches soil layers are removed and stored separately for later correct refilling of the hole; Picture 2: Depths are referred to a common ground level; Pictures 3-8: Installation of sensor below the trench; Picture 9: Sensor installed vertically at 30 inches of depth

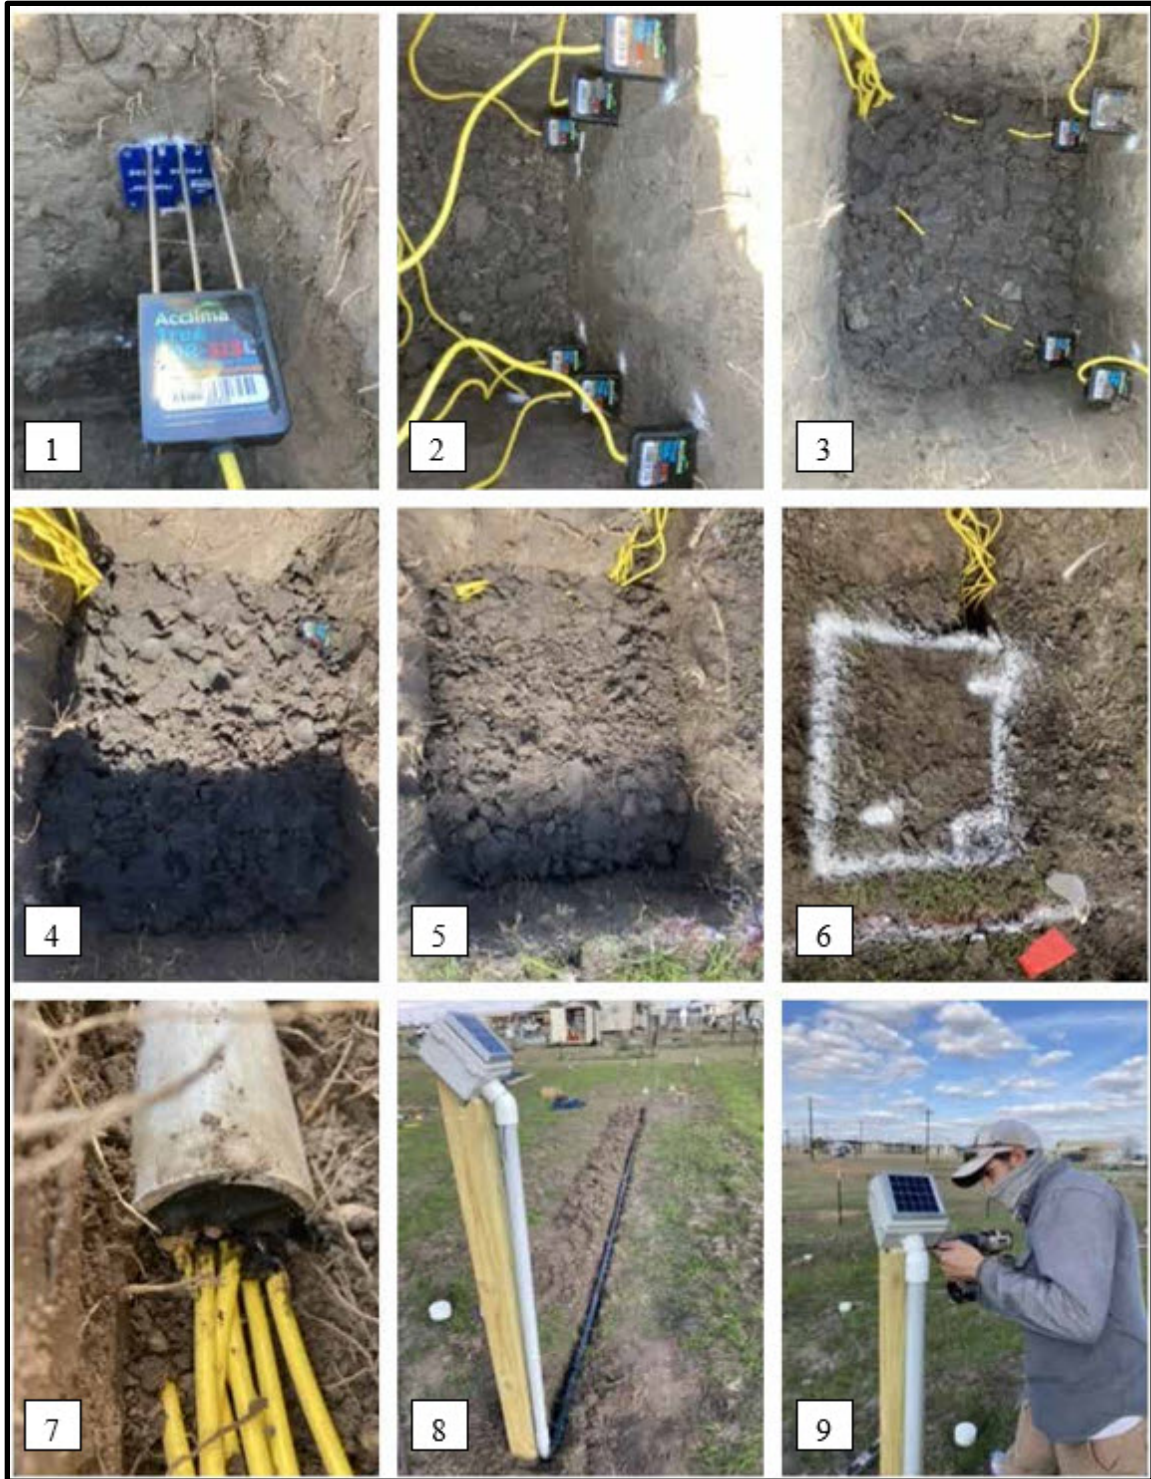
Figure 35. Phases of Time Domain Reflectometer (TDR) installation. Picture 1: Installation of one of the horizontal sensors (6, 12, and 18 inches of depth) using a plastic guide; Picture 2: Installation of all six horizontal sensors; Pictures 3-6: Typical cables placement inside the hole; Picture 7: Electrician's putty used to plug the entrance of the conduit; Pictures 8-9: Final sensors set up and connection to the node

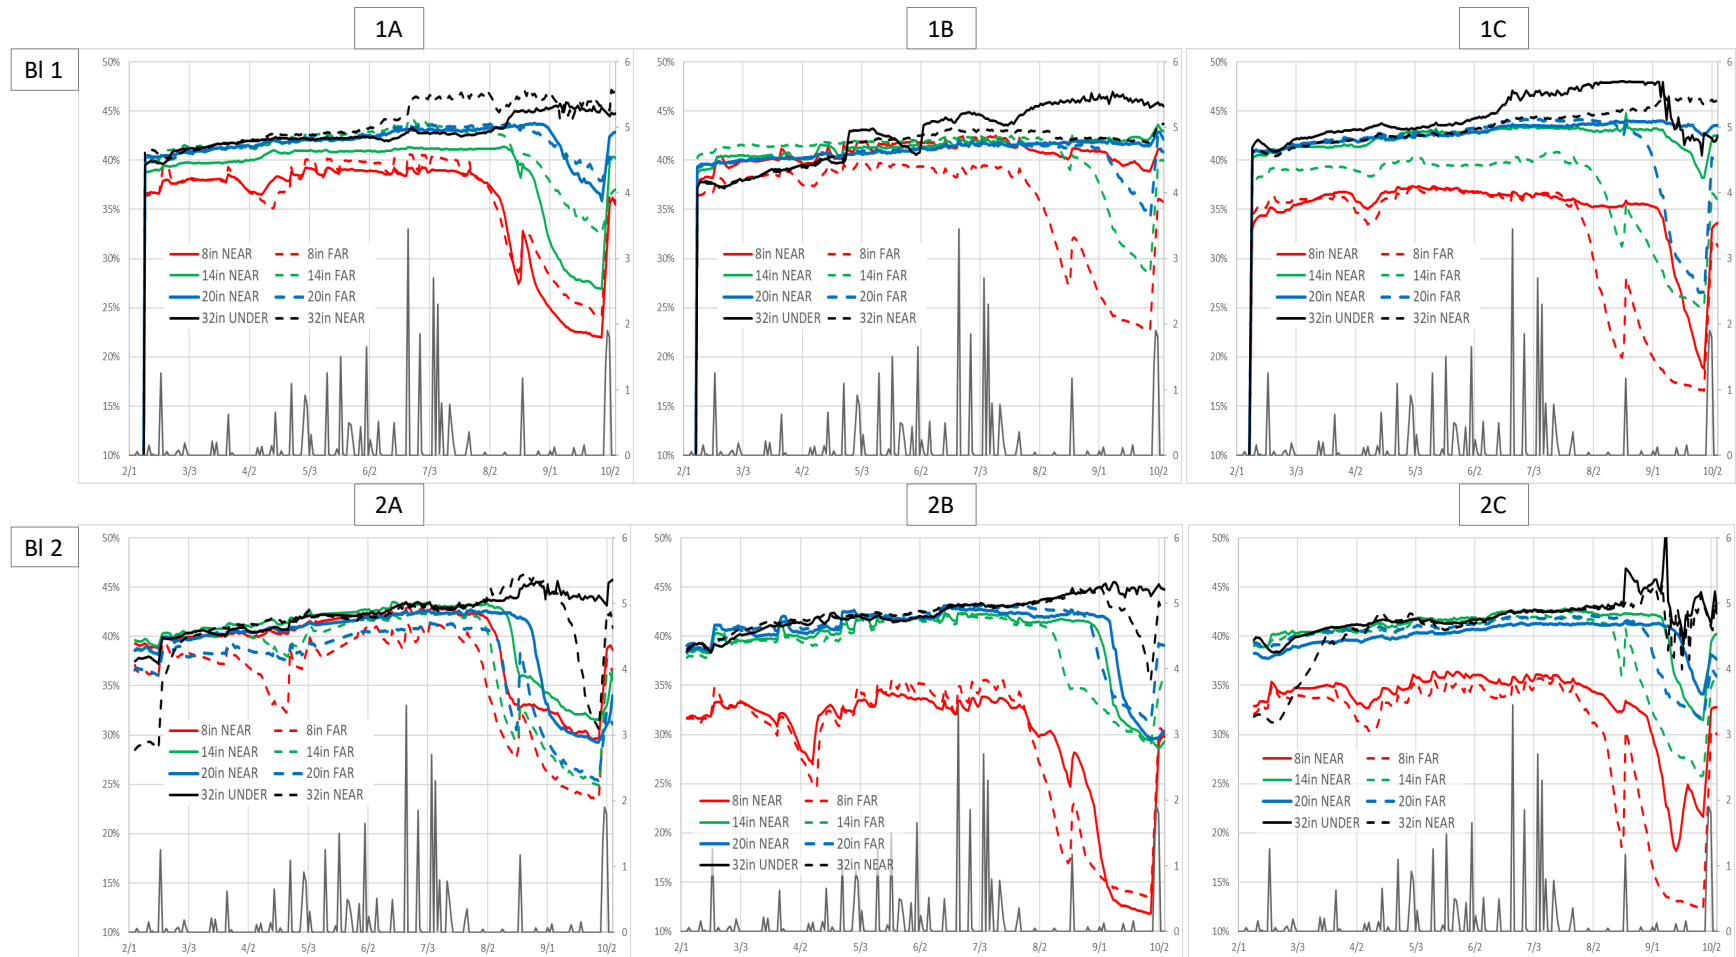
Figure 36. Soil moisture readings, expressed as volumetric moisture, together with precipitation height. Readings are reported for all individual TDR sensors. Sensors are abbreviated as #in<LOCATION>, where # is the depth of the sensor, “in” stands for inches, and LOCATION can be NEAR (6 inches from the trench wall vertical), FAR (2 feet from the trench wall), or UNDER (under the trench)

Overall, profiles behaved similarly, with moisture reaching saturation during the wet season, except for the most superficial locations, and started going down between end of July and begin of September. In most cases such decrease started in shallow sensors far from the trench. In September 2021, moisture at 32 inches of depth under the trenches decreased only in design C, which corresponds to these trenches getting dry; and moisture at 32 inches of depth near the trenches decreased only in Block 2, which corresponds to the observation made at installation that in these locations soil resulted harder (likely drier) compared to the rest of the area.

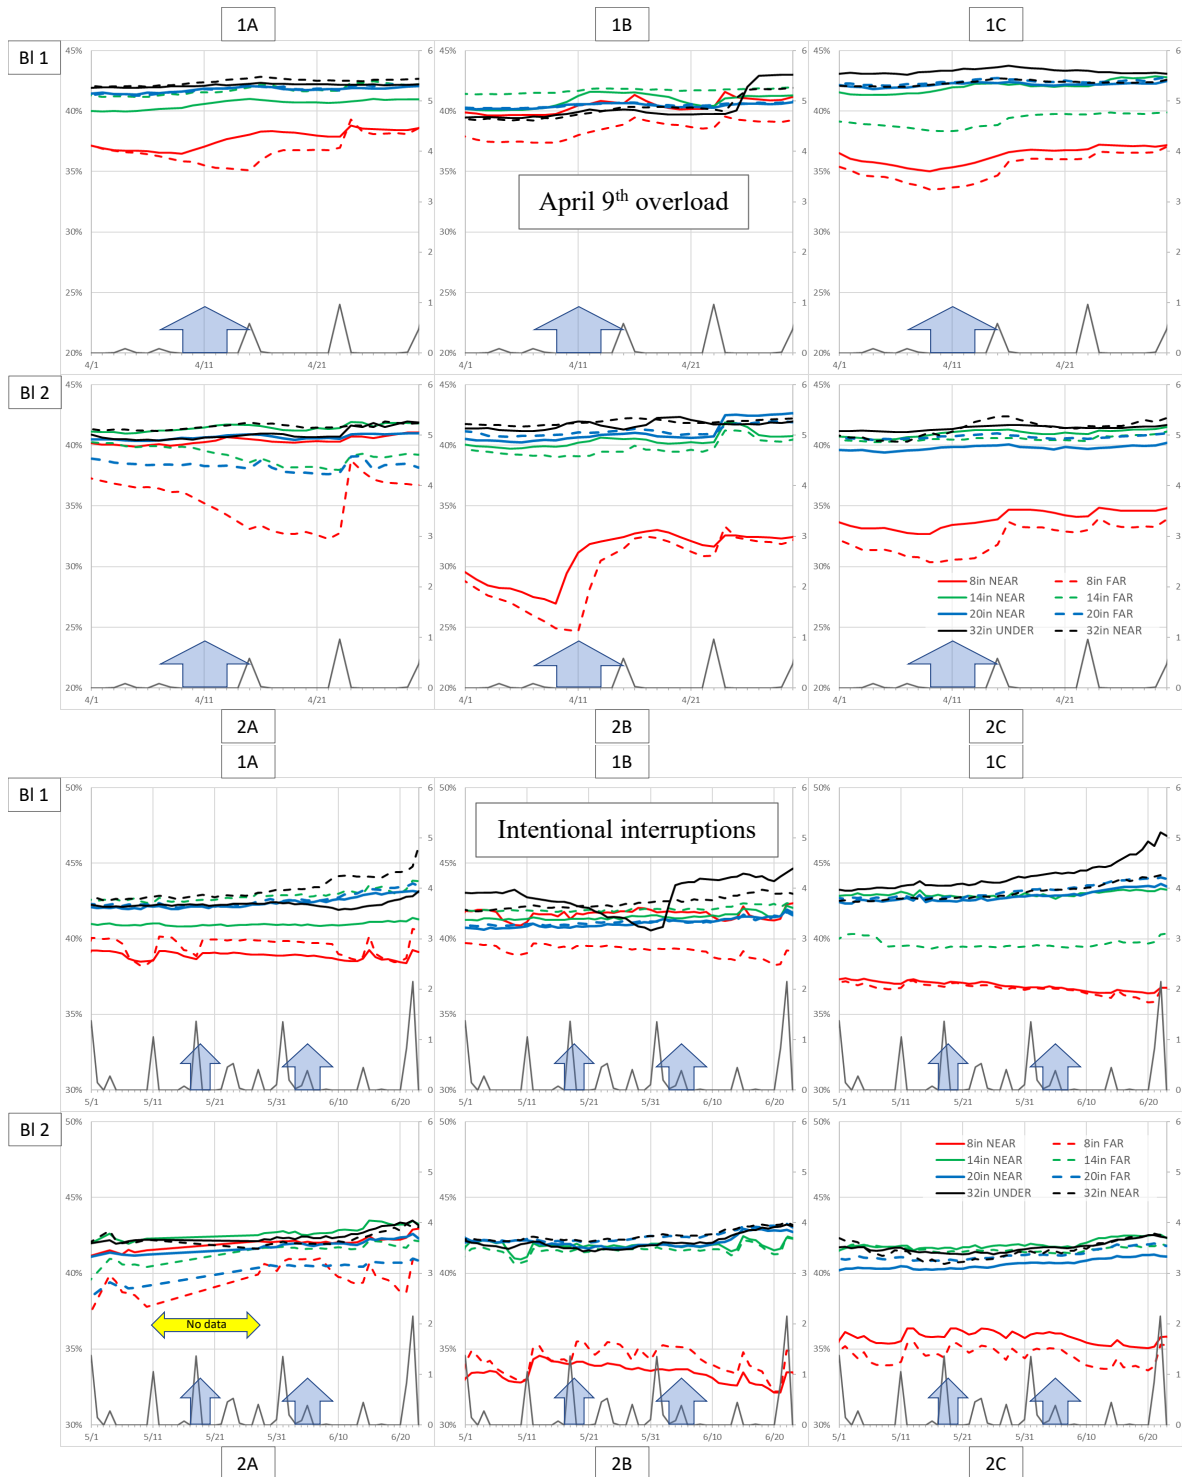
Figure 37. Effect of overload and intentional interruptions on soil moisture readings, expressed as volumetric moisture. Width of the arrows identifies the length of the event. Top: Overload on April 9th and the following days; Bottom: intentional interruptions on May 17-20 and June 3-7. Sensors 2A did not record any data on May 10-29, as node 2A was out for repair

The overload event that occurred in April 2021 had an immediate effect on the driest portions of the soil close to the trench, but moisture variation was noticeable in most sensors. When selected data (one moisture measure about every month) were statistically compared, a lower moisture was found in design C with respect to the other two configurations at 8 (both distances) and 14 (far from the trench) inches of depth. This is consistent with water level, which resulted lower in this configuration. Results showed also that there was a statistically significant difference between the two blocks,

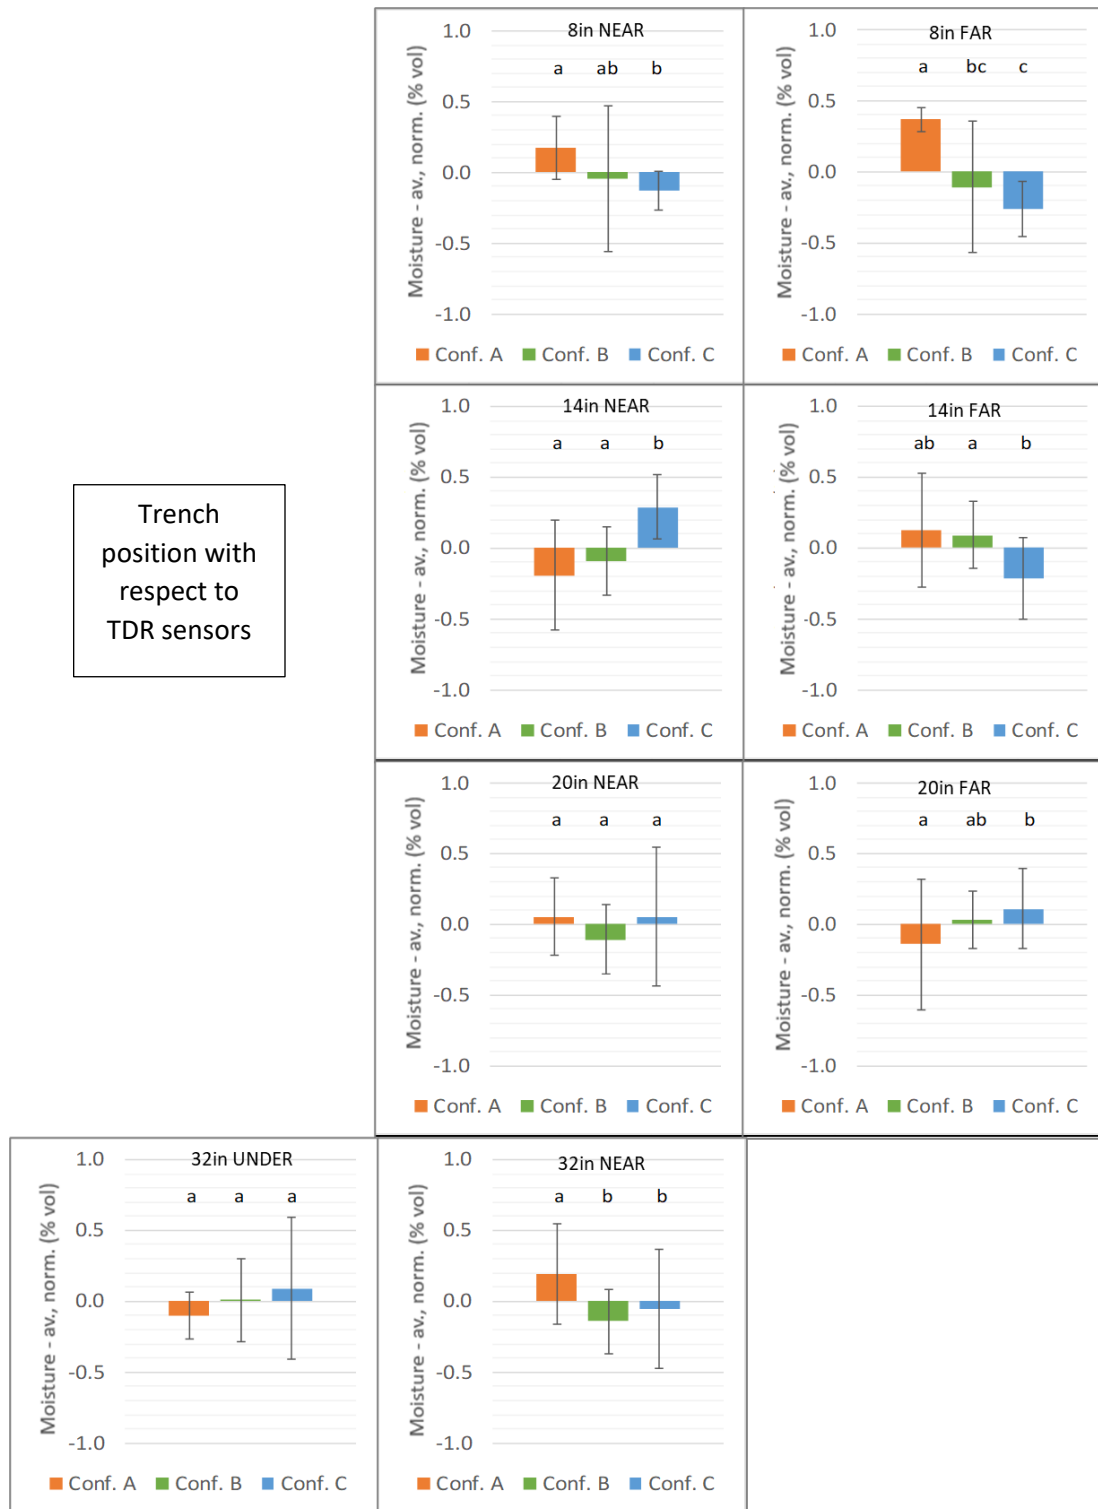
Figure 38. Average volumetric soil moisture at all sensors locations and all configurations. Each moisture value is obtained from the difference between a period (10-days of data) average and the period average among all configurations and blocks, then normalized for the period range among all configurations and blocks. Bars indicate standard deviation, and letters show if configurations are statistically significantly different among each other with the T-Test

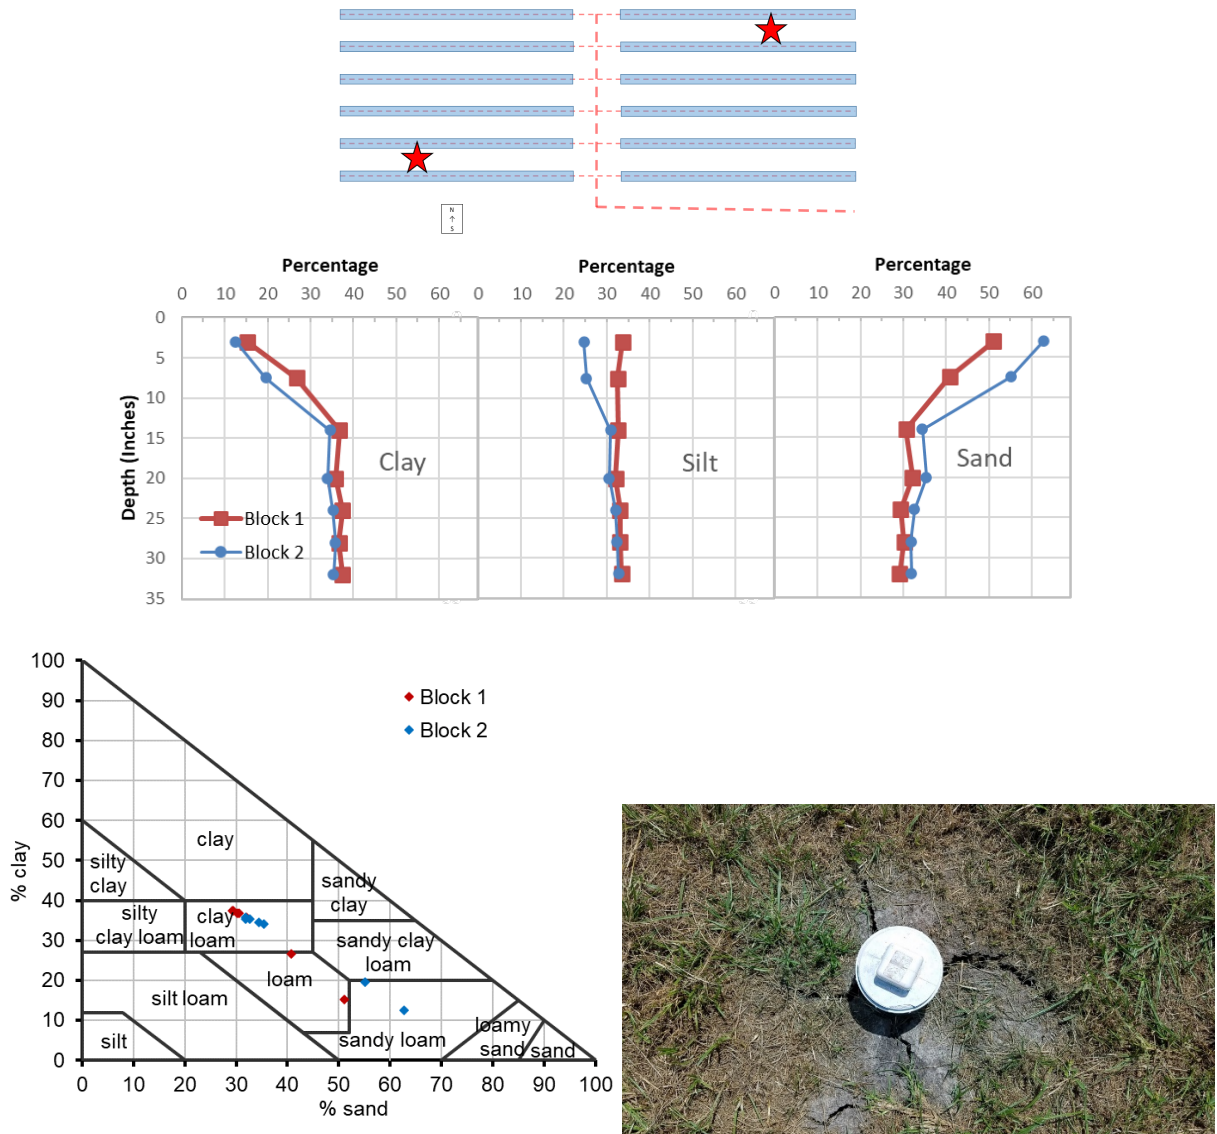
Figure 39. Top: Location of sampling (stars); Middle: Soil texture observed at the South-West side (Block 1) and the North-East side (Block 2) of the LPD drain field, near the corresponding TDR sensors, from samples collected with hand auger bucket on March 5, 2020; Bottom (left): Texture USDA classification of the two profiles; Bottom (right): Cracking of the topsoil in proximity of an inspection port

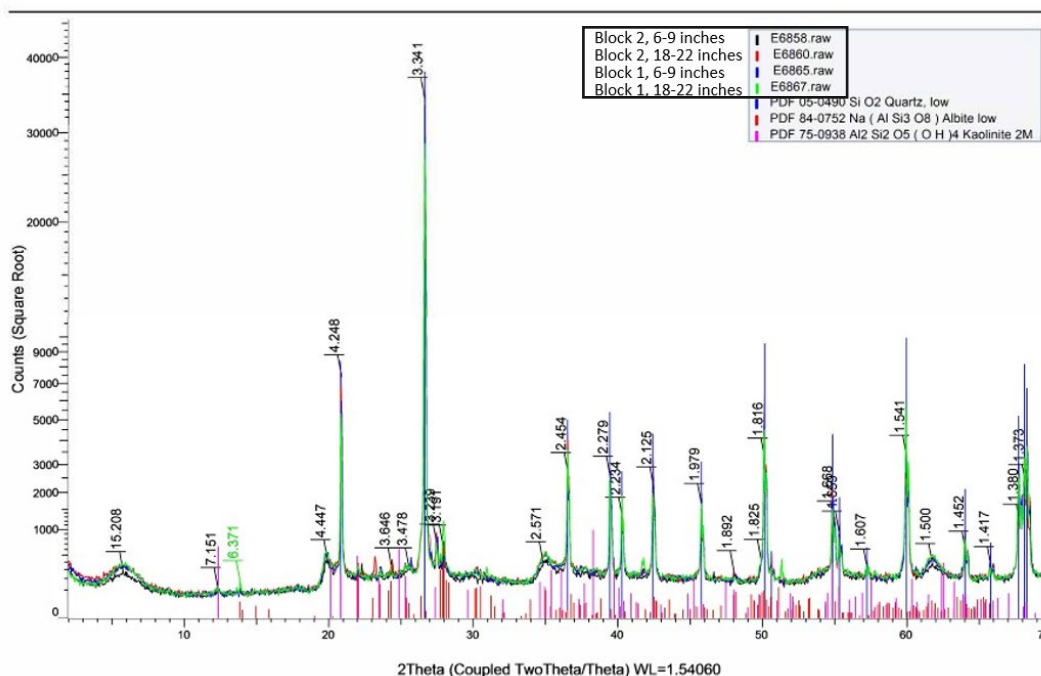
Figure 40. Clay detailed analysis (X-ray diffraction, XRD), from samples collected at 6-9 and 18-22 inches of depth with hand auger bucket on March 5, 2020

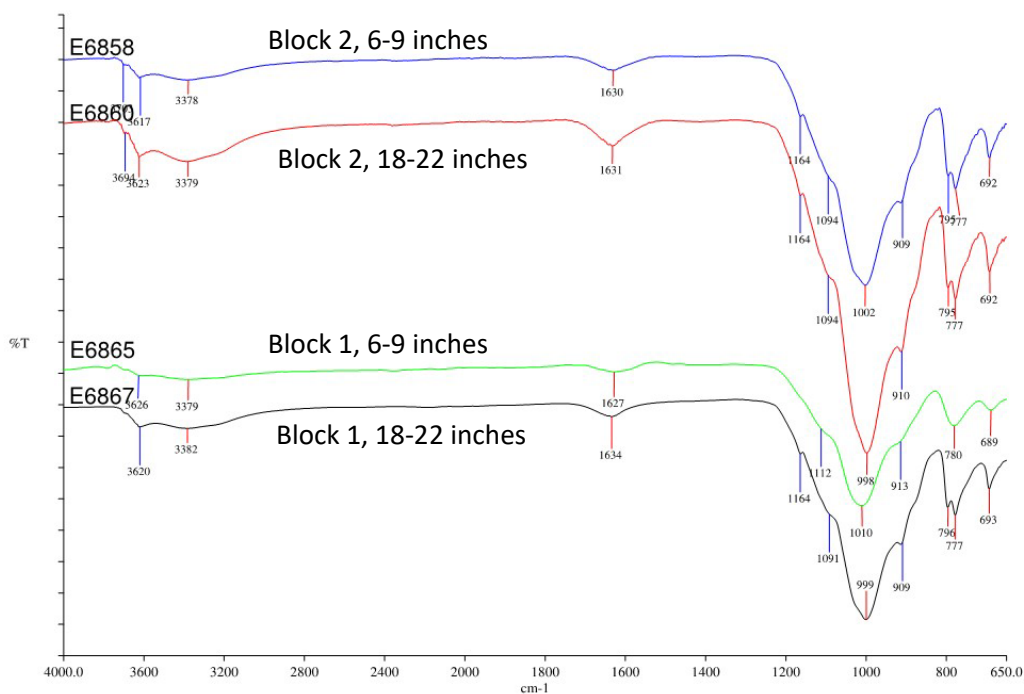
Figure 41. Clay detailed analysis (Fourier transform infrared, FTIR) from samples collected at 6-9 and 18-22 inches of depth with hand auger bucket on March 5, 2020

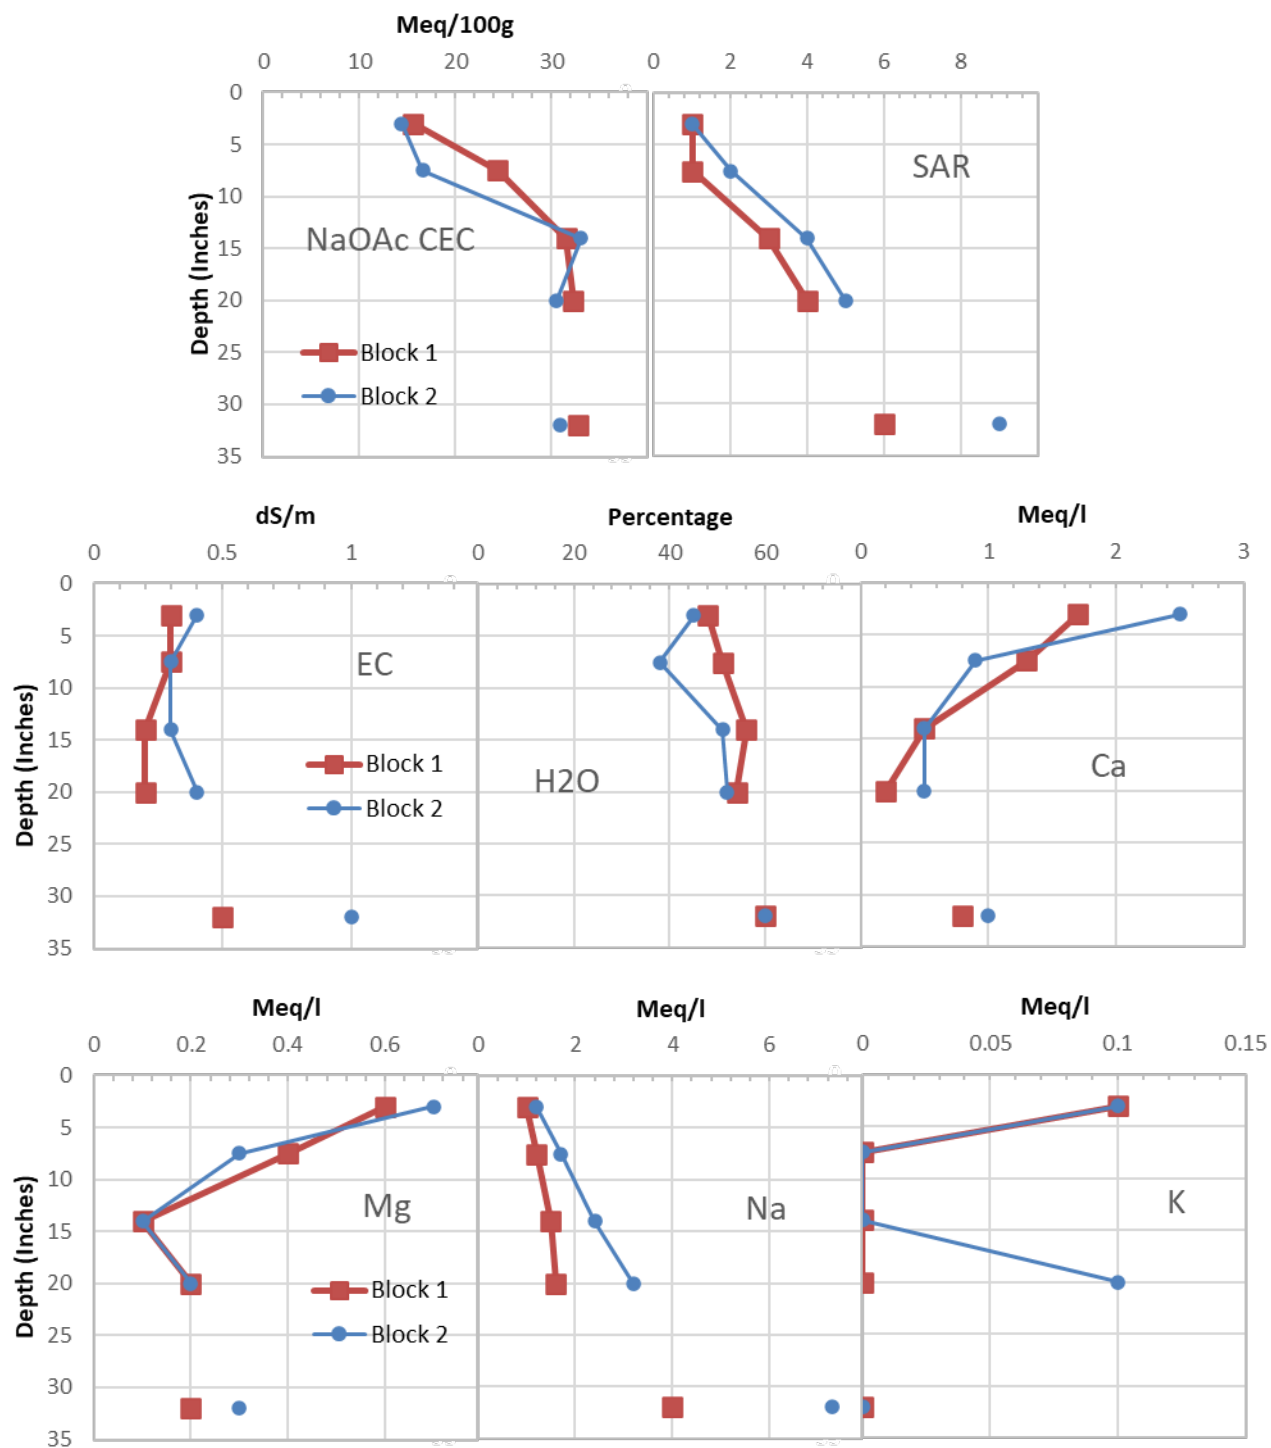
Figure 42. Cation exchange capacity and water soluble salts from saturated paste from samples collected with hand auger bucket on March 5, 2020. Top: Sodium acetate/ammonium acetate extraction, SAR; Middle: electrical conductivity, water content, Ca; Bottom: Mg, Na, K

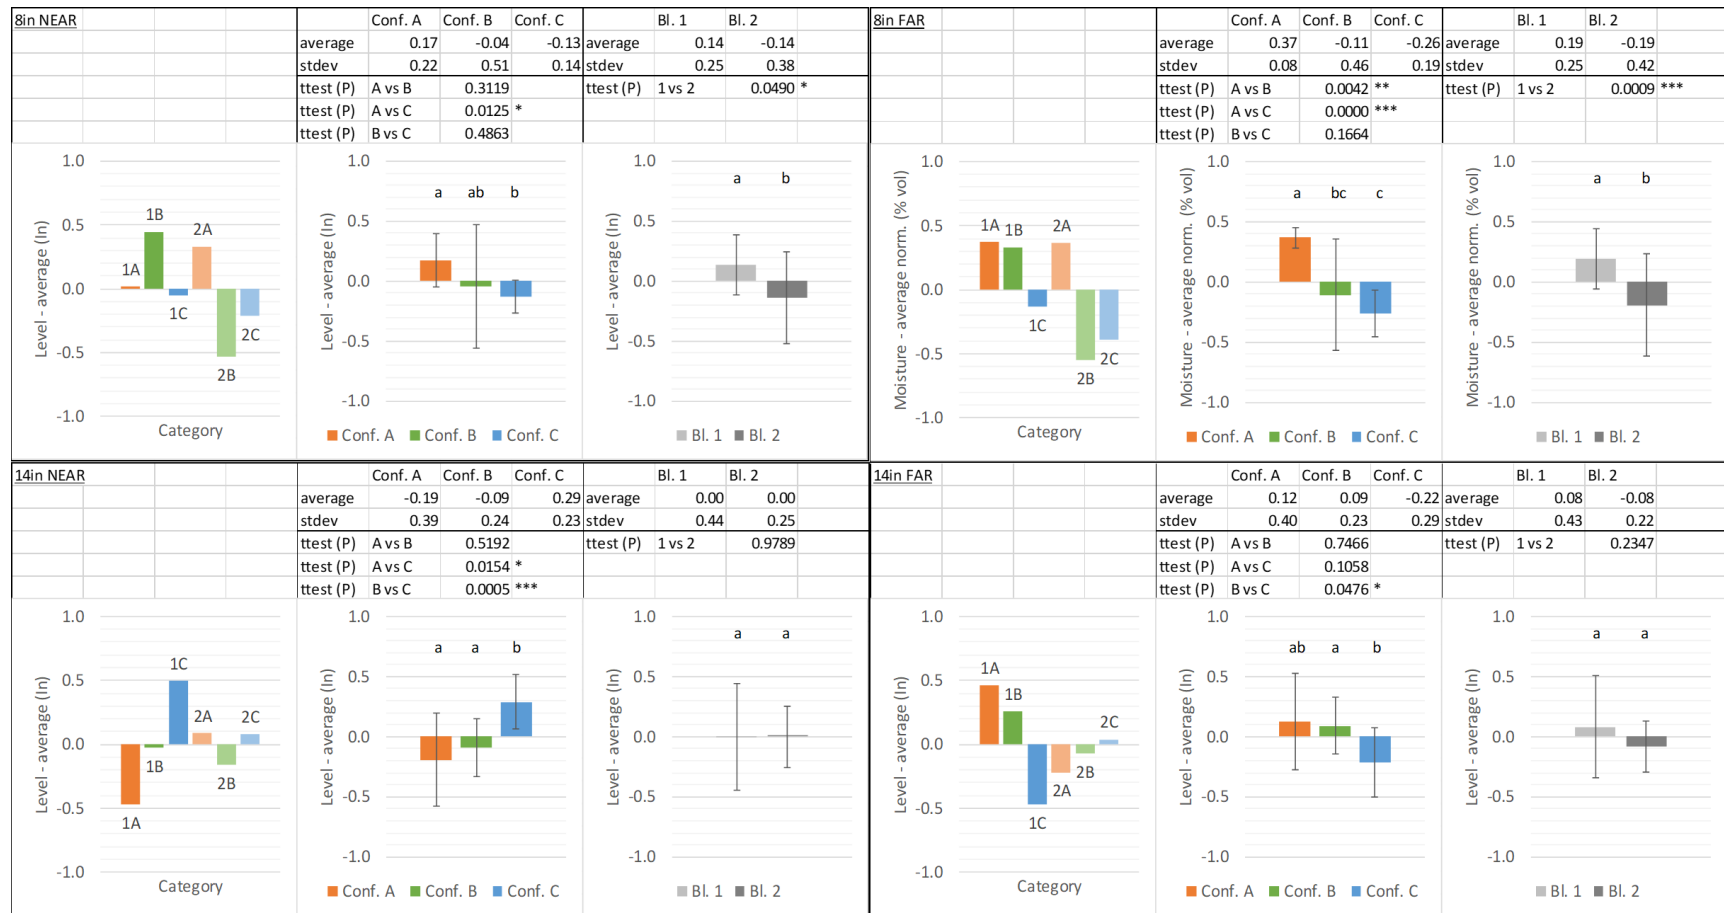
Statistical analysis of volumetric soil moisture readings at sensors located at 8 and 14 inches of depth. Moisture is expressed as difference between the reading and the daily average of all configurations and blocks, and normalized for the daily range. Bars indicate standard deviation, and letters show if configurations are significantly different among each other with the T-Test

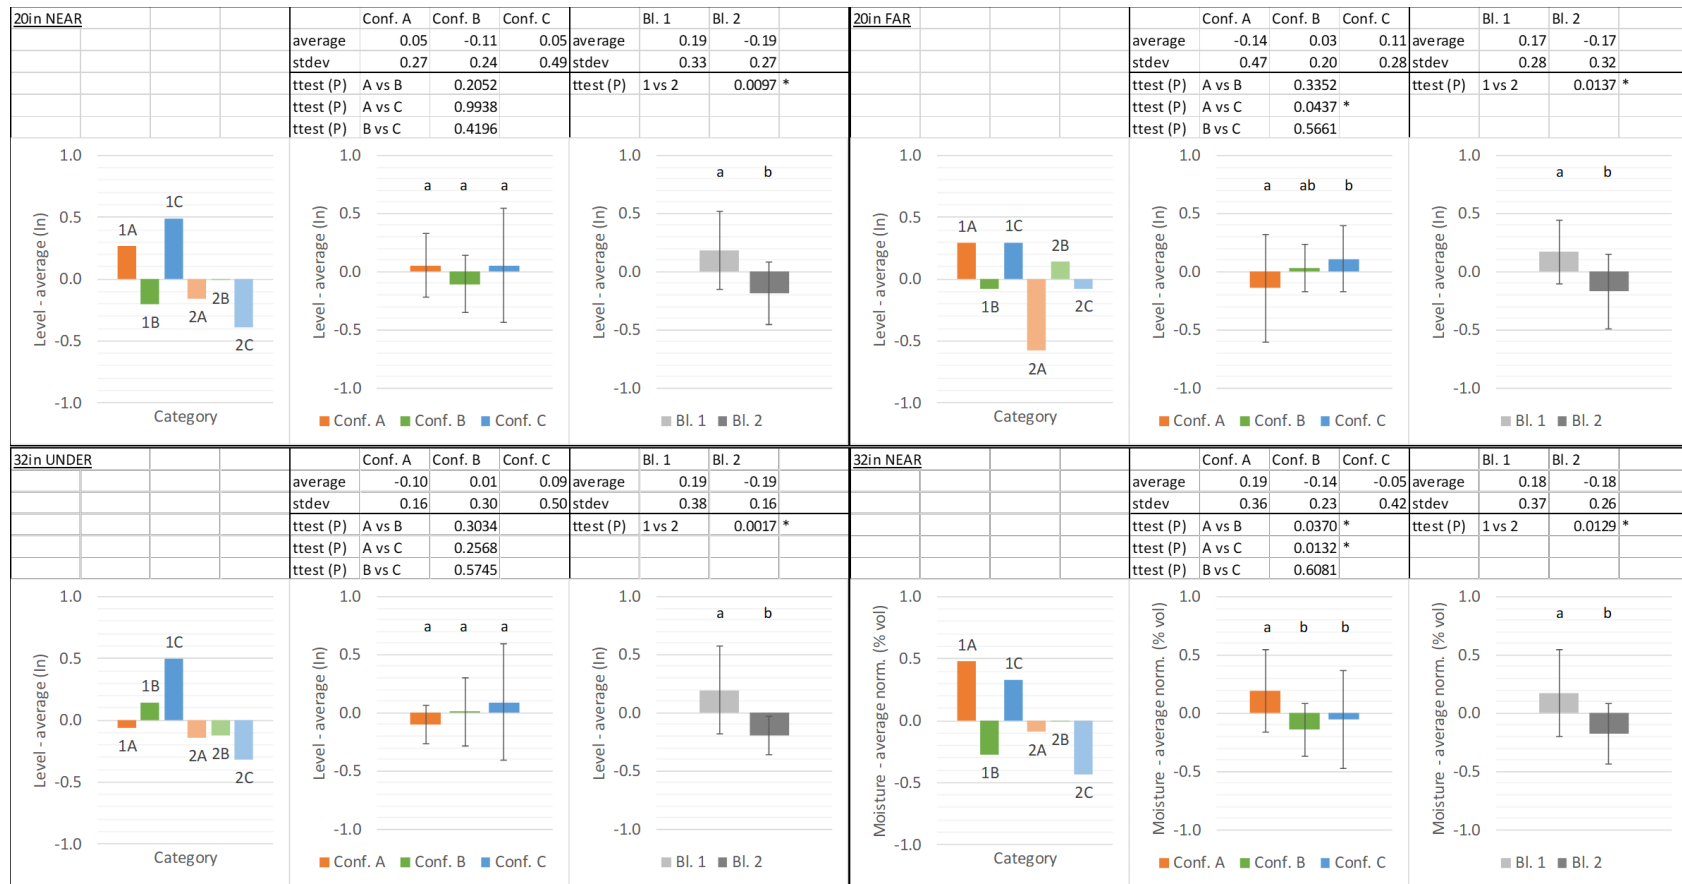
Statistical analysis of volumetric soil moisture readings at sensors located at 20 and 32 inches of depth. Moisture is expressed as difference between the reading and the daily average of all configurations and blocks, and normalized for the daily range. Bars indicate standard deviation, and letters show if configurations are significantly different among each other with the T-Test

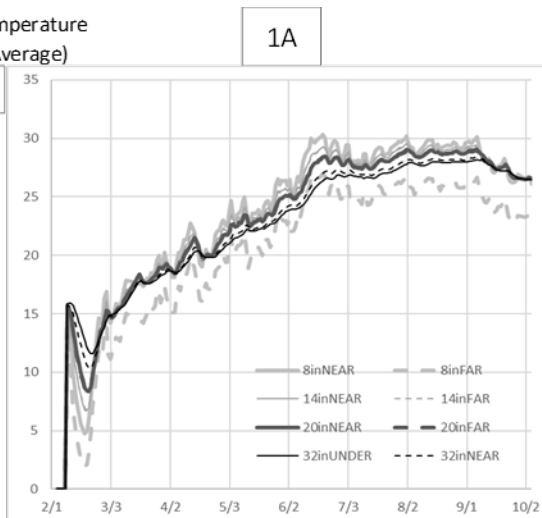
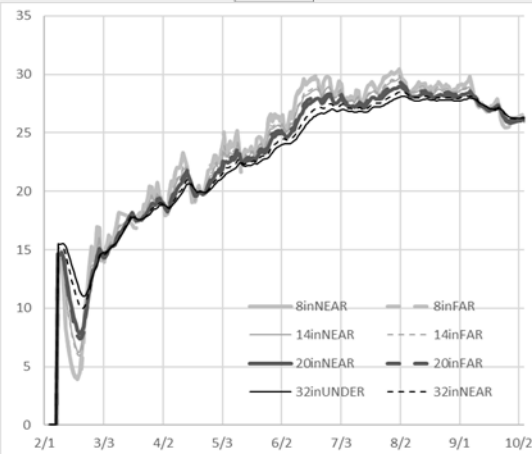
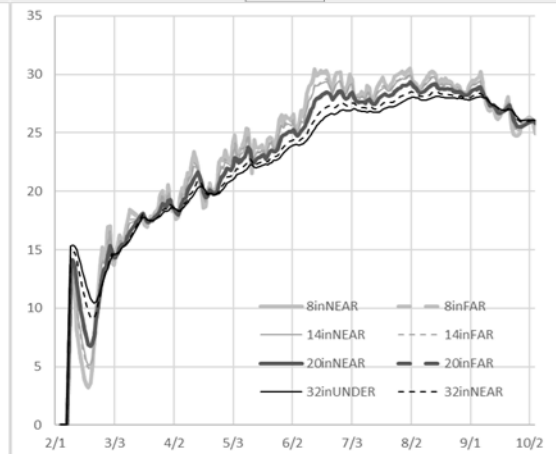
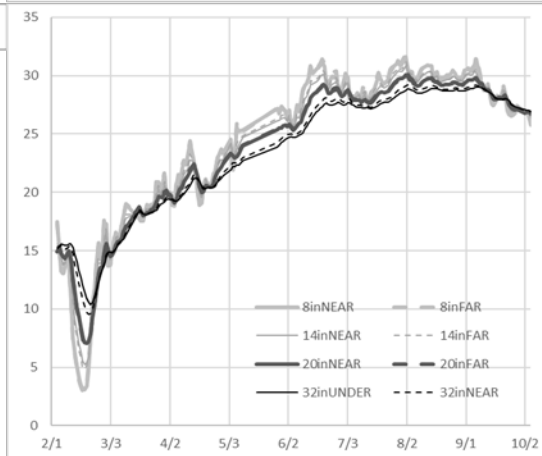
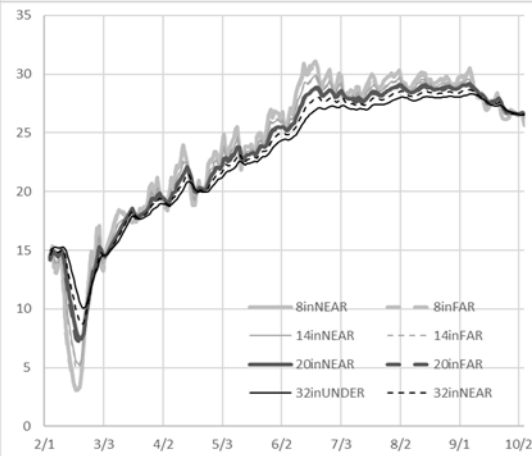
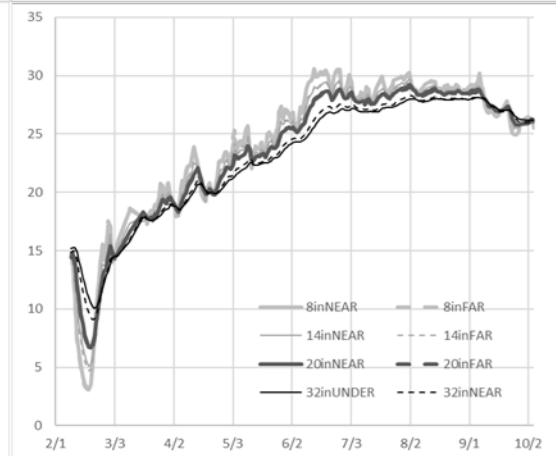
Soil temperature recorded by each TDR sensor
