Final Report DRAFT
Work Period: September 1, 2019 – August 31, 2021

For Texas On-Site Sewage Facility (OSSF) Research Contract #582-19-96830

Implementation of Low Pressure Dose Systems with Various Configurations

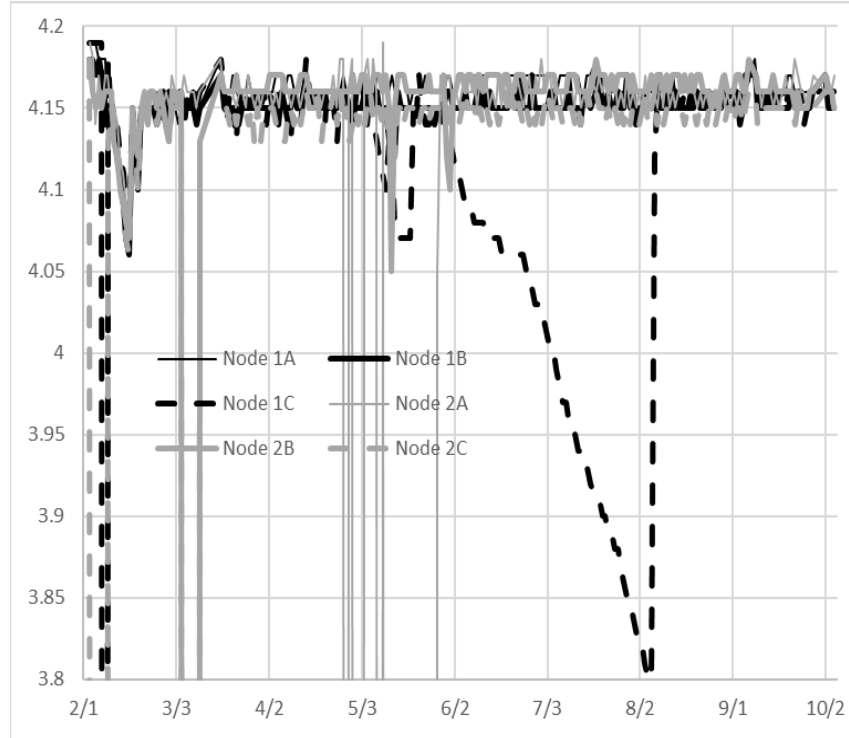
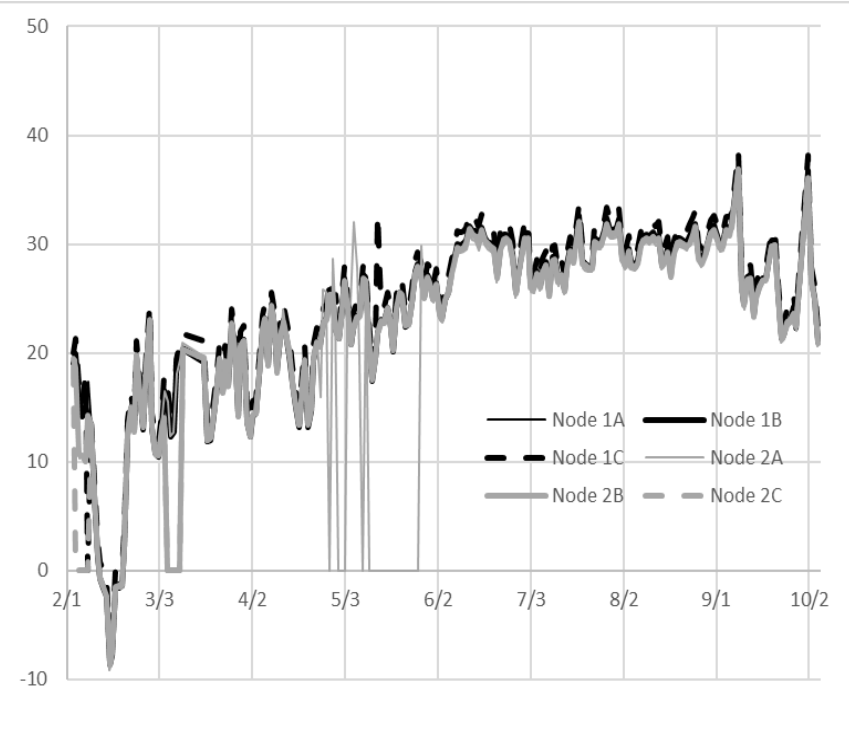
Solar voltage (left) and Air temperature (right) recorded by each node
