Final Report
Work Period: September 1, 2021 – November 30, 2023

For Texas On-Site Sewage Facility (OSSF) Research Contract #582-21-10767

**Aerobic Treatment Units in the Real World
(Sampling and New Data)**

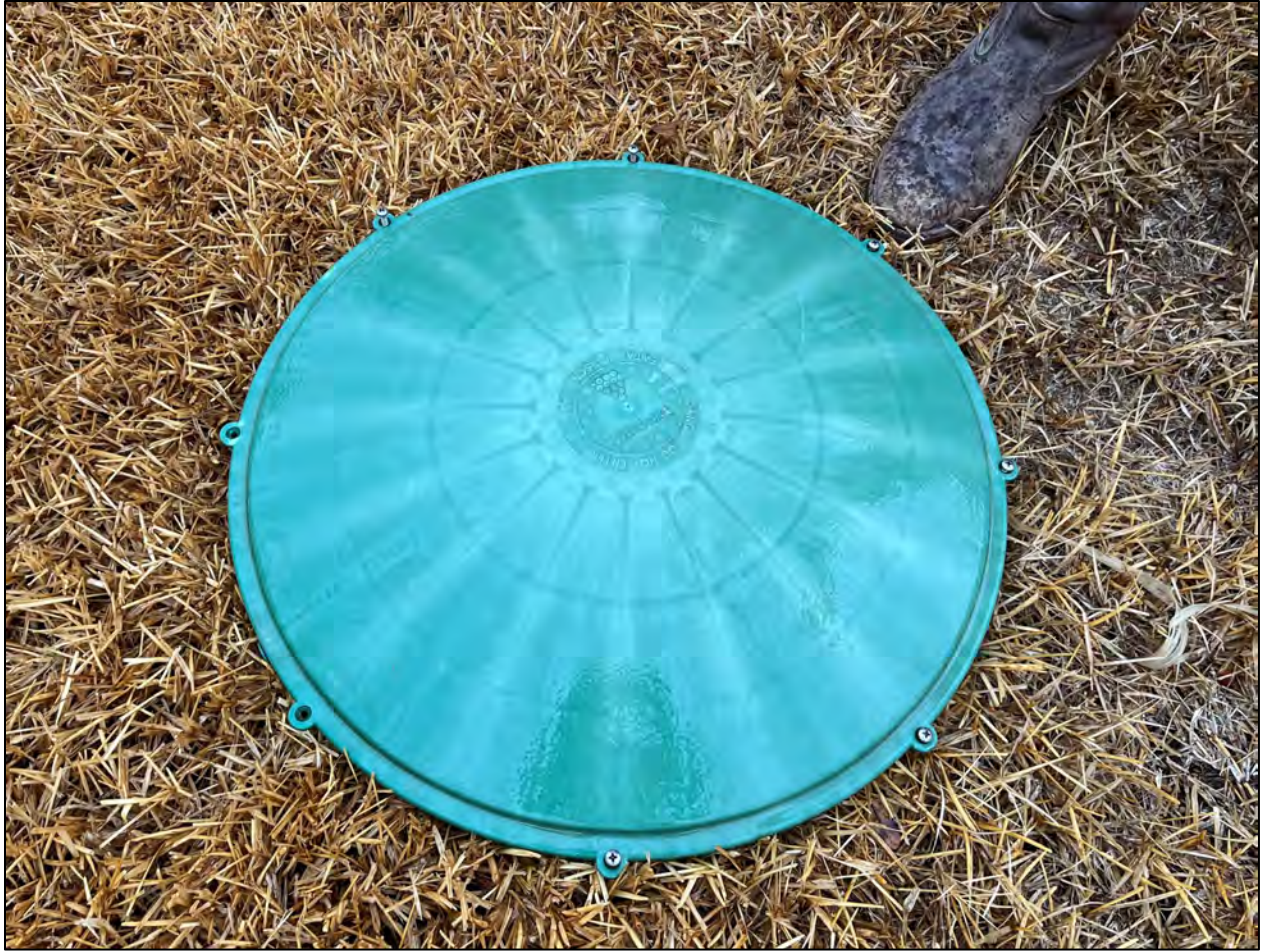
Lid Condition – Riser lid condition was judged based upon observations of the pump tank lid when accessed for water quality sample collection (Figure 3). The lid condition was described as: Excellent – secure with all fasteners present, including safety screw, Good – secure with all fasteners present but safety screw missing, Fair – secure with most fasteners present, Poor – more than 50% of fasteners missing. If the lid was not made of plastic, the condition was judged at the discretion of field personnel using the same categories.

Figure 3 - ATU pump tank riser lid missing two screws at ~8 and 9 o'clock positions.

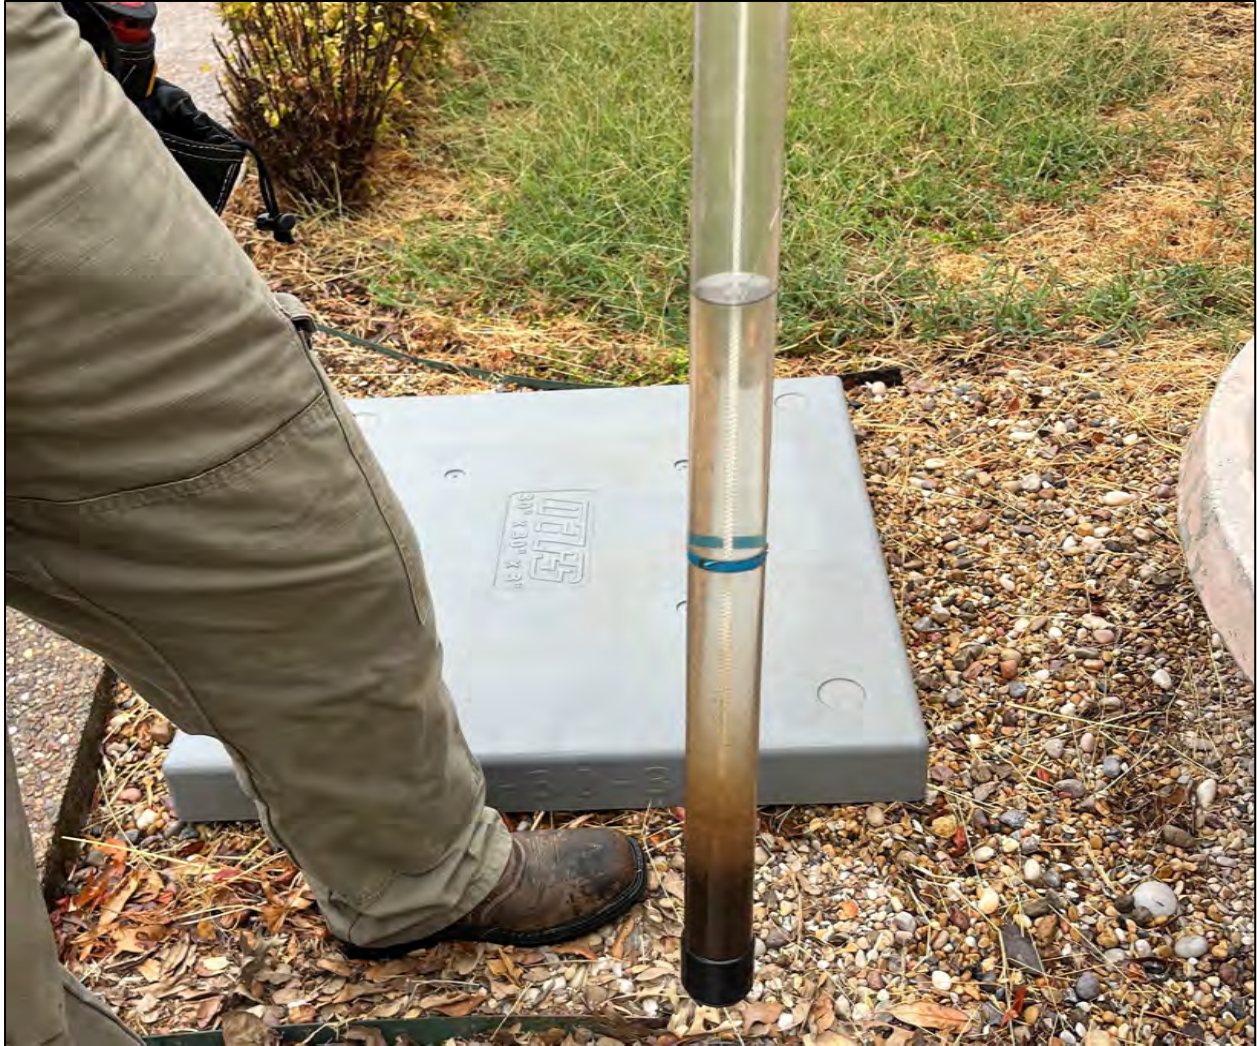
Sludge (pump tank) – Sludge accumulation in the pump tank was examined to assess ATU effluent quality being disposed through surface or subsurface mechanisms (Figure 4). Sludge accumulation condition was described as: Excellent – clear with no visible sludge present, Good – visible sludge <~5% of total water column, Fair – visible sludge <~25% of total water column, Poor – visible sludge >~25% of total water column.

Figure 4 - Visually evaluating sludge level in residential ATU pump tank with sludge sampler

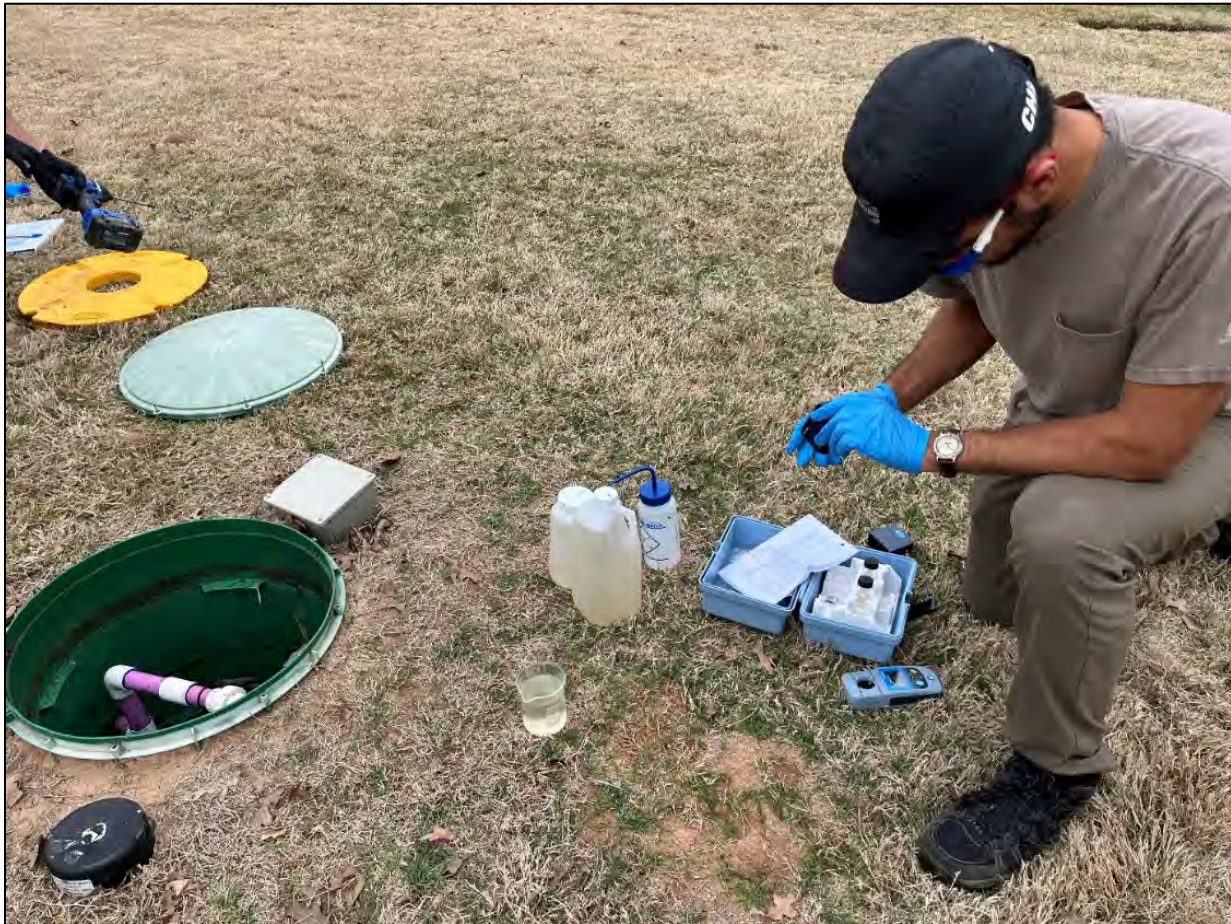
Free and Total Chlorine – Free chlorine and Total was measured for most residential and non-residential systems utilizing surface effluent disposal. Free and total chlorine was also measured on a number of subsurface systems for interest and comparison. Concentration was determined on-site at the time of water sample collection by AgriLife field personnel due to the volatile nature of chlorine. Measurements were made using a HACH DR300 Portable Colorimeter (HACH, Loveland, CO) using low-range DPD (N,N-diethyl-p-phenylenediamine) chemistry (Figure 6). Results are reported as milligrams per liter (mg/L) concentration.

Figure 5- Measuring chlorine on-site at a residential ATU

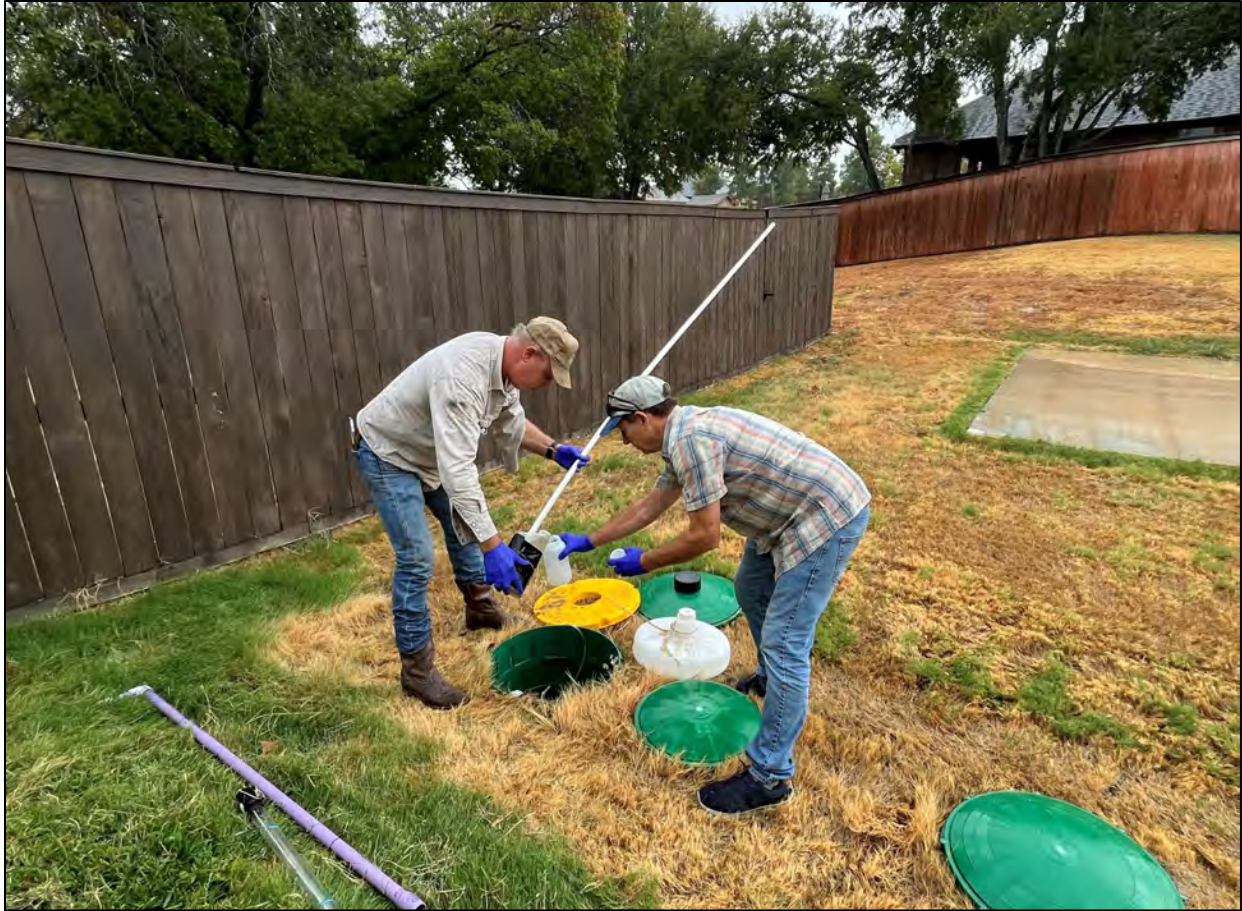
Effluent Sample Collection – Effluent water quality samples were collected from the ATU pump tank using a simple dip sampler (Figure 7). Field personnel attempted to take representative effluent samples by collecting from the middle of the water column in the ATU pump tank.

Figure 6- Collecting water quality sample from ATU pump tank.

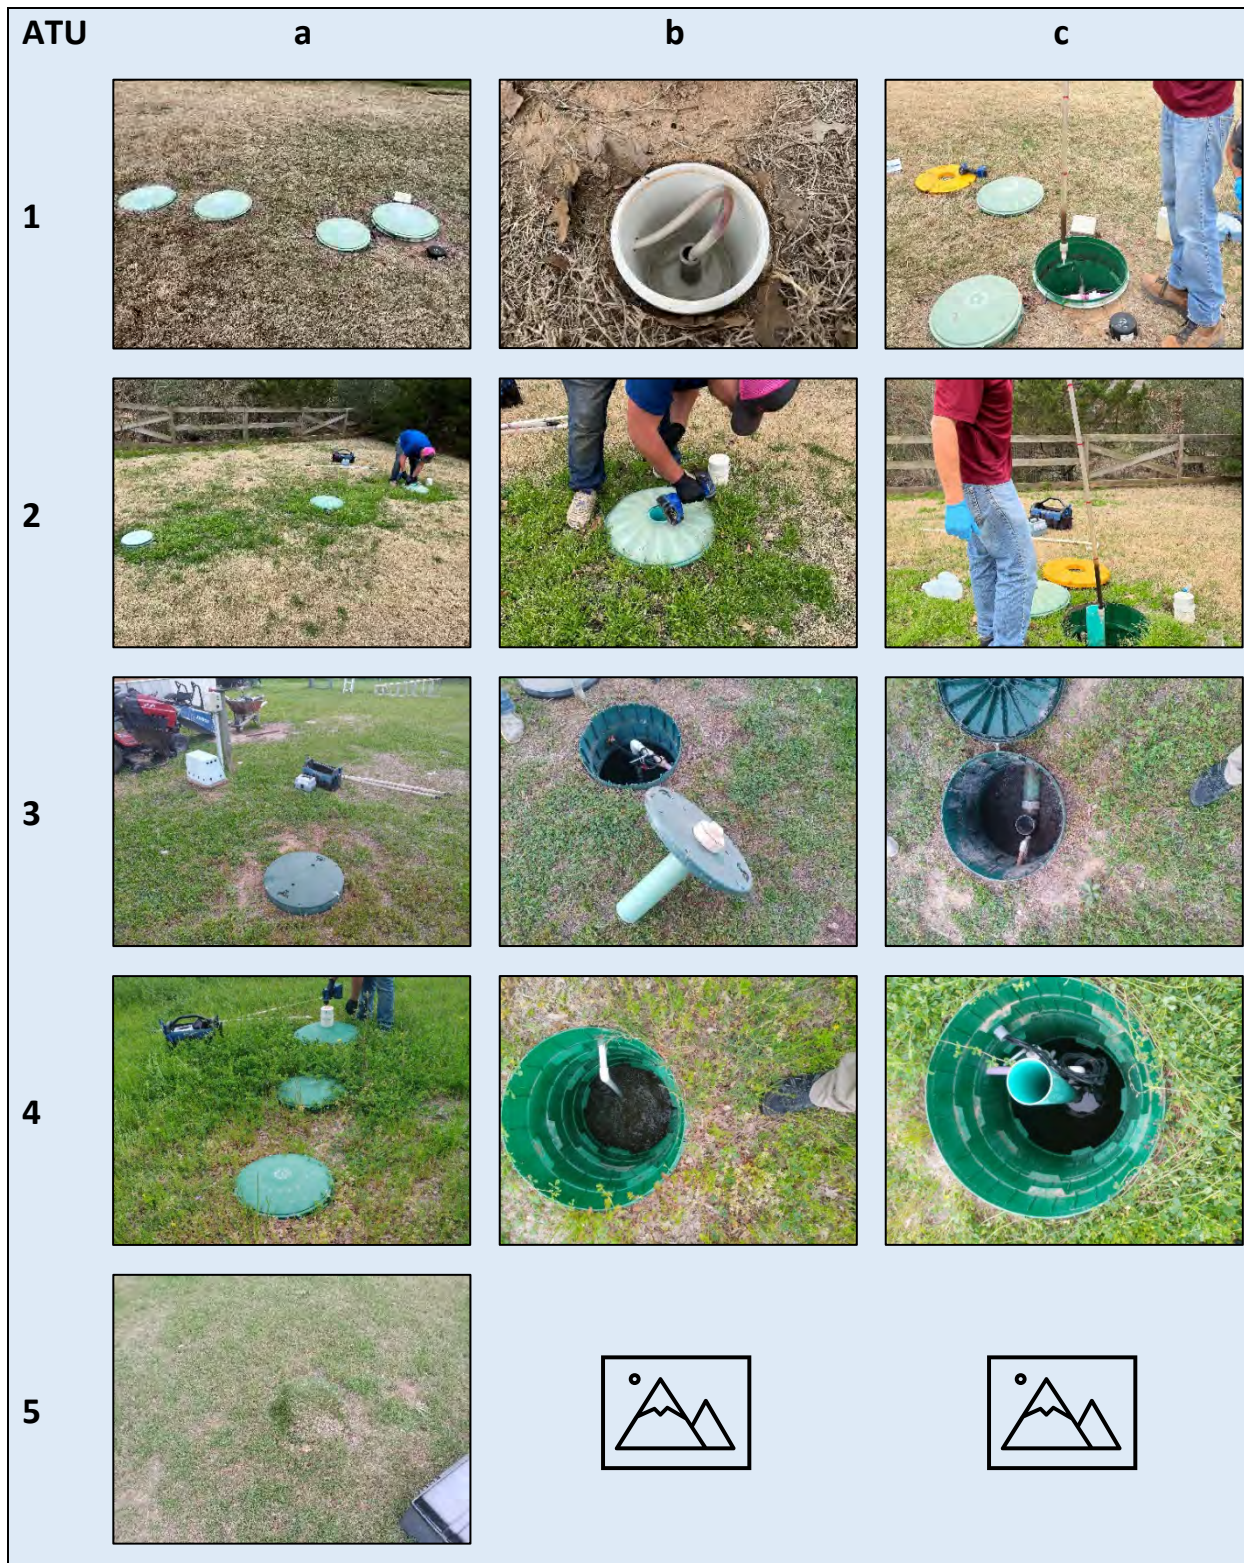
Additional Observations		One spray head worn, ants around air pump	Mobile home, chlorine meter over range		No photos available

Plate 1 – Photographs of ATU systems 1 through 5. Designations a, b, and c generally show a) overall system, b) pump tank, chlorinator, or lid condition or other anomaly, and c) sludge condition (if available).

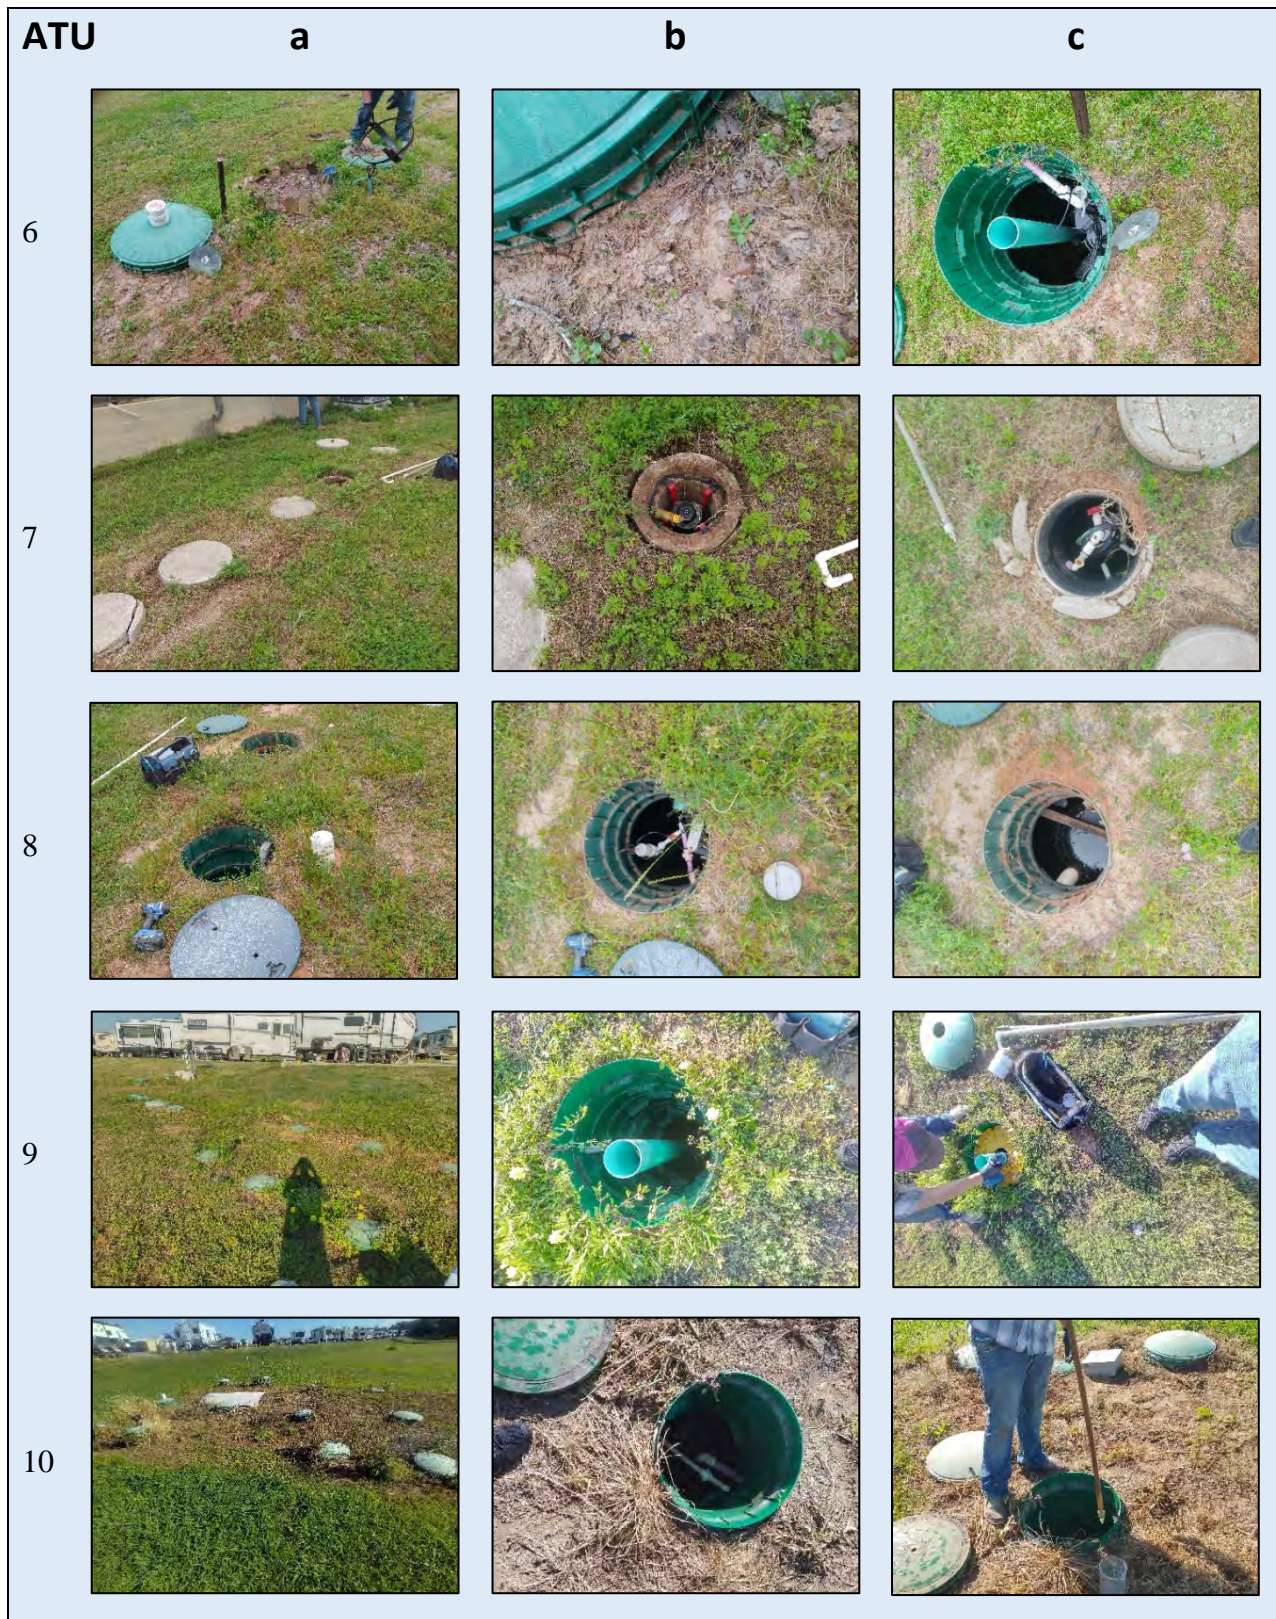
Additional Observations		Aeration, 2 sprinklers, and lid broken. Wet. Needs pumping.	Sprinkler heads broken, Age unknown, estimated		Unkept, ants everywhere

Plate 2 – Photographs of ATU systems 6-10. Designations a, b, and c generally show a) overall system, b) pump tank, chlorinator, or lid condition or other anomaly, and c) sludge condition (if available).

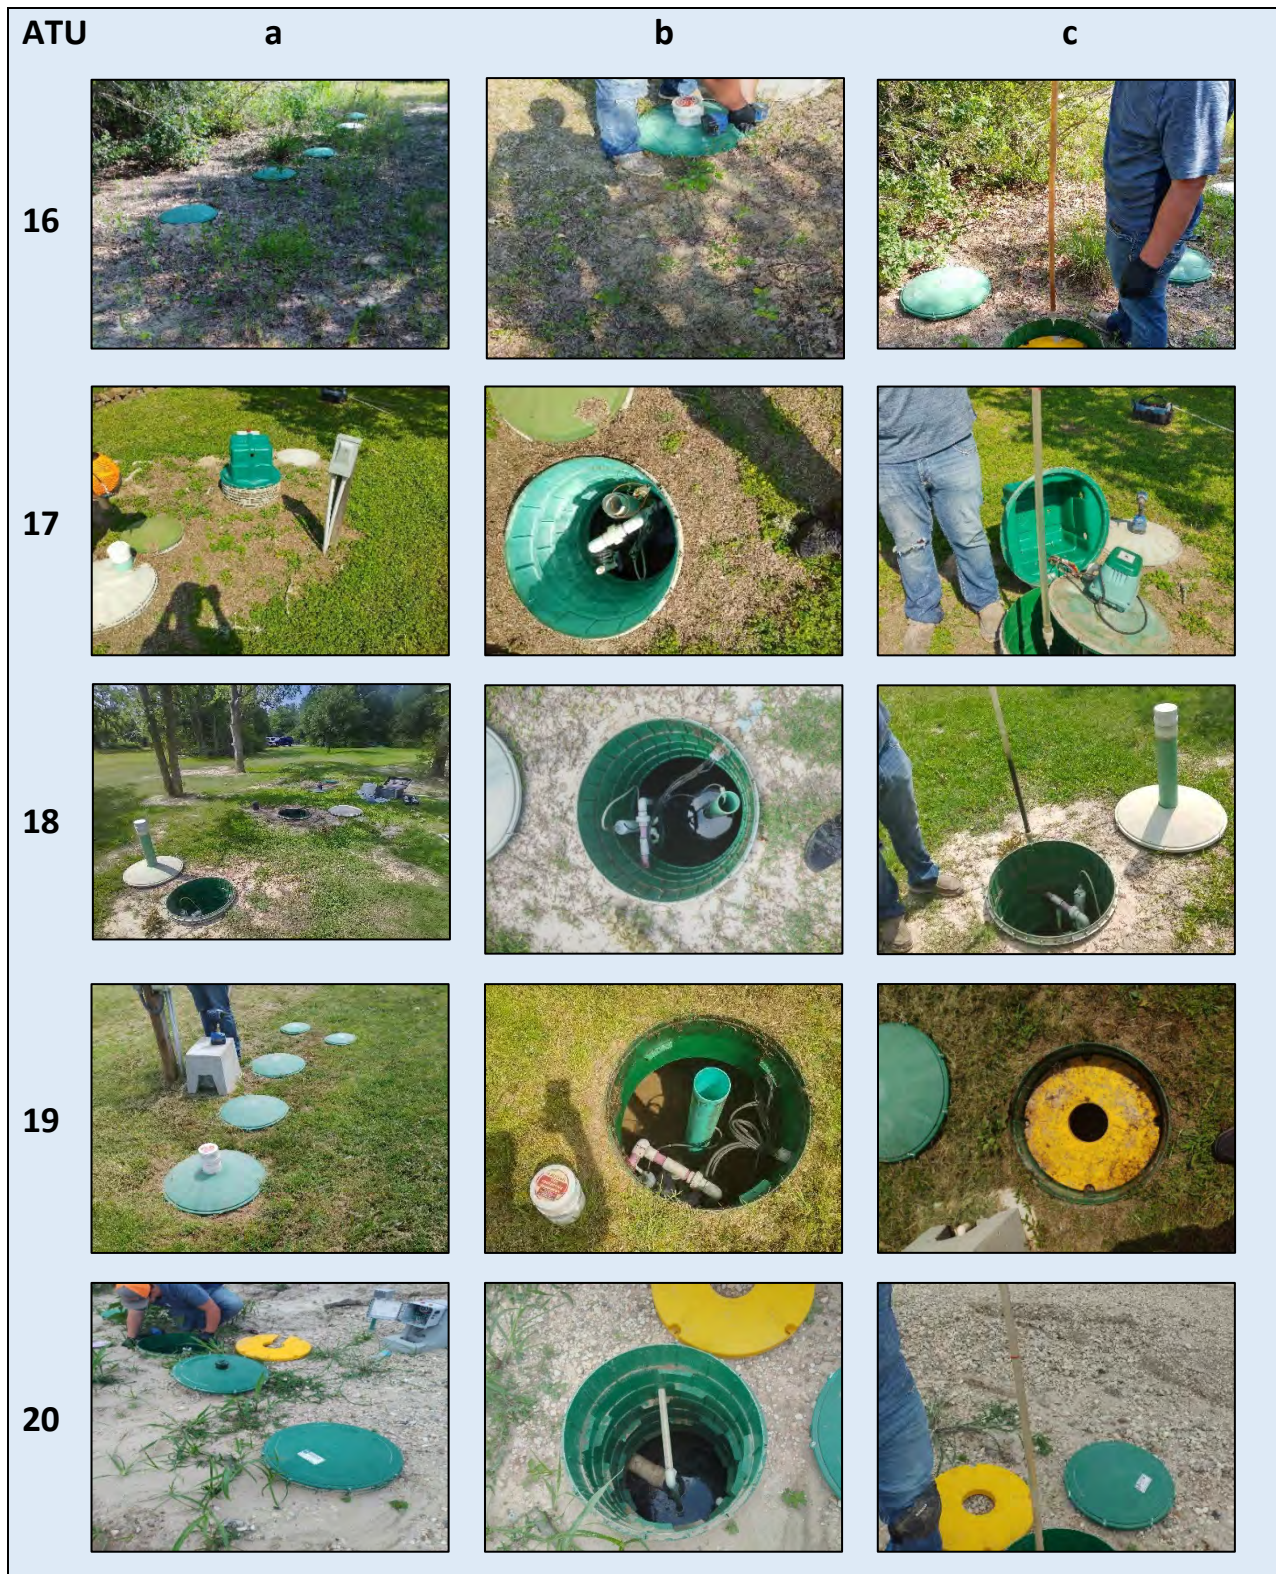
Plate 4 – Photographs of ATU systems 16 through 20. Designations a, b, and c generally show a) overall system, b) pump tank, chlorinator, or lid condition or other anomaly, and c) sludge condition (if available).

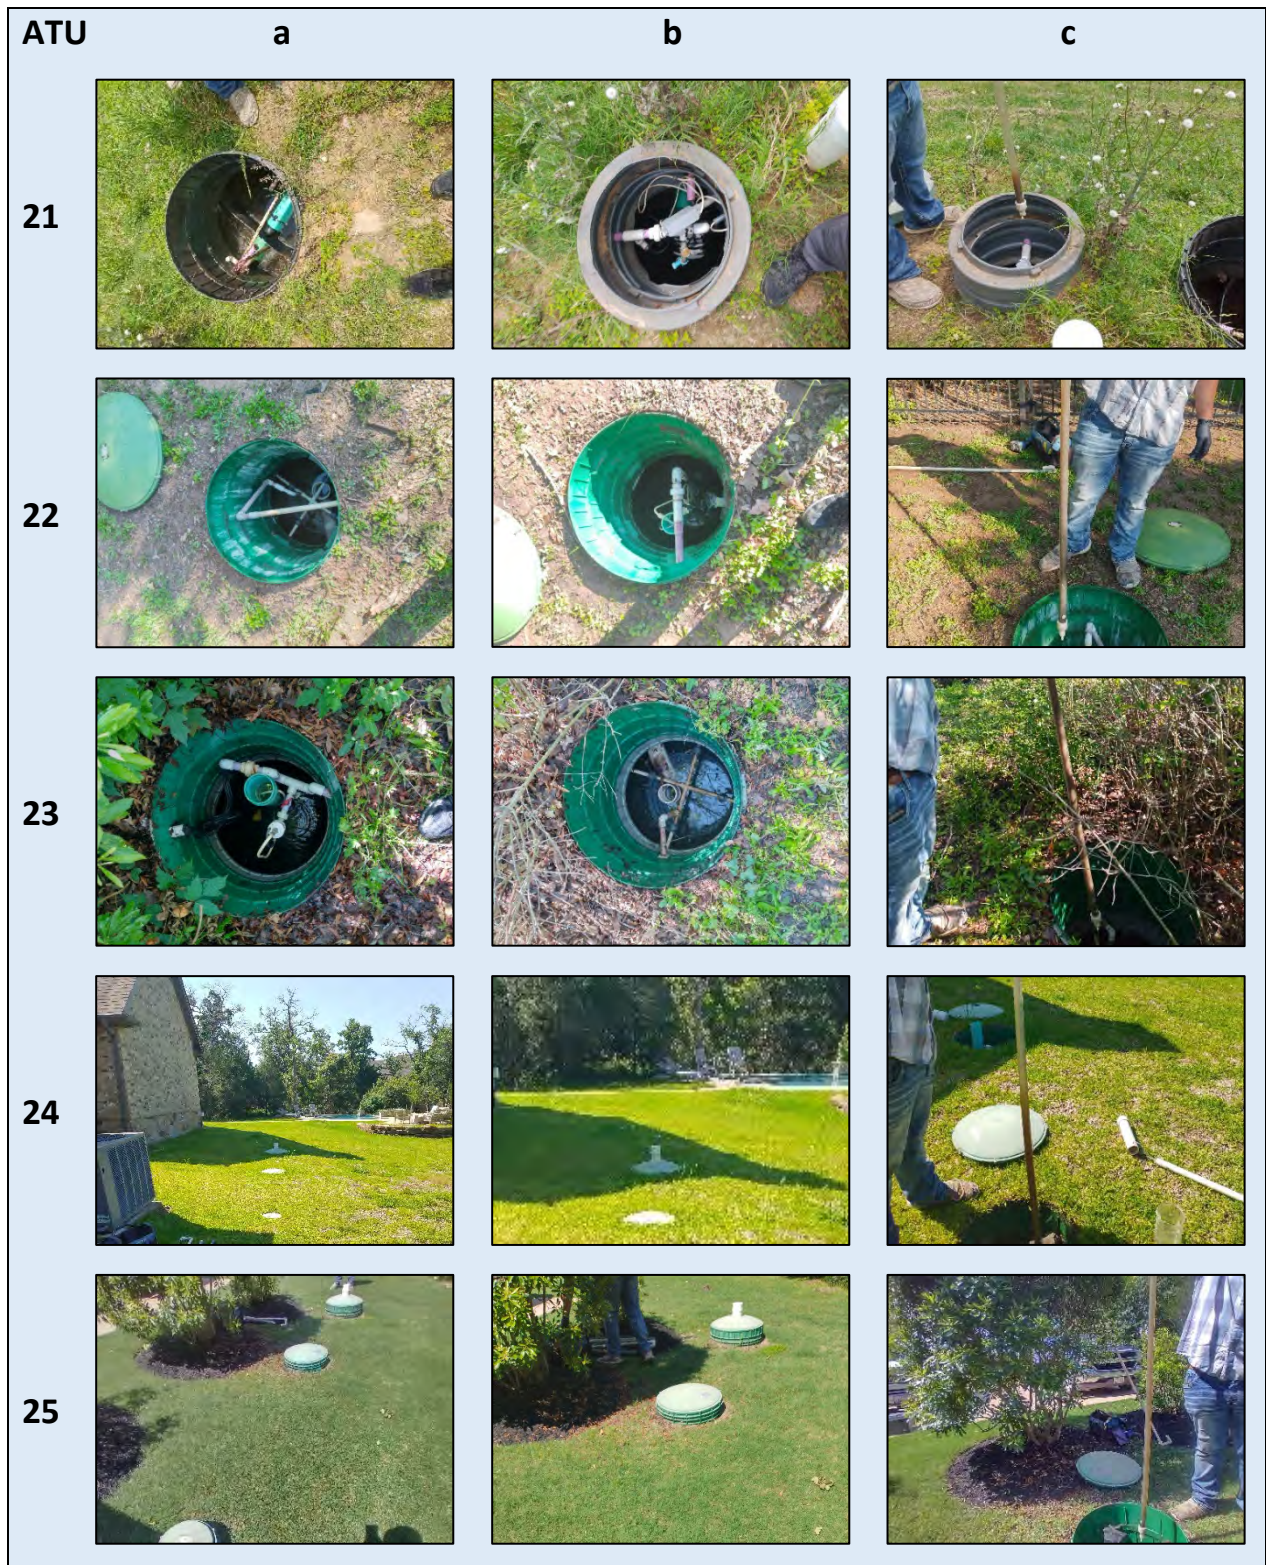
Plate 5. Photographs of ATU systems 21 through 25. Designations a, b, and c generally show a) overall system, b) pump tank, chlorinator, or lid condition or other anomaly, and c) sludge condition (if available).

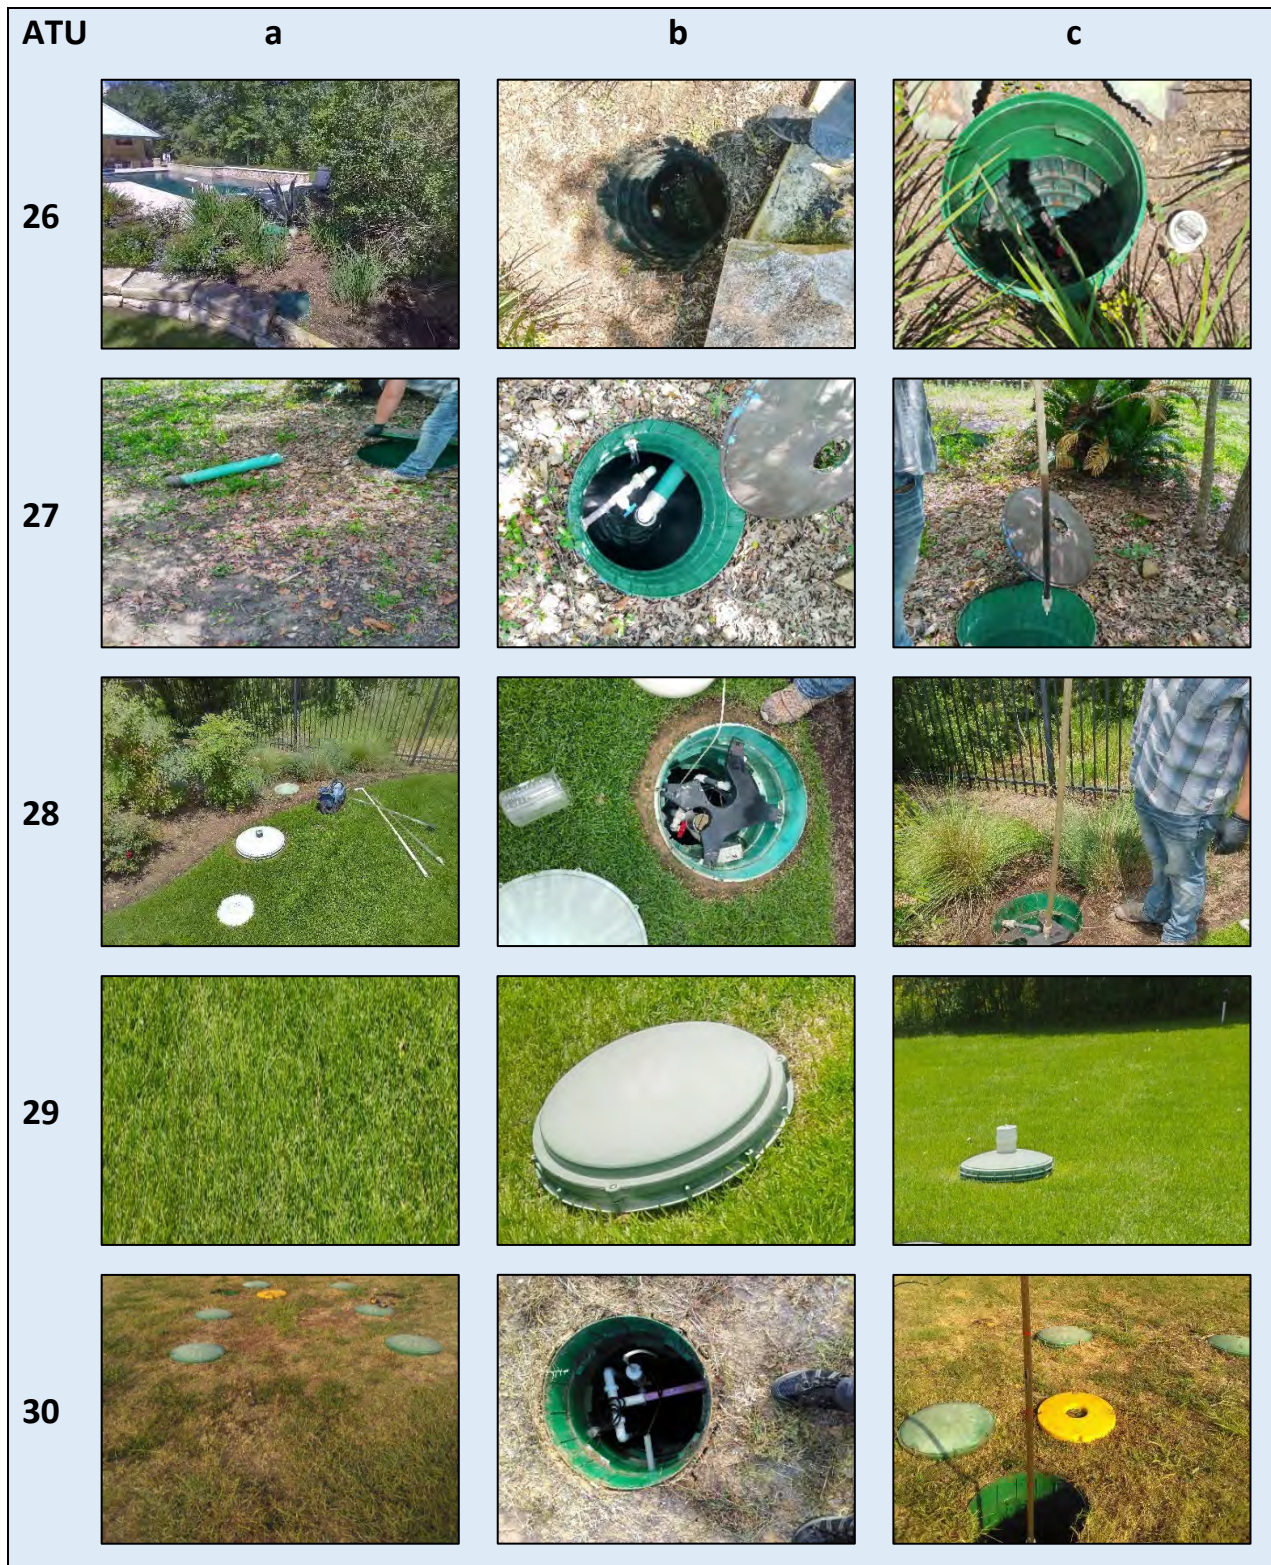
Additional Observations	Sprinkler system needs repair, excessive sludge	Aeration tank in critical condition			Well-kept

Plate 6. Photographs of ATU systems 26 through 30. Designations a, b, and c generally show a) overall system, b) pump tank, chlorinator, or lid condition or other anomaly, and c) sludge condition (if available).

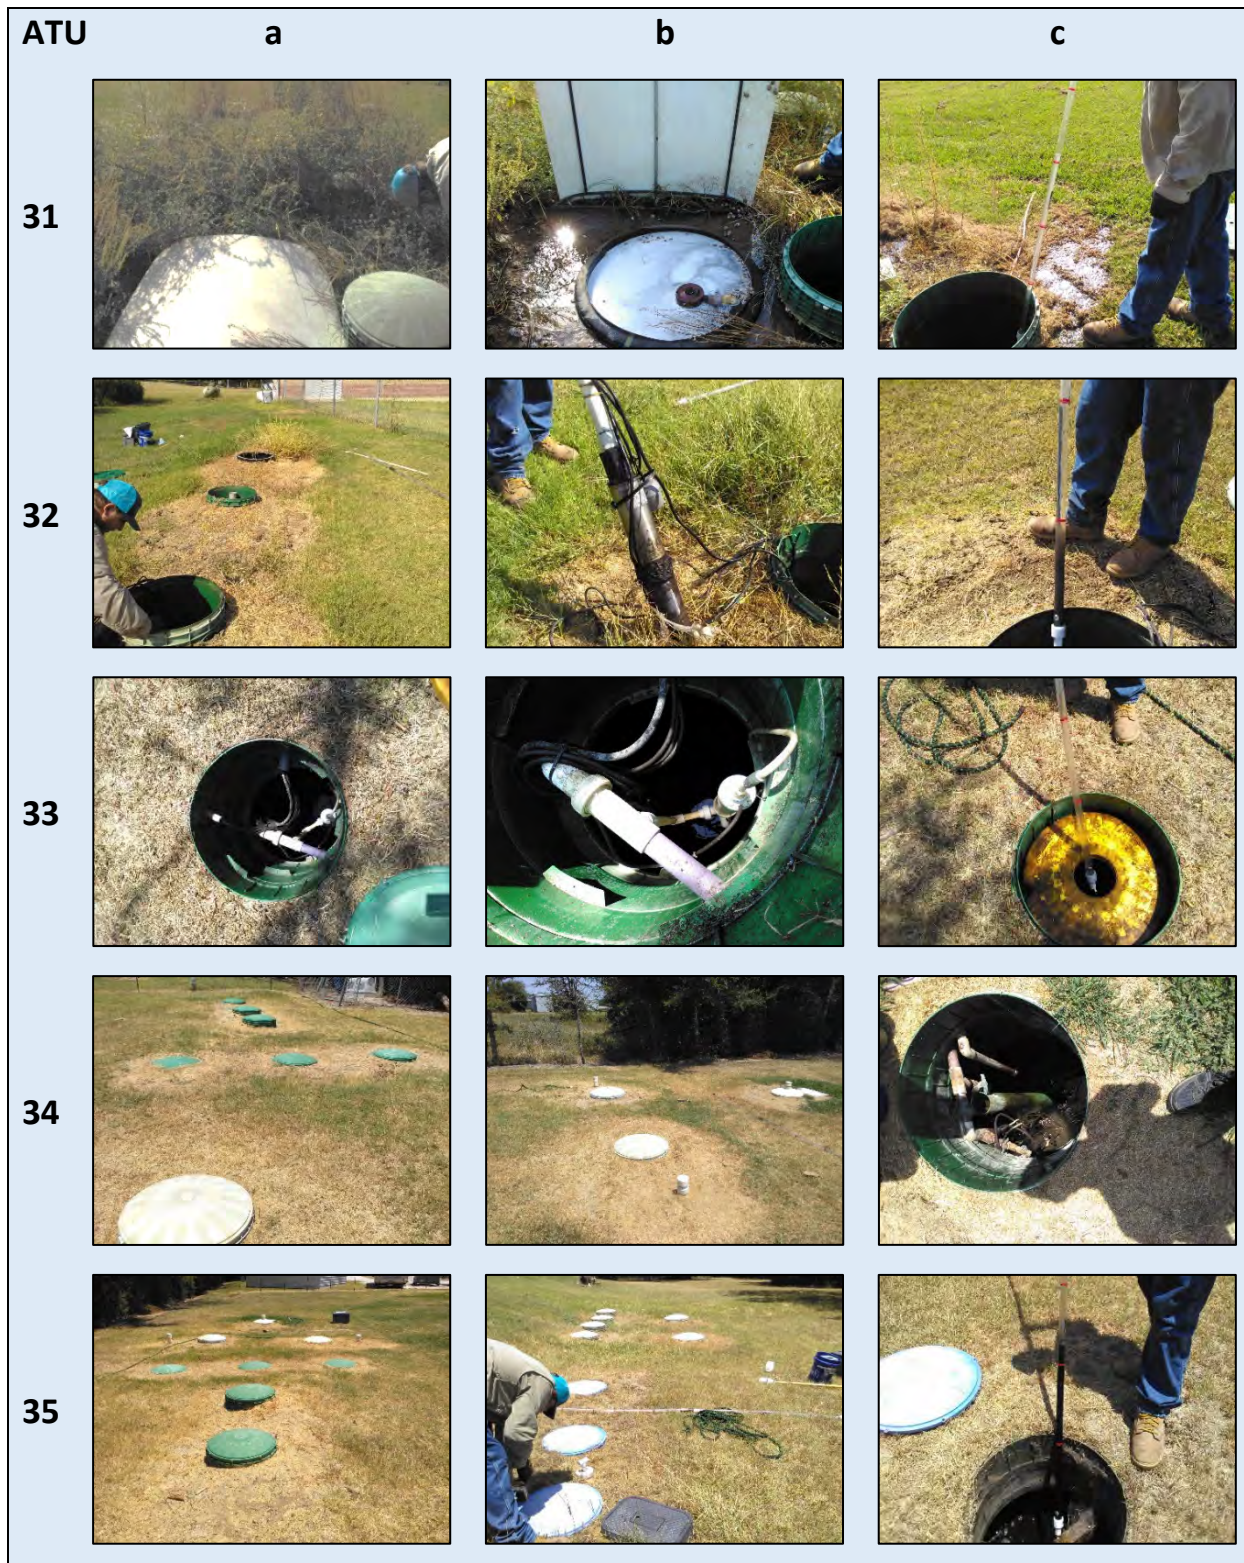
Plate 7. Photographs of ATU systems 31 through 35. Designations a, b, and c generally show a) overall system, b) pump tank, chlorinator, or lid condition or other anomaly, and c) sludge condition (if available).

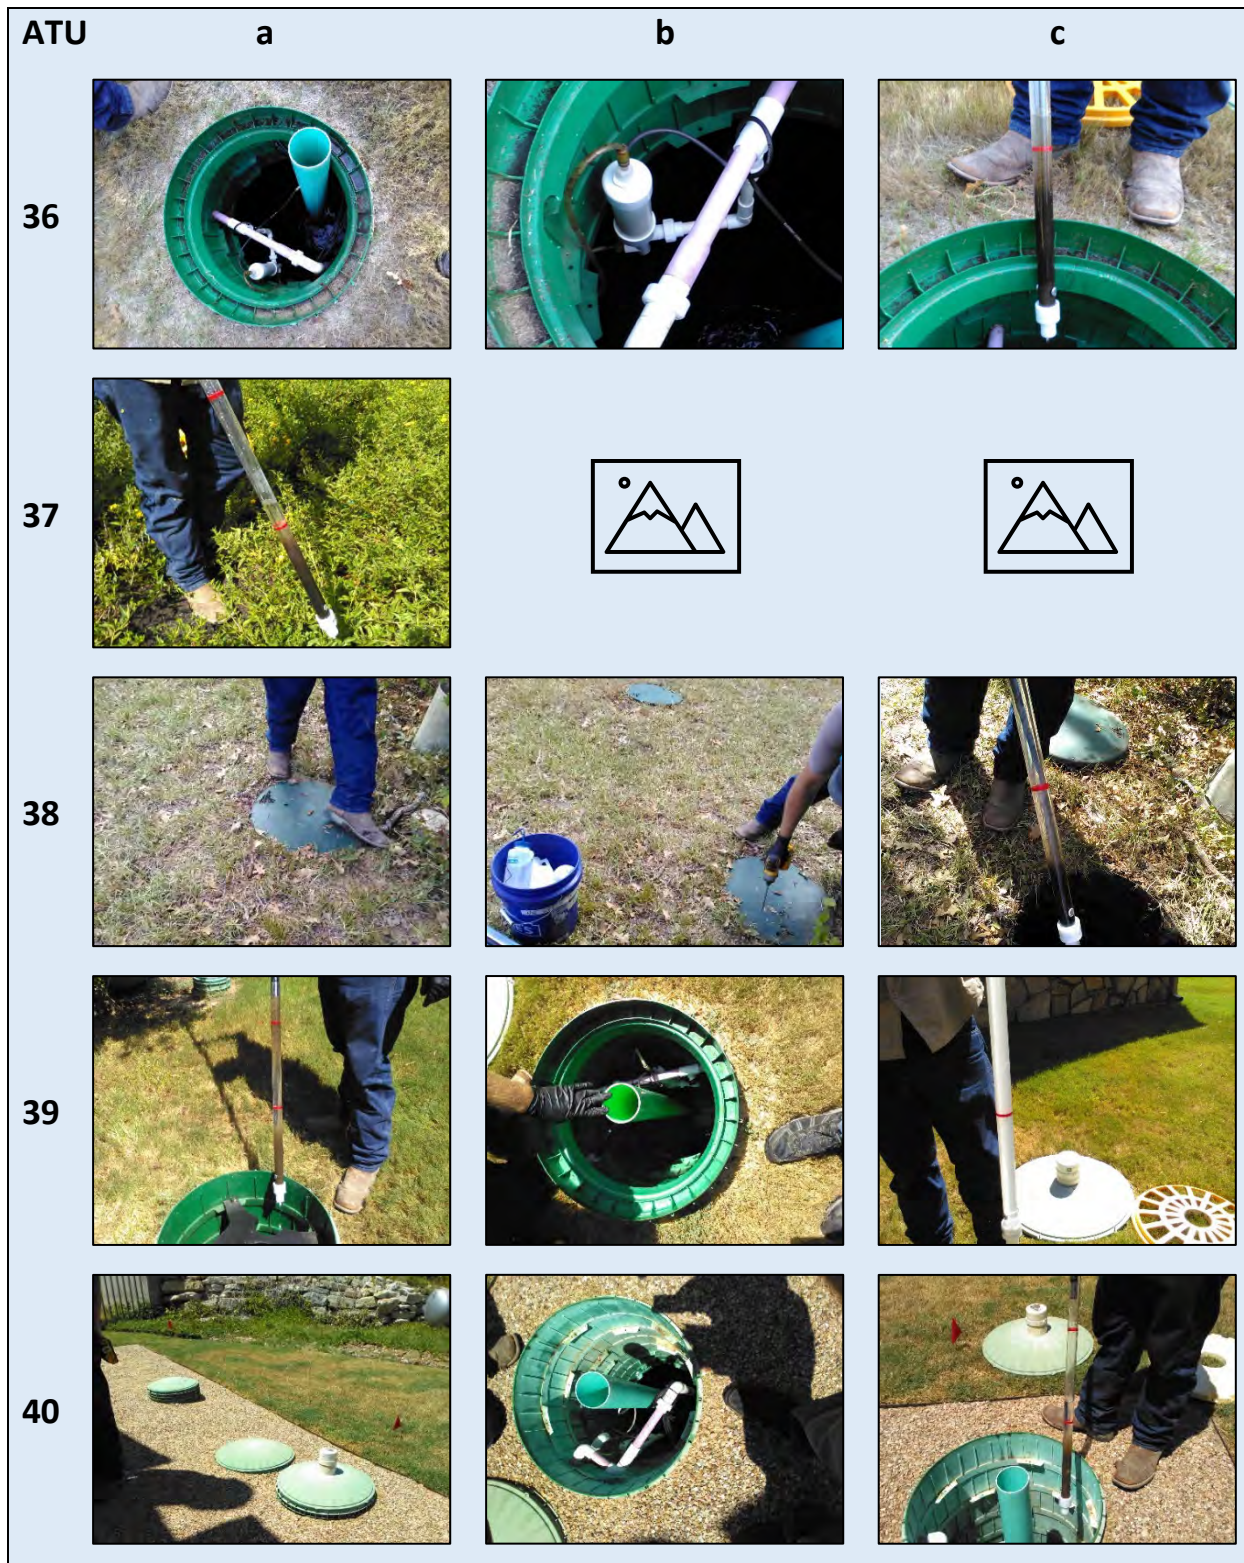
Plate 8. Photographs of ATU systems 36 through 40. Designations a, b, and c generally show a) overall system, b) pump tank, chlorinator, or lid condition or other anomaly, and c) sludge condition (if available).

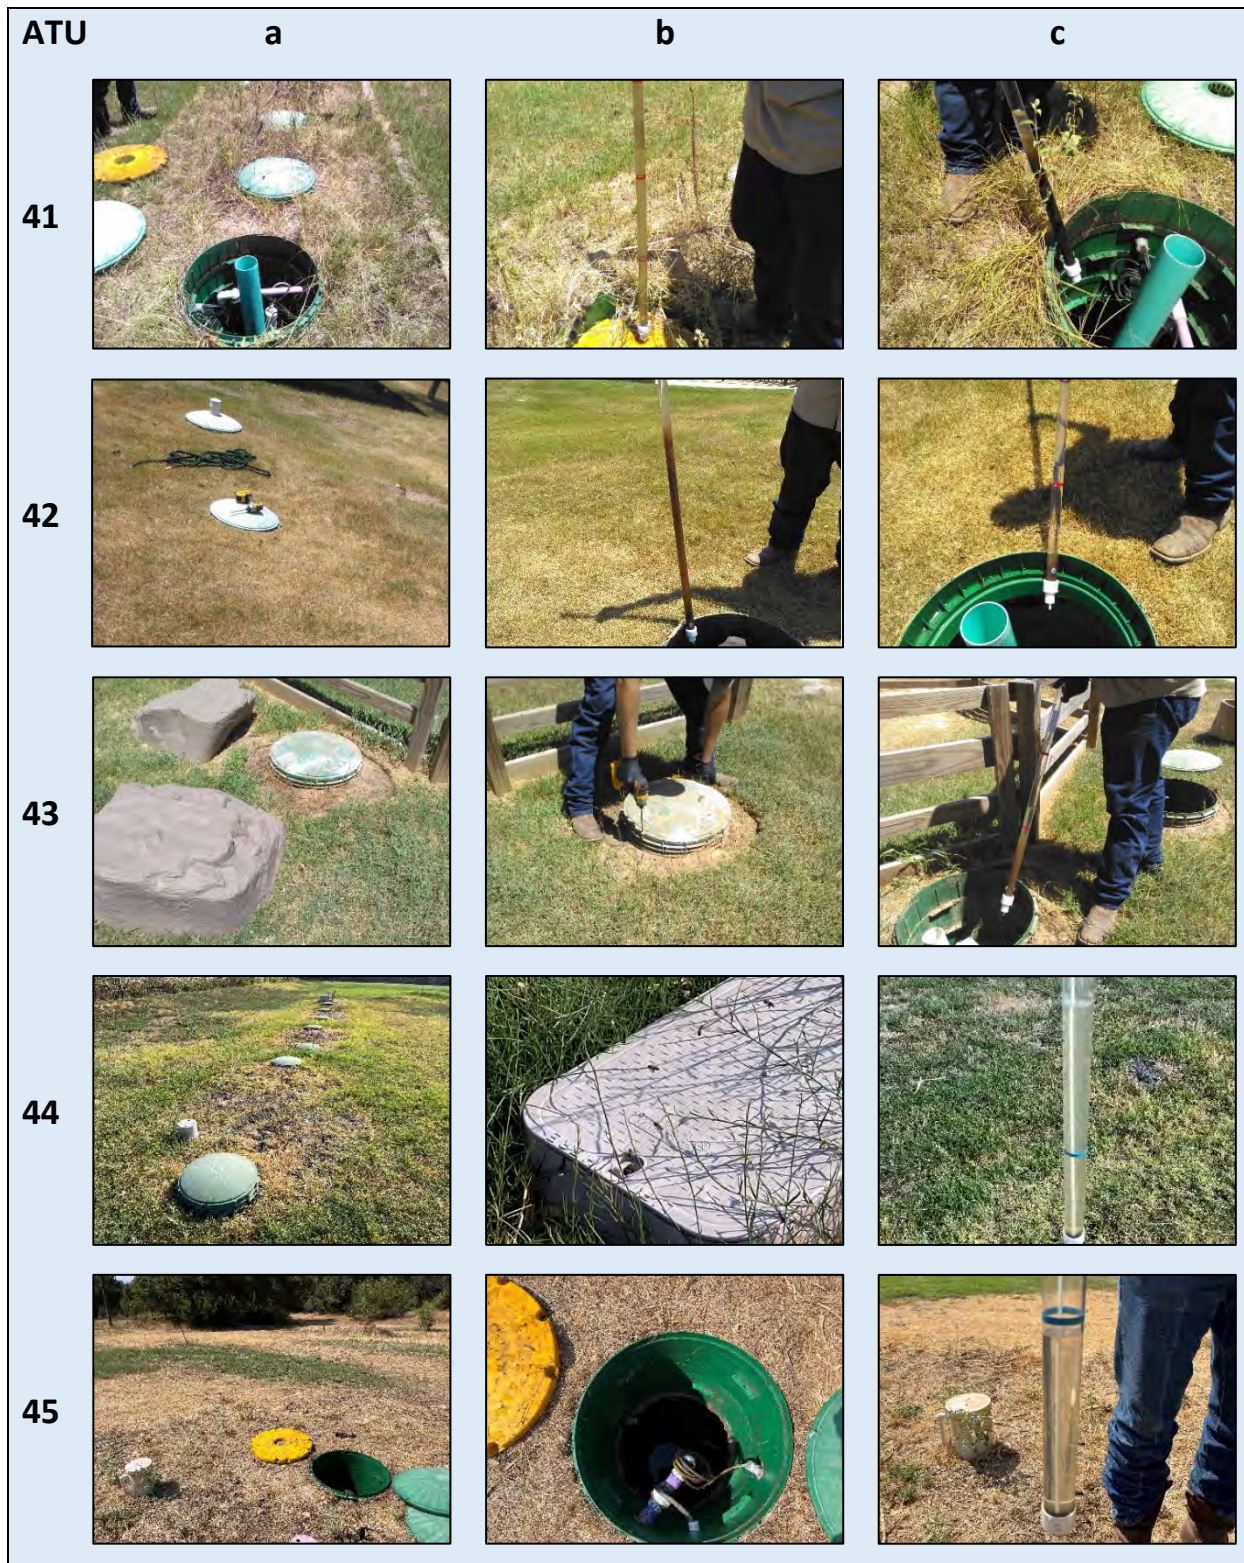
BOD ₅ (mg/L)	36	ND	15	34	22
TSS (mg/L)	17	ND	21	27	55
Additional Observations	Vegetation needs maintenance	Grass well-kept	Air compressor failure, needs ant control	Grass in drip field green, Beehive in effluent water meter box	RV park system with 101 spaces

Plate 9. Photographs of ATU systems 41 through 45. Designations a, b, and c generally show a) overall system, b) pump tank, chlorinator, or lid condition or other anomaly, and c) sludge condition (if available).
