Final Report
Work Period: September 1, 2021 – November 30, 2023

For Texas On-Site Sewage Facility (OSSF) Research Contract #582-21-10767

**Aerobic Treatment Units in the Real World
(Sampling and New Data)**

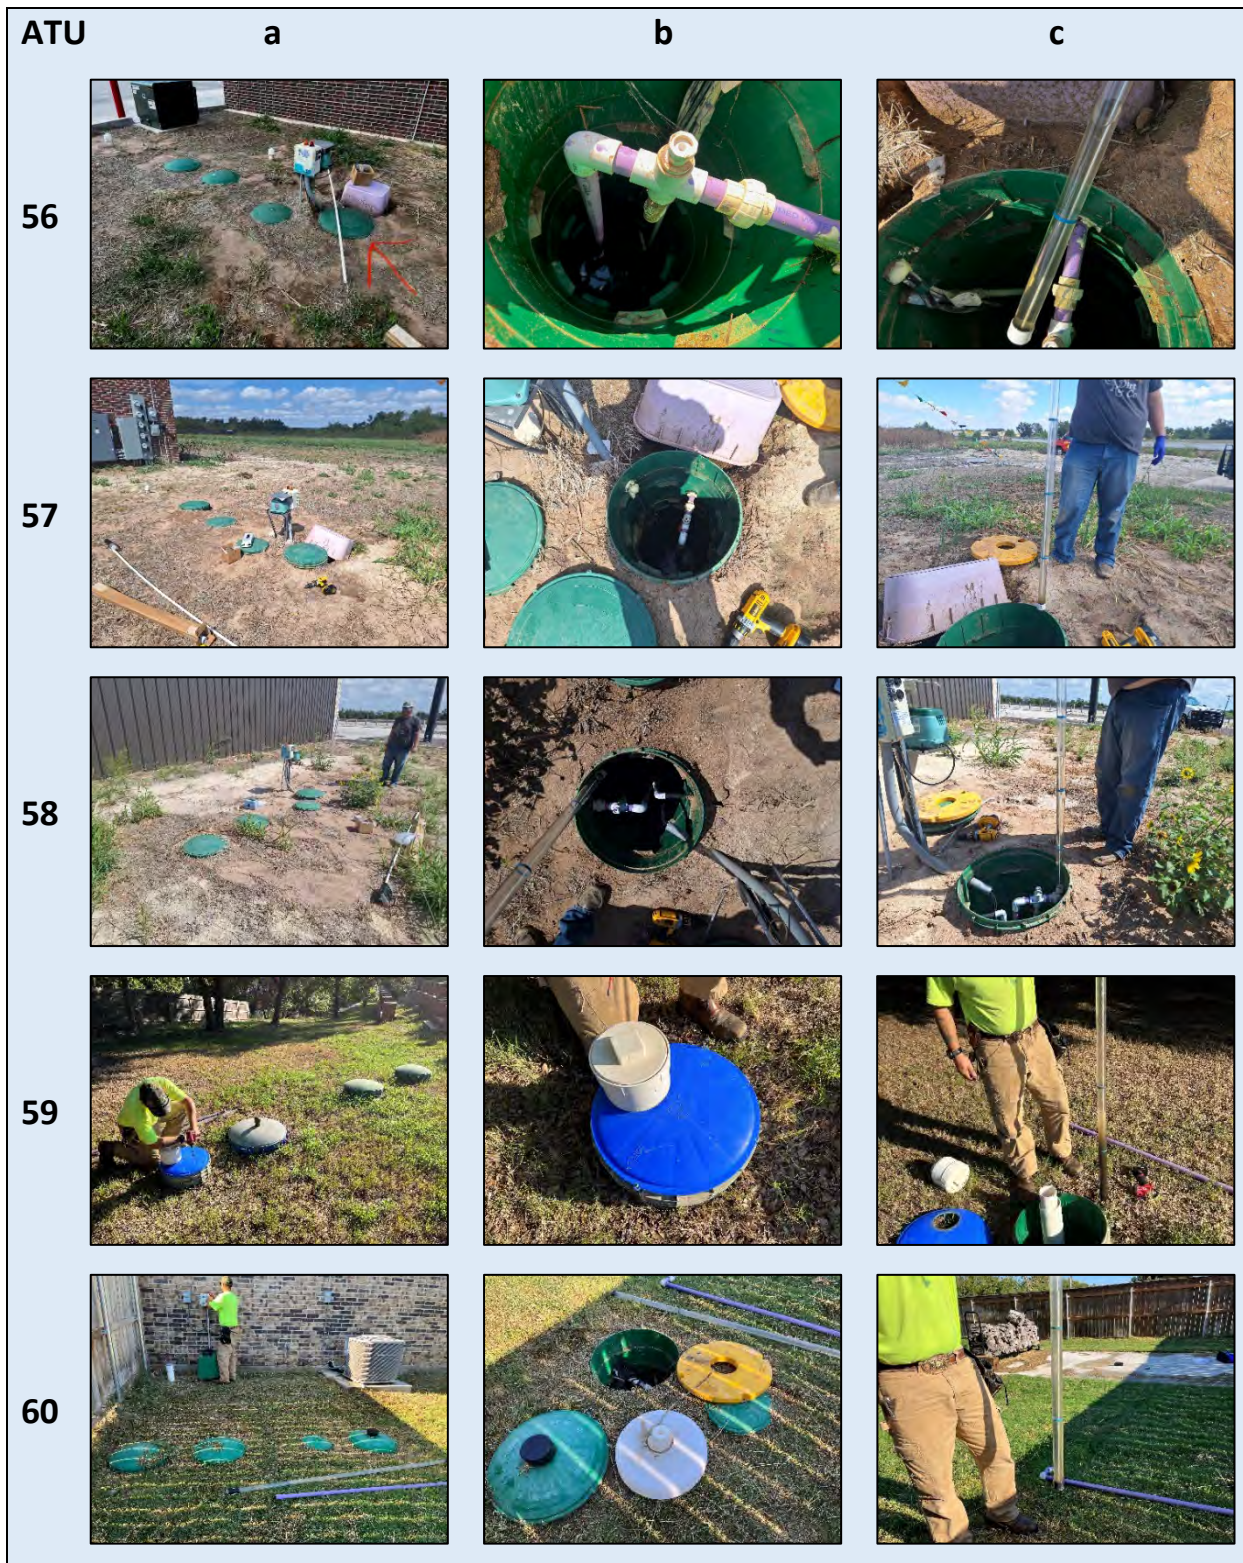
Plate 12. Photographs of ATU systems 56 through 60. Designations a, b, and c generally show a) overall system, b) pump tank, chlorinator, or lid condition or other anomaly, and c) sludge condition (if available).

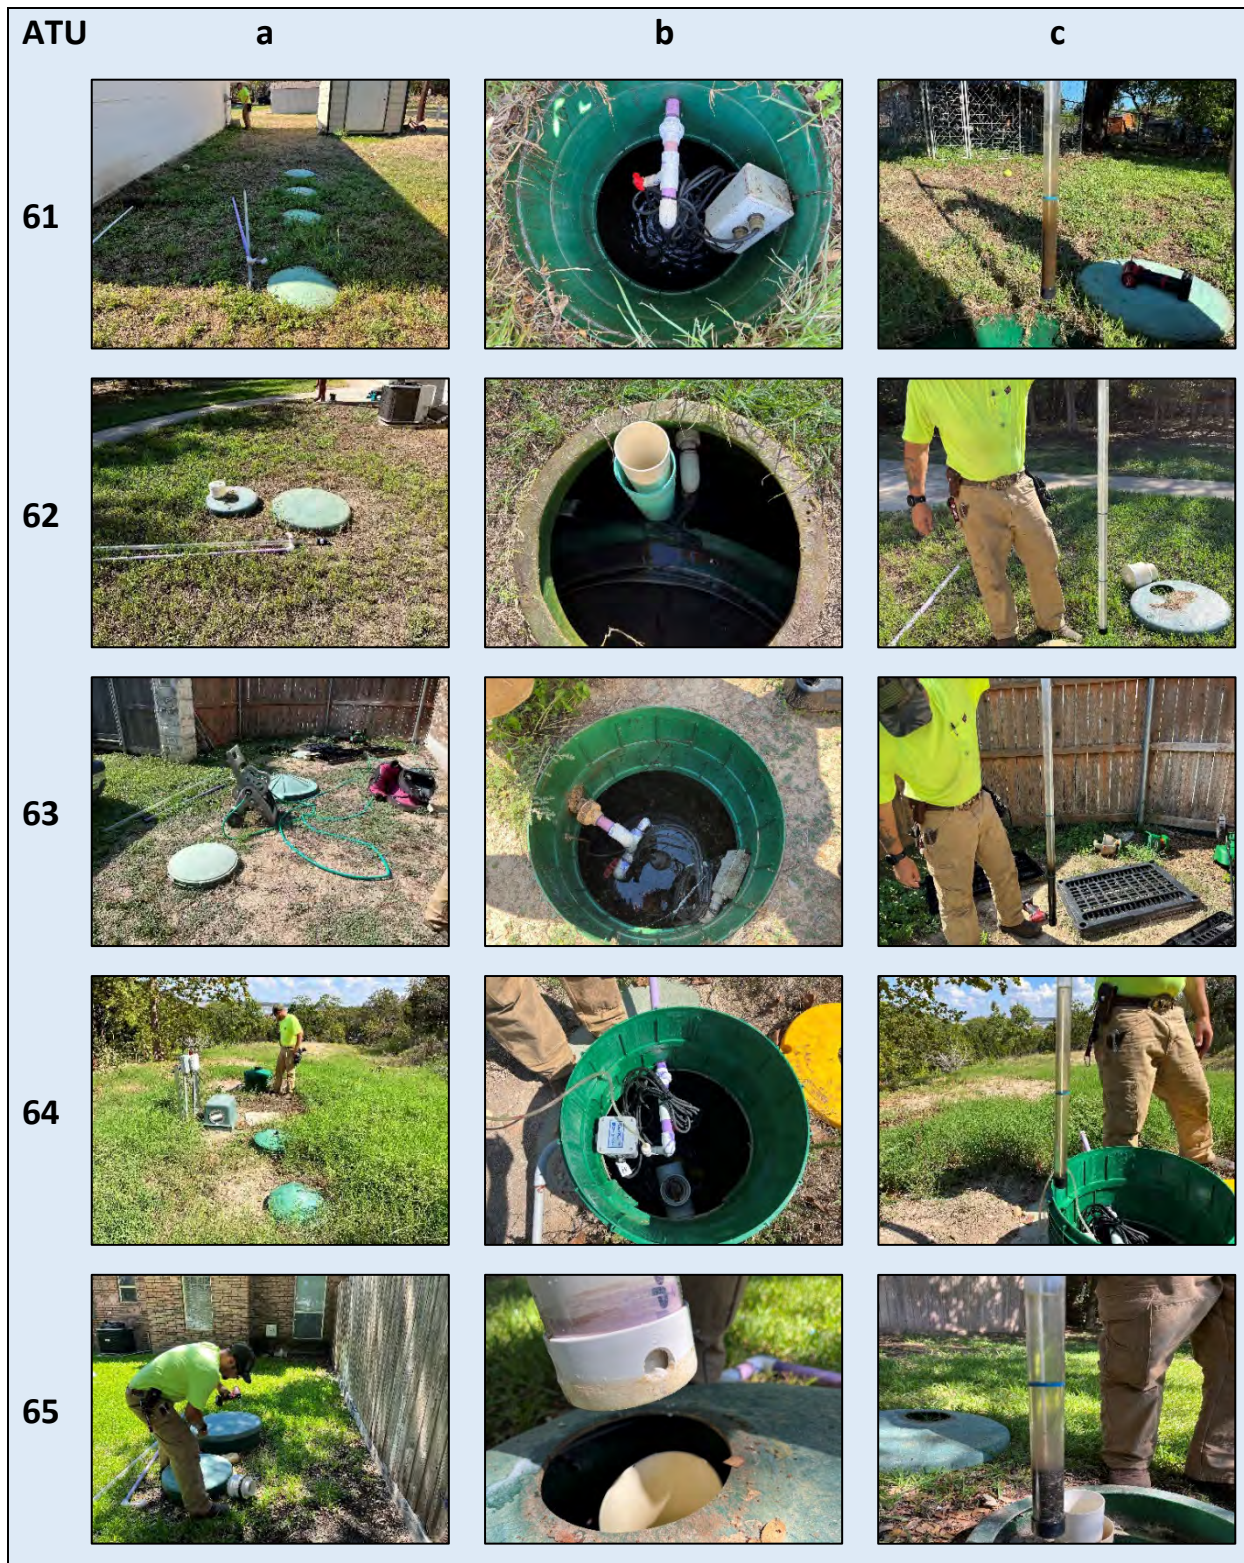
Plate 13. Photographs of ATU systems 61 through 65. Designations a, b, and c generally show a) overall system, b) pump tank, chlorinator, or lid condition or other anomaly, and c) sludge condition (if available).

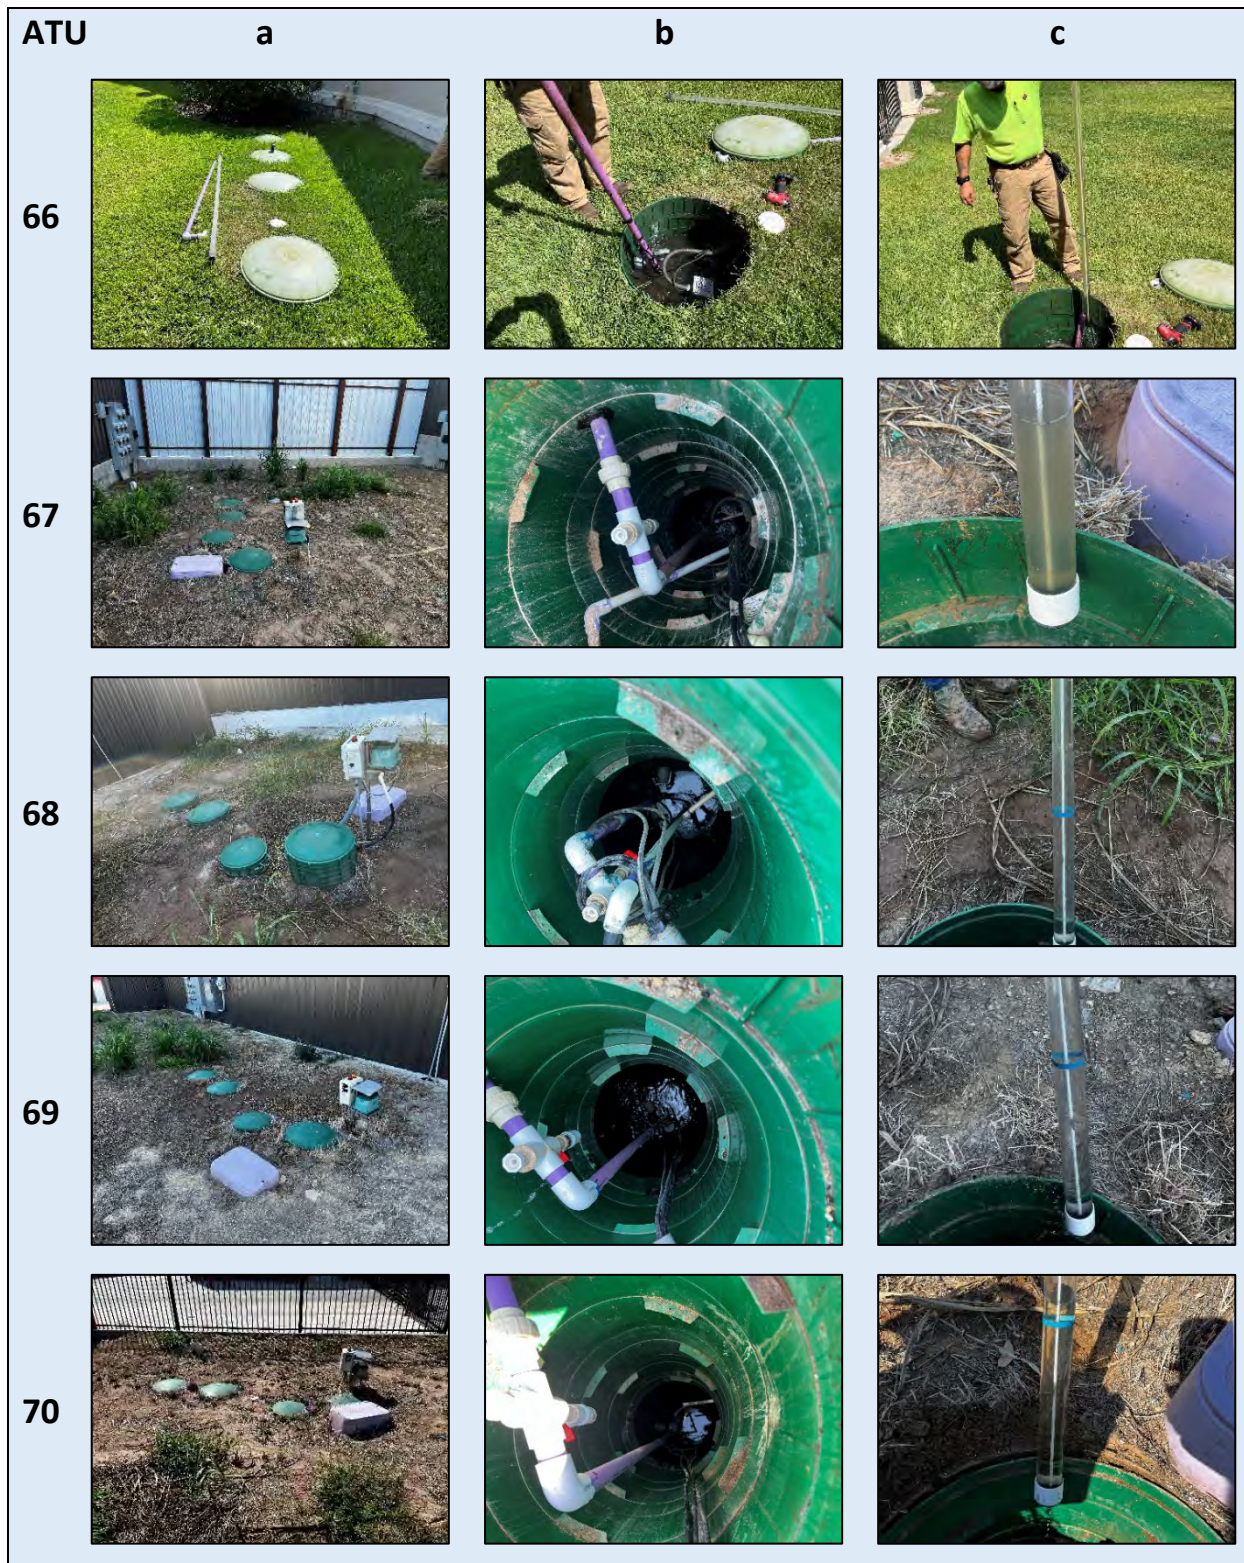
Plate 14. Photographs of ATU systems 66 through 70. Designations a, b, and c generally show a) overall system, b) pump tank, chlorinator, or lid condition or other anomaly, and c) sludge condition (if available).

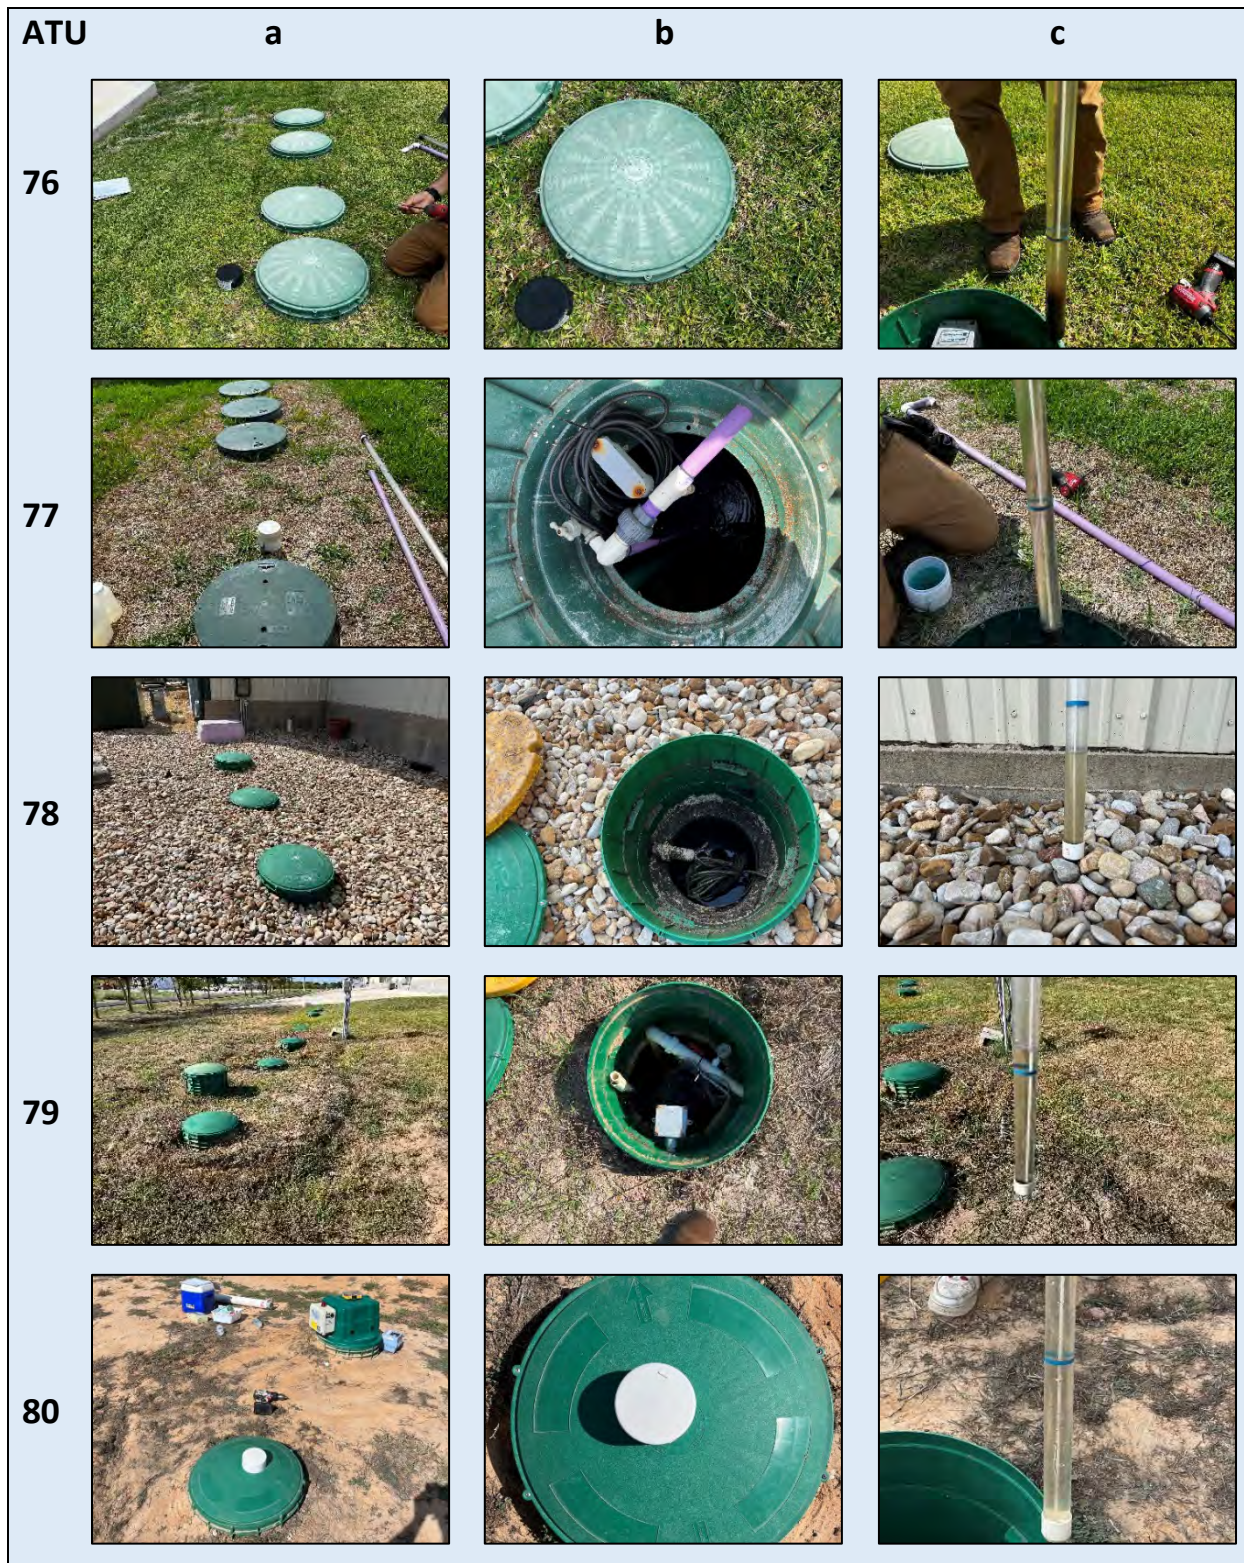
Plate 16. Photographs of ATU systems 76 through 80. Designations a, b, and c generally show a) overall system, b) pump tank, chlorinator, or lid condition or other anomaly, and c) sludge condition (if available).

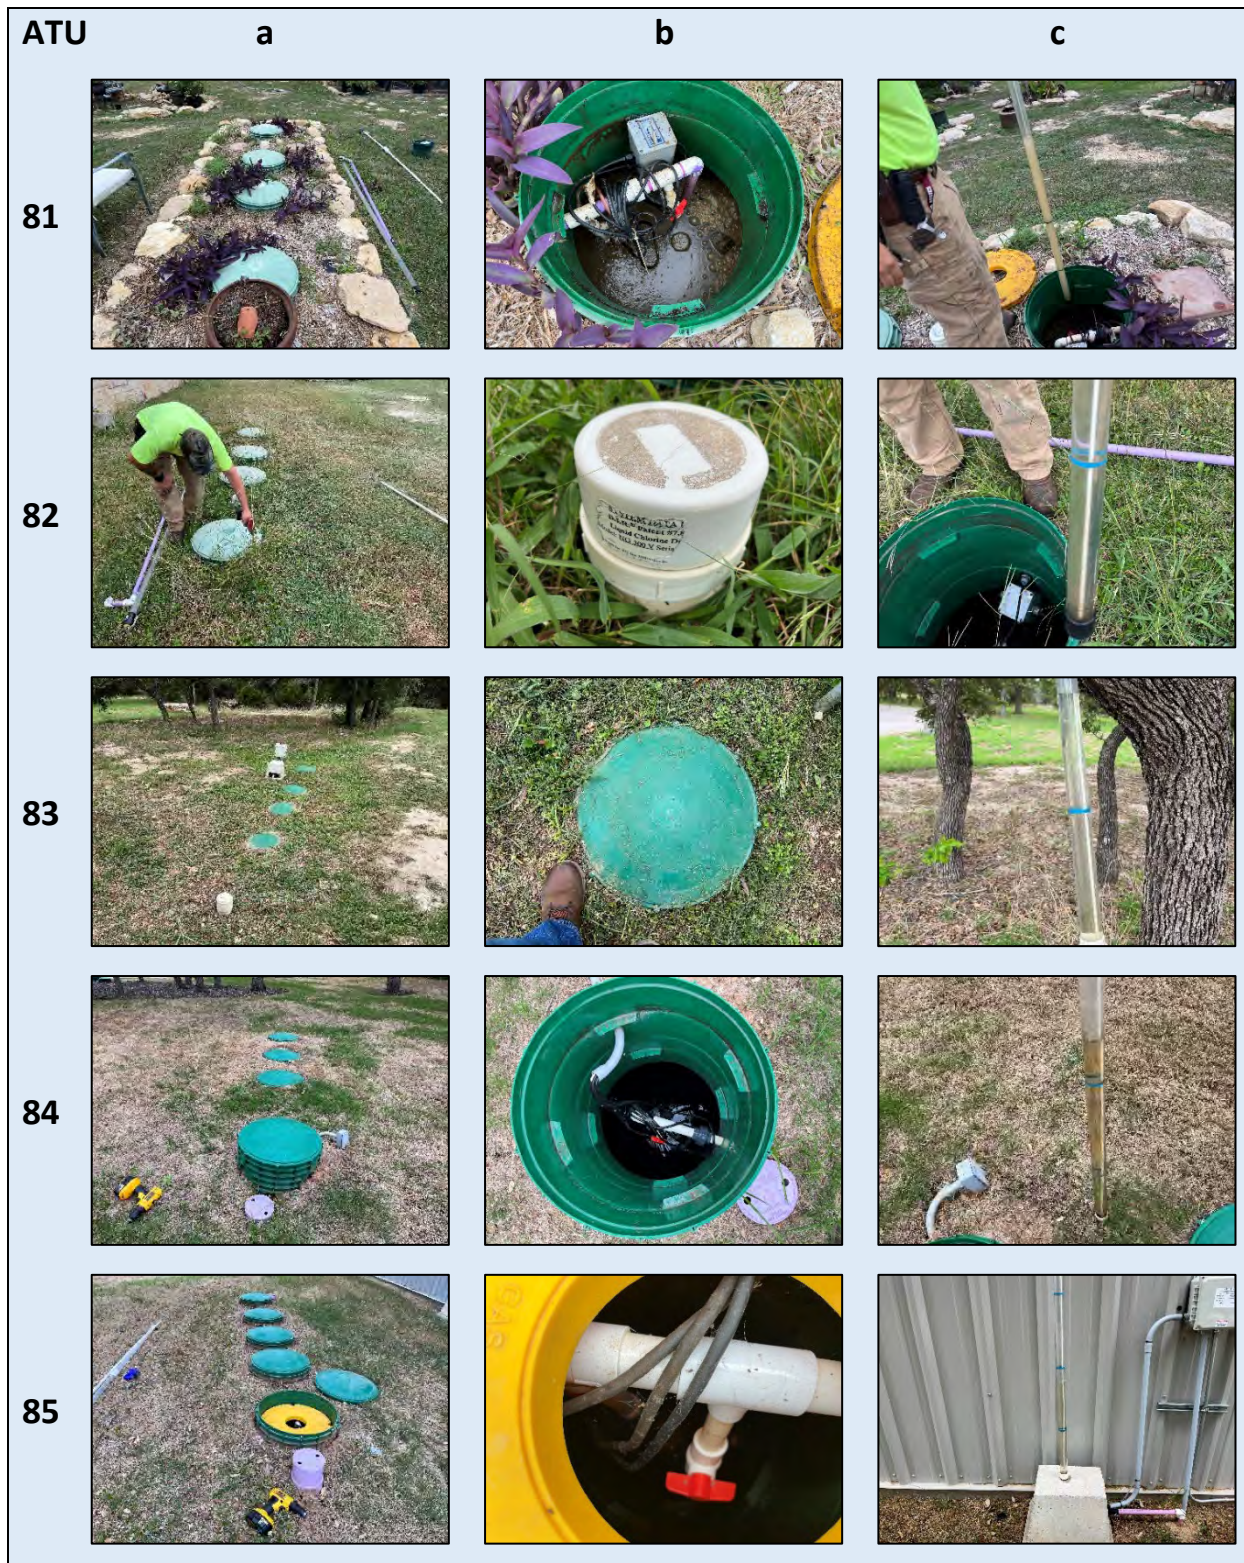
Plate 17. Photographs of ATU systems 81 through 85. Designations a, b, and c generally show a) overall system, b) pump tank, chlorinator, or lid condition or other anomaly, and c) sludge condition (if available).

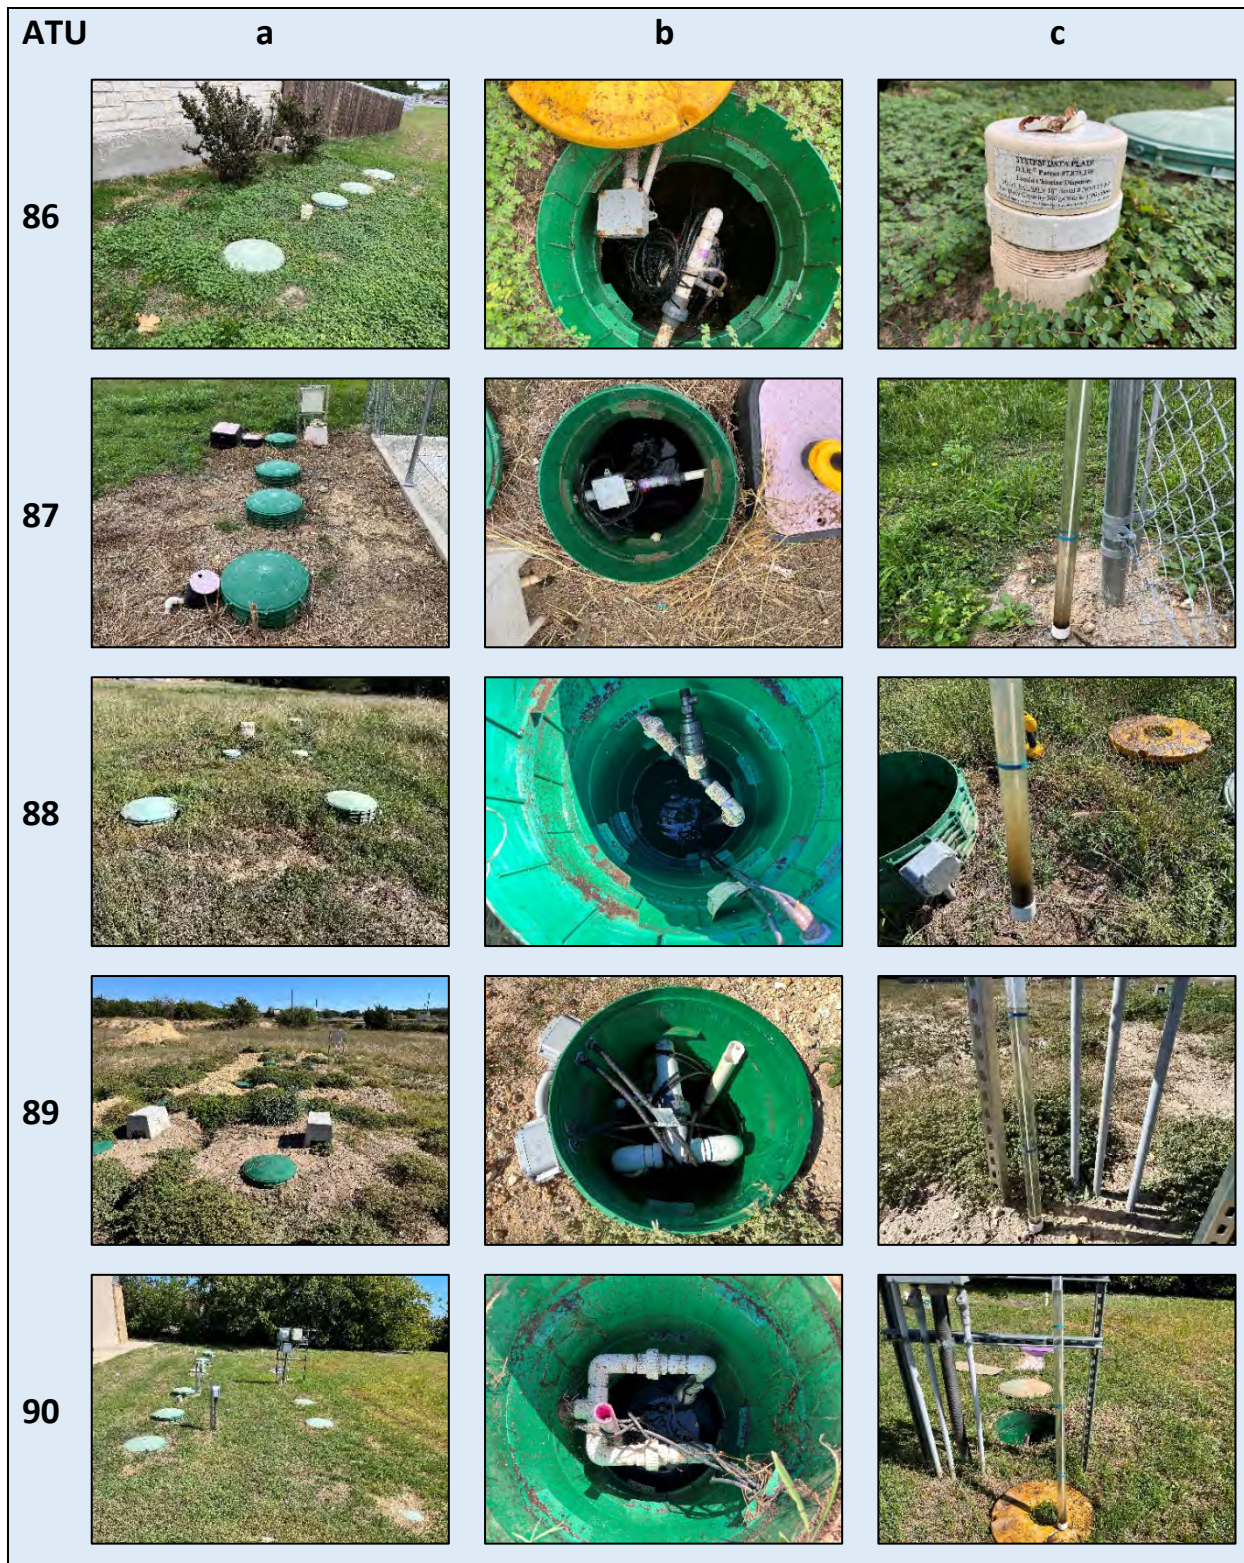
Plate 18. Photographs of ATU systems 86 through 90. Designations a, b, and c generally show a) overall system, b) pump tank, chlorinator, or lid condition or other anomaly, and c) sludge condition (if available).

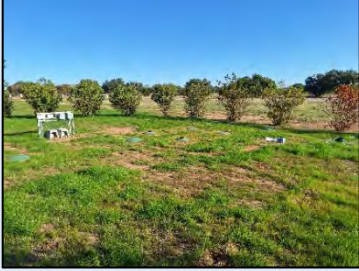
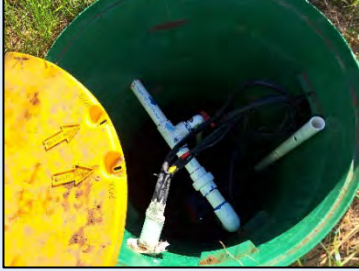
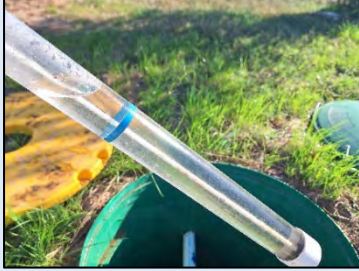
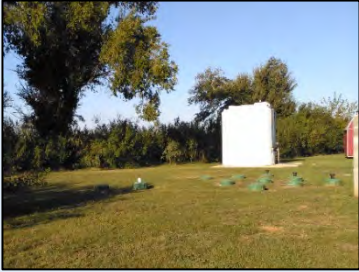
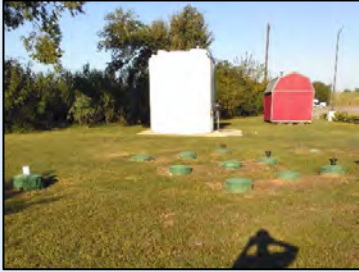
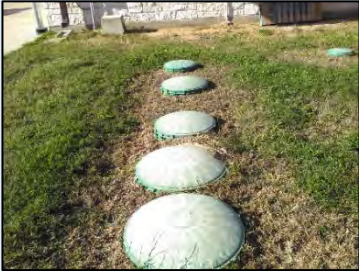
Plate 20. Photographs of ATU systems 96 through 100. Designations a, b, and c generally show a) overall system, b) pump tank, chlorinator, or lid condition or other anomaly, and c) sludge condition (if available).

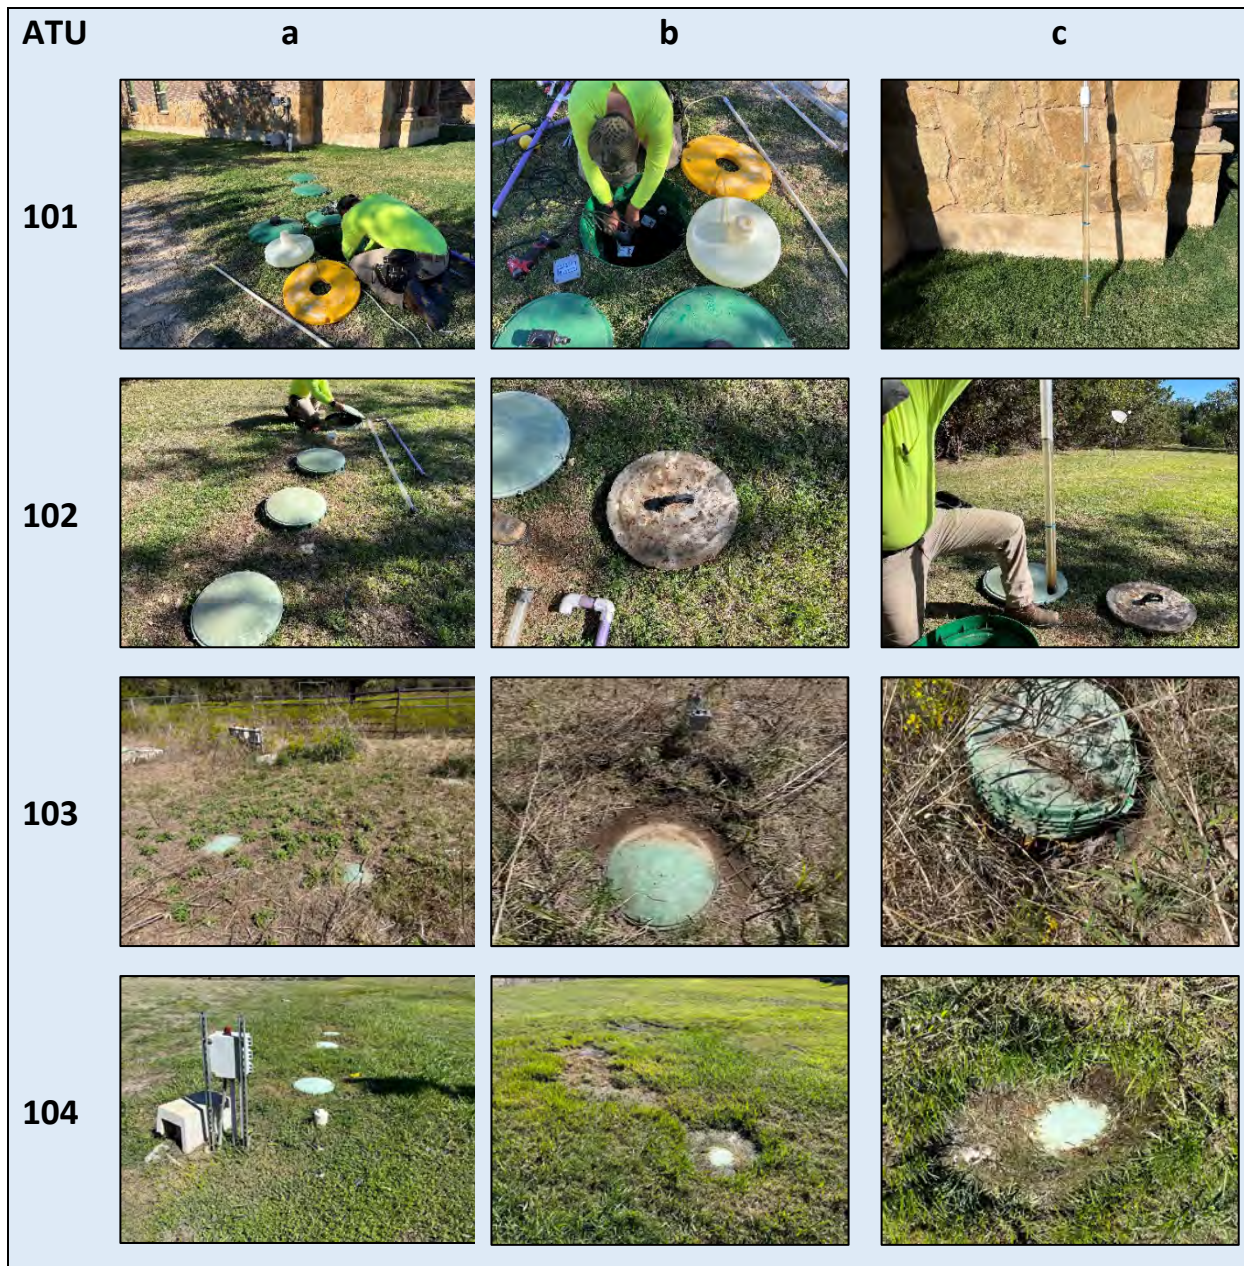
Plate 21. Photographs of ATU systems 101 through 104. Designations a, b, and c generally show a) overall system, b) pump tank, chlorinator, or lid condition or other anomaly, and c) sludge condition (if available).
