## Final Report Work Period: September 1, 2021 – November 30, 2023

For Texas On-Site Sewage Facility (OSSF) Research Contract #582-22-31192

# Understanding Problems and Identifying Solutions for Texas OSSFs using Drip Irrigation

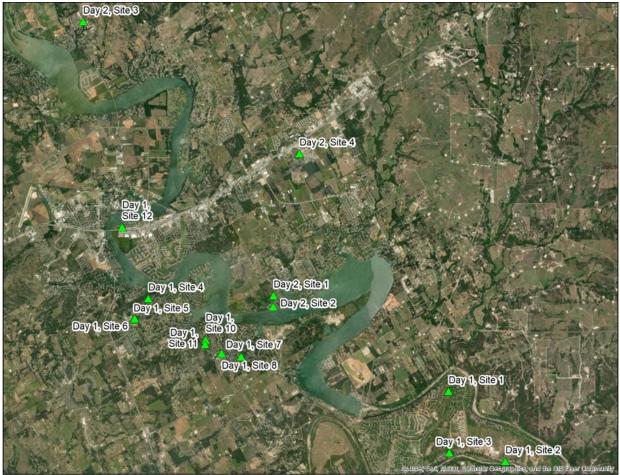
Field visits conducted in Texas during the research project included a two-day tour of the Hood County drip systems on May 3-4, 2023, near Lake Granbury. The Health Department staff, local designers, and installers guided the visit to observe and understand real world problems (Fig. 7). The following information was summarized at the end of the visit:

- Frequent issues:
  - Wrong timer settings/models.
  - Surfacing on first year.
  - External runoff on drain field.
  - Intermittent use (e.g., B&B).
- Recommendations:
  - Homeowner education.
  - Adding gravel bedding material and/or valves to isolate areas.
  - Monitoring.
  - Timer settings.
  - o Maintenance.
  - "Feed" system in vacant periods.
  - Managing runoff.

Figure 7. Sites visited with the Hood County health department staff near Lake Granbury to see operating conditions of existing drip systems and new installations (May 3 and 4, 2023).

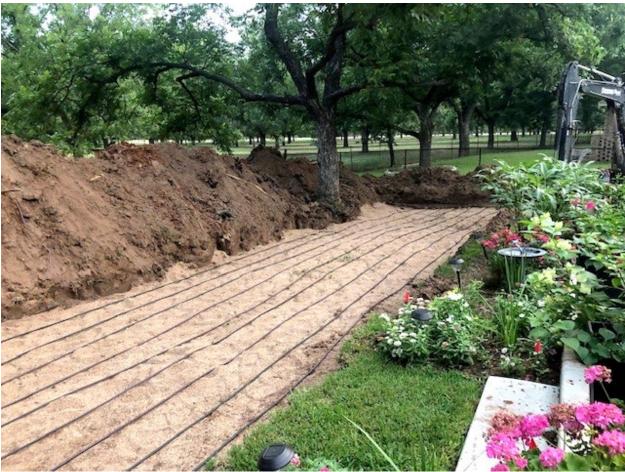
Based on a follow up interview with the Health Department, conducted at the end of the summer 2023, a new contractor was then hired (after the visit by AgriLife here reported) and started repairing the system in July 2023. During the repair, the contractor found old leaching chambers under the drip full of water. The contractor dug up the chambers and filled the entire area with the gravel material that he uses for his drip installation and installed a new drip system (Fig. 10). Upon revisiting the site in May 2024, the repaired drip field appeared to have fixed the effluent surfacing problems and the homeowner indicated that the system was finally working fine for them (Fig. 11).

Figure 10. Pecan Plantation site (Site # 1-1). Image taken at installation in July 2023 (Photos taken by homeowner)

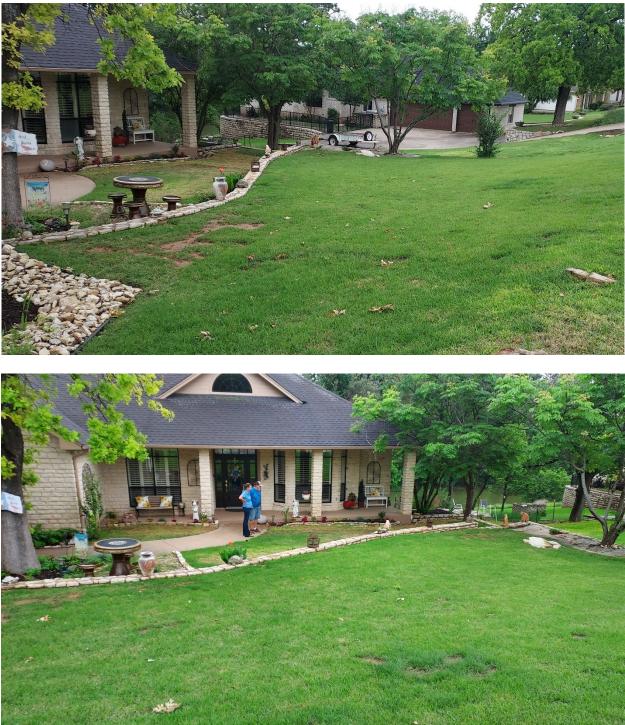
Figure 12 shows another property where the same contractor was installing a repair system using his approach for drip systems. Based on a follow up interview with the Health Department, the repaired system started operating on July 14, 2023, and no problems had been noticed, although very little rain had fallen since the repair. Figure 13 shows the photos taken during the follow-up visit in May 2024, where the system was observed to be operating in good condition. These observations suggest that it may be beneficial in certain site conditions to use gravel bedding for installation of drip systems.

Figure 13. Site # 1-2, visited on May 2, 2024 (Photo Anish Jantrania).

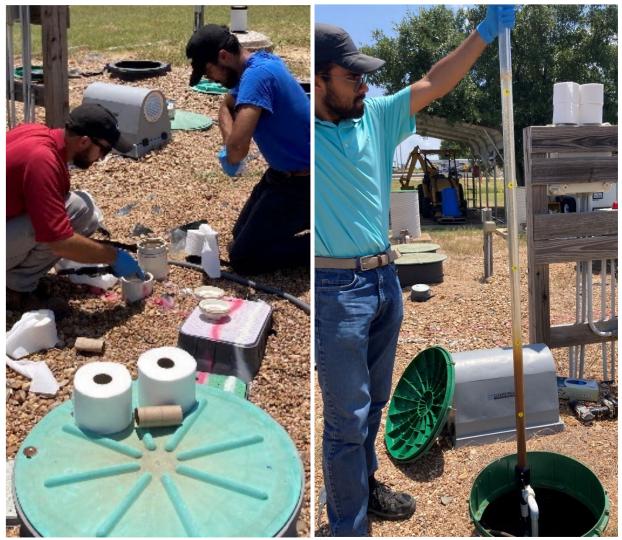
Figure 28. After initial pump filters' clogging, toilet paper started to be added in the clean outs between the trash and the aeration tanks (LEFT, July 28, 2023). Later, sludge was collected from the aeration tank instead of the MBR system (RIGHT, September 15, 2023).

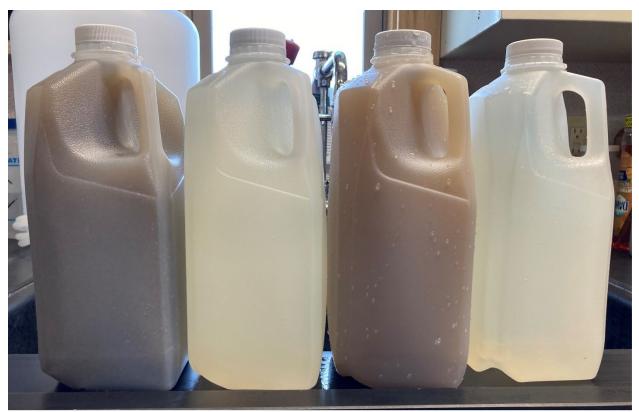
Return flow water was sampled and sent to the lab for analysis of TSS on September 7, 2023. Other samples were collected and observed only visually on July 28, 2023. In both cases, filters being compared were simple screen vs Dual Aztec filter screen. September 7 samples had similar concentration (respectively, 6,520 and 4,840 mg/L) and were much higher than the ones found for the samples from the bottom of the trash tank (about 20 times). Visual observations suggested a similar pattern and revealed that after a few seconds of flow, the color of the return water was again comparable to the color of the water from the bottom of the tank (Figs. 37-40).

Figure 37. Visual comparison of samples collected from the pump tank bottom and from the return flow on July 28, 2023. From left to right: Sc pump, Sc return, Sc.A/D tank, Sc.A/D return.

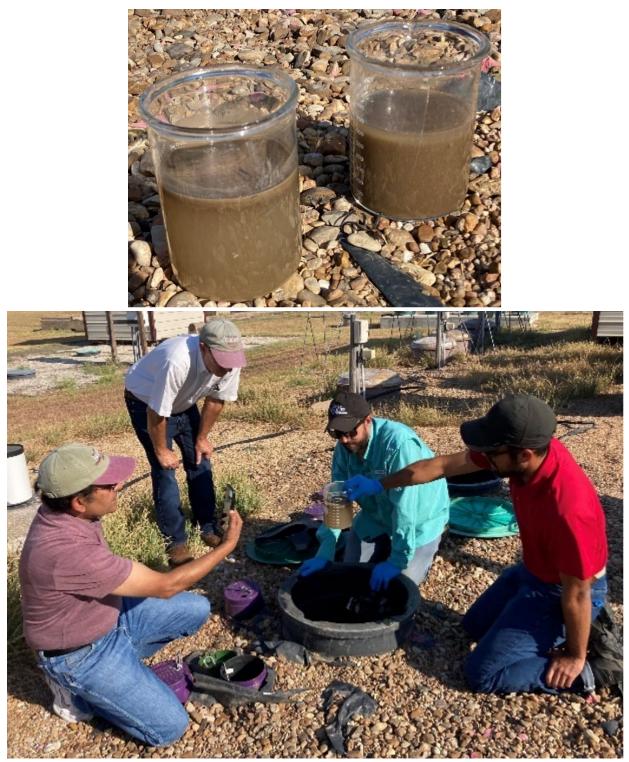
Figure 38. Visual comparison of samples collected from return flow on September 7, 2023. Initial samples (Sc sample, TOP LEFT, Sc.A/D, TOP RIGHT), collection moments (BOTTOM).

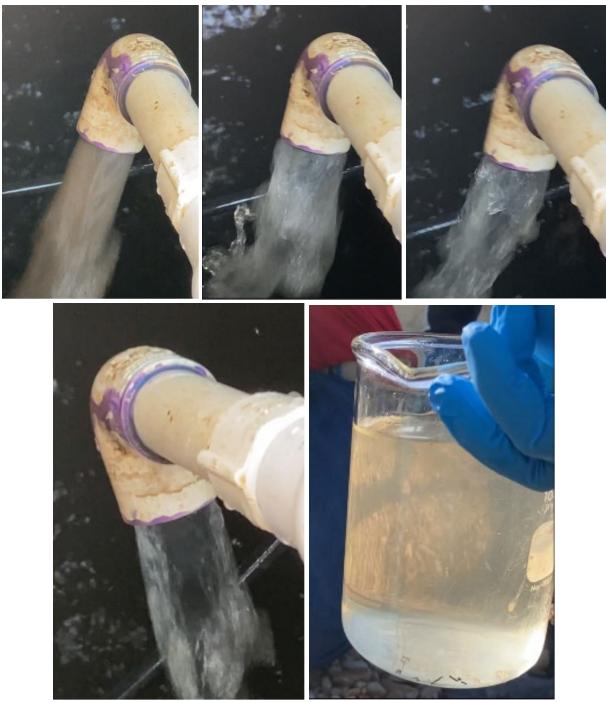
Figure 39. Visual comparison of samples collected from the return flow on September 7, 2023. Changing color progression and final sample from the Sc line (from top left to bottom right).

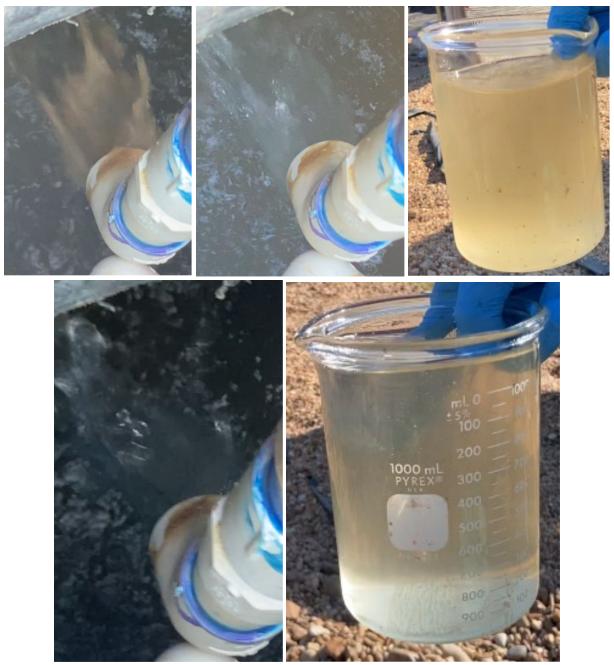
Figure 40. Visual comparison of samples collected from the return flow on September 7, 2023. Changing color progression and final sample from the Sc.A/D line (from top left to bottom right).
